# No. 09 – Brno – arch bridge over Hybešova street

railway truss arch bridge

CTU

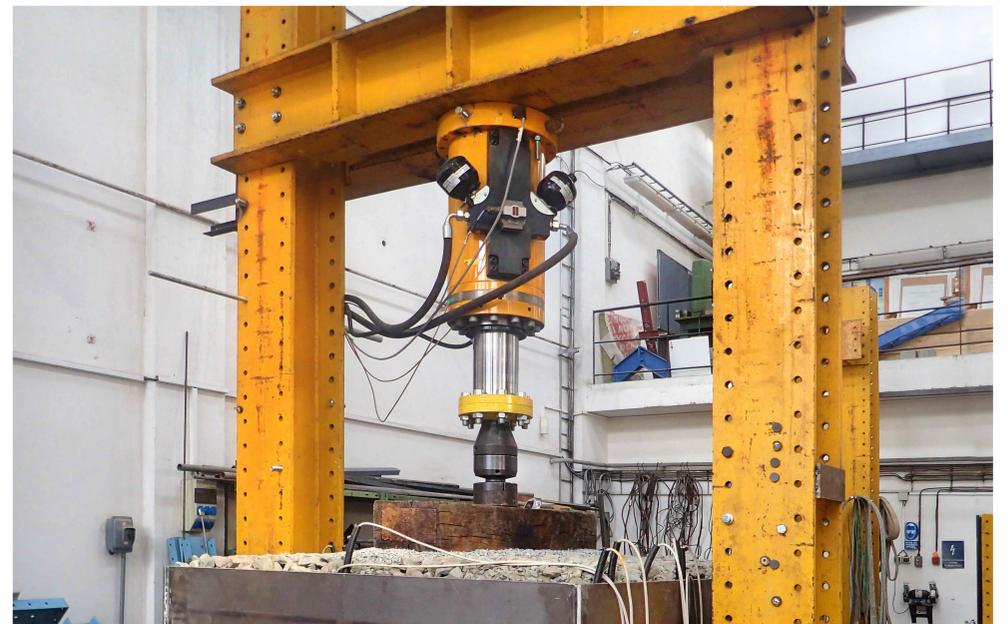
After these tests, static and dynamic loading tests were carried out. A test set-up was created for the load test. The test assembly consisted of a steel frame, into which the plates of the existing historic buckle plates were riveted and then filled with gravel. A sleeper was placed on top of the gravel, through which the load was imposed. The loading was carried out under conditions corresponding to the actual loading of the buckle plate in the bridge. During the loading, the stresses and the vertical and horizontal deformation of the plate were measured.

Test assembly with gravel bed and sleeper

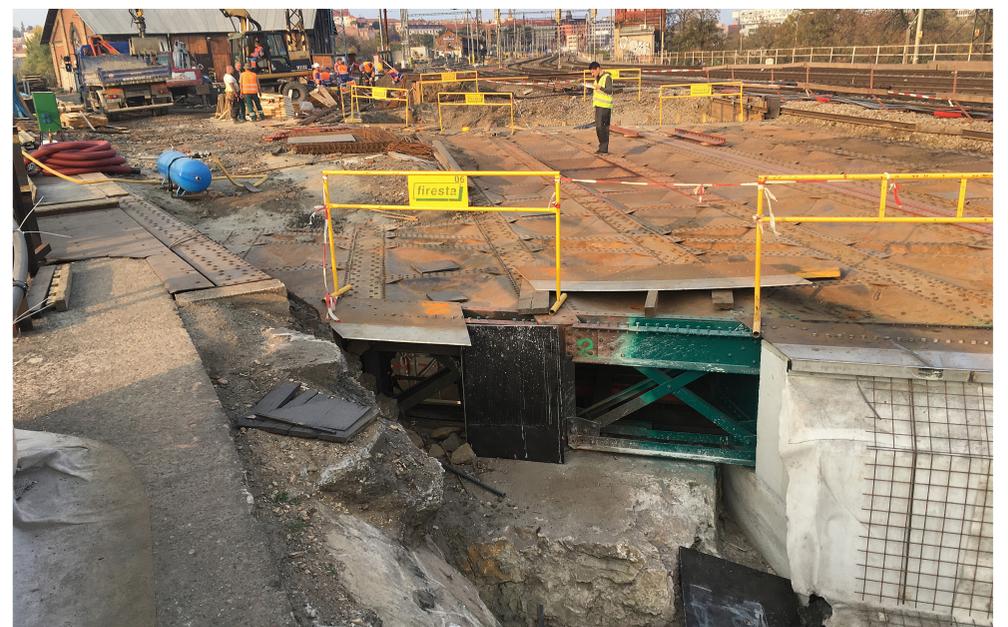
The bridge deck and coating of the end cross beam

The bridge is well maintained; a complete repair carried out in 2018 included the replacement of some bridge plates and the restoration of corrosion protection. After this repair, the bridge is in good condition. The future use of the bridge will be decided by the Brno city administration in conjunction with the renovation of the main railway station.
