No. 13 – Prague – railway bridge below Vyšehrad

railway truss girder bridge

TÚ 0201, DÚ 04, evd. km 3,706

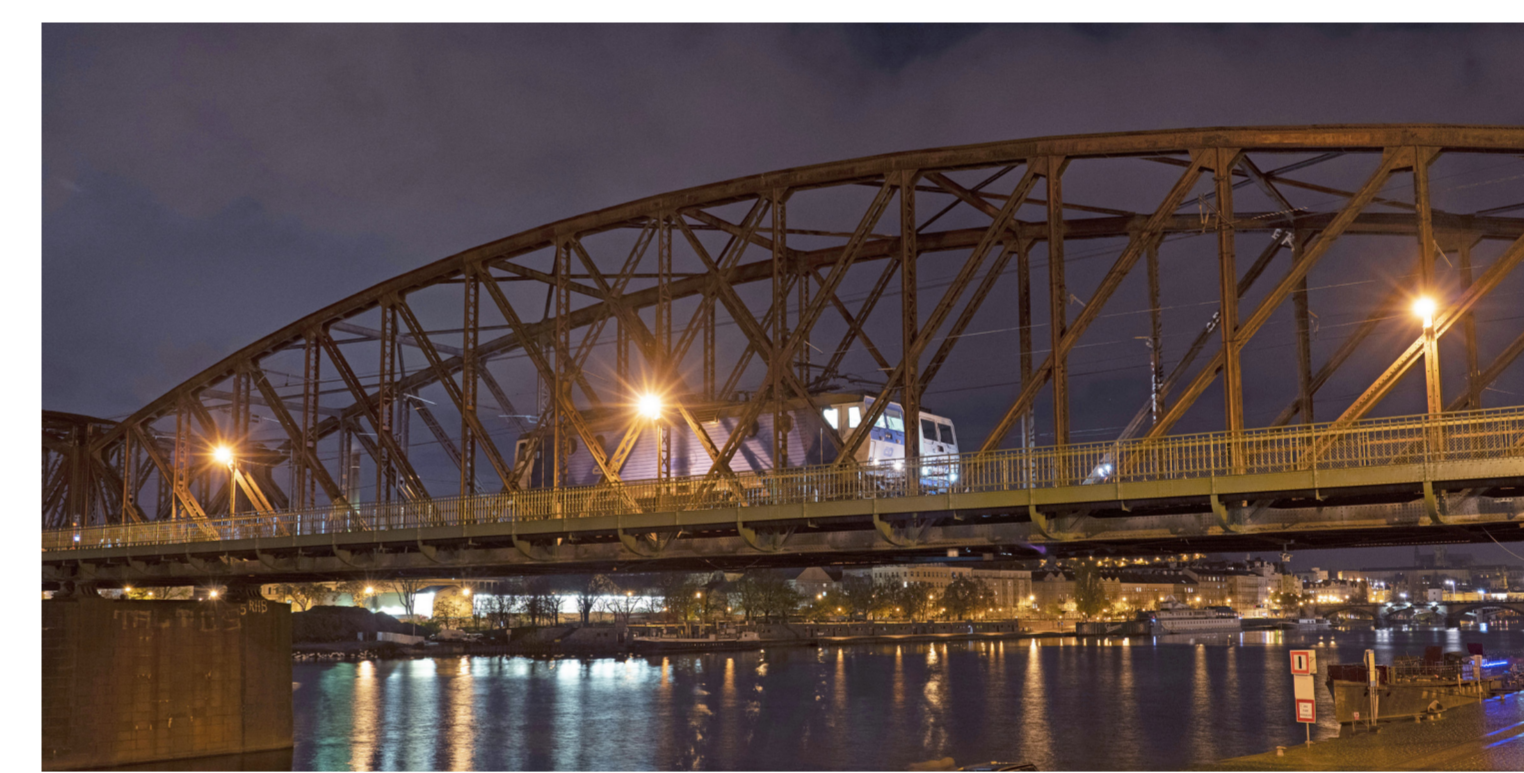
Load test

The notch toughness impact tests revealed that the structural material is not suitable for such a dynamically loaded structure due to likelihood of brittle fracture. Static and dynamic load tests were carried out in 2017; the following variables were measured:

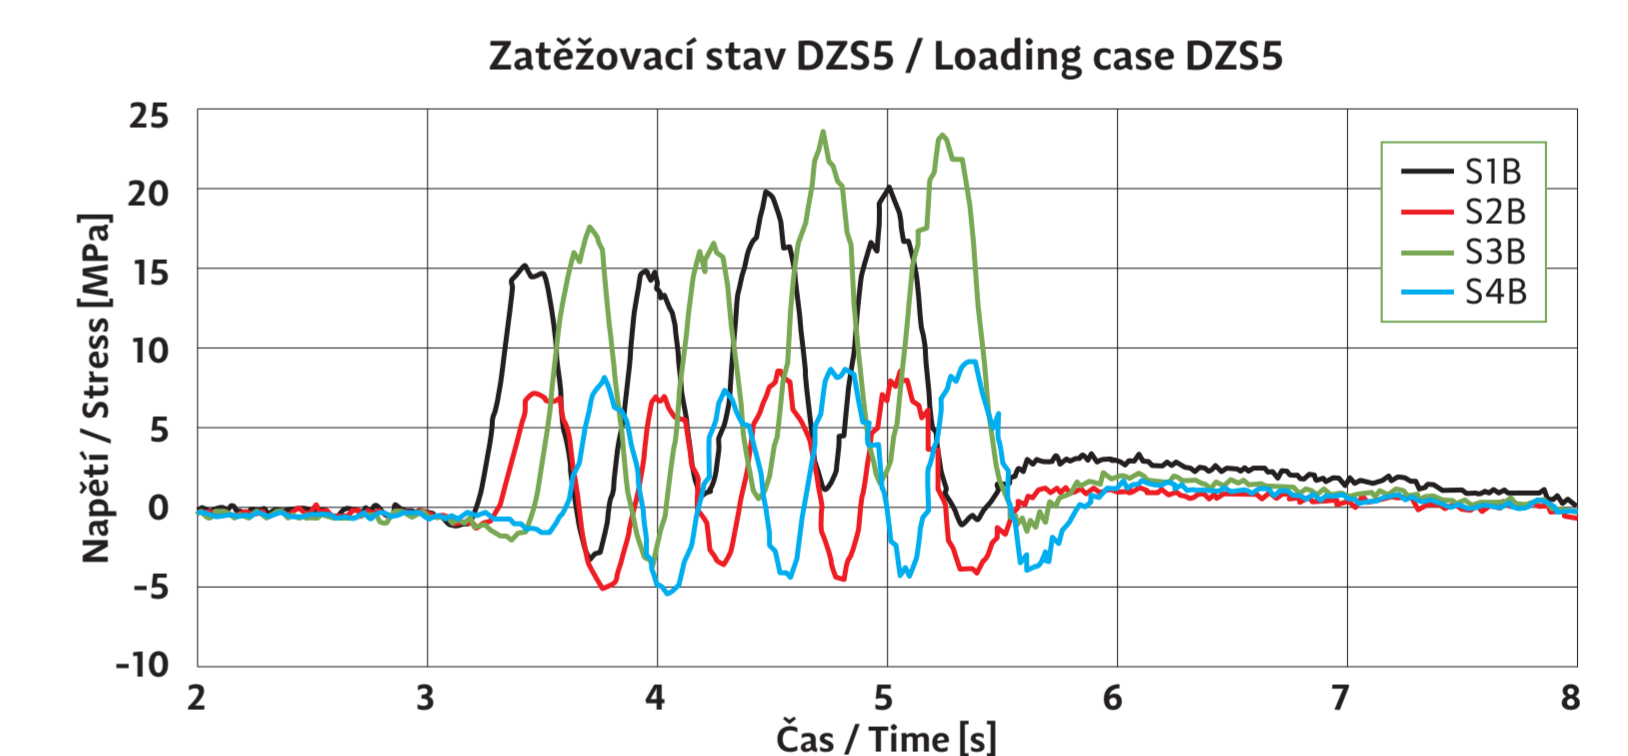
Time development of stresses during test

- vertical deflections
- deformations of the end crossbeams
- normal stresses on selected members (top and bottom chords, diagonals, crossbeams, stringers)

During the dynamic load test, acceleration of vertical and transverse deformation at mid-span and at approximately a quarter of the span and normal stresses on selected members (following the static tests) were measured.

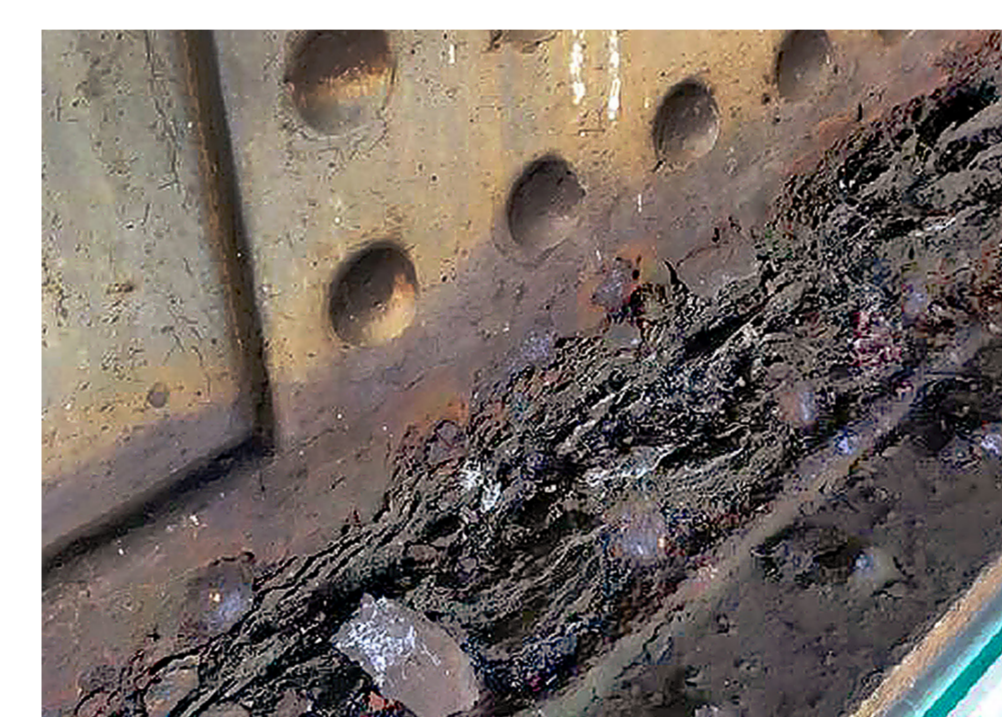
Bottom chord corrosion

- cracks in top flanges of stringers
- significant corrosion weakening of structural members
- excessive crevice corrosion
- missing bolts fixing bearings
- largely damaged corrosion protection of steel structure

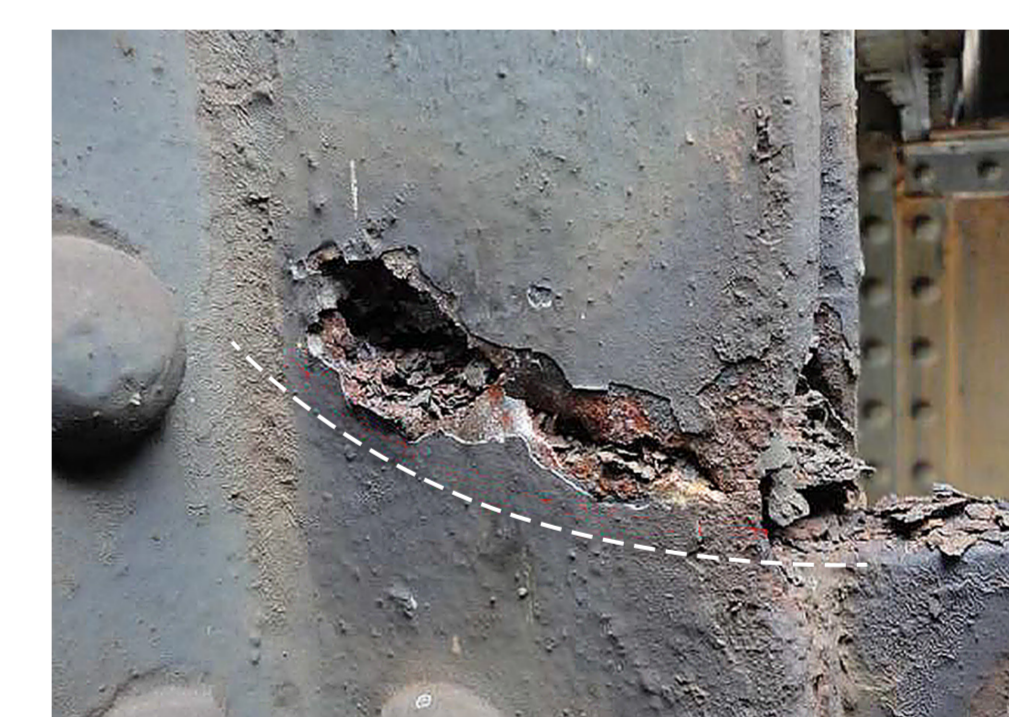
Crevice corrosion

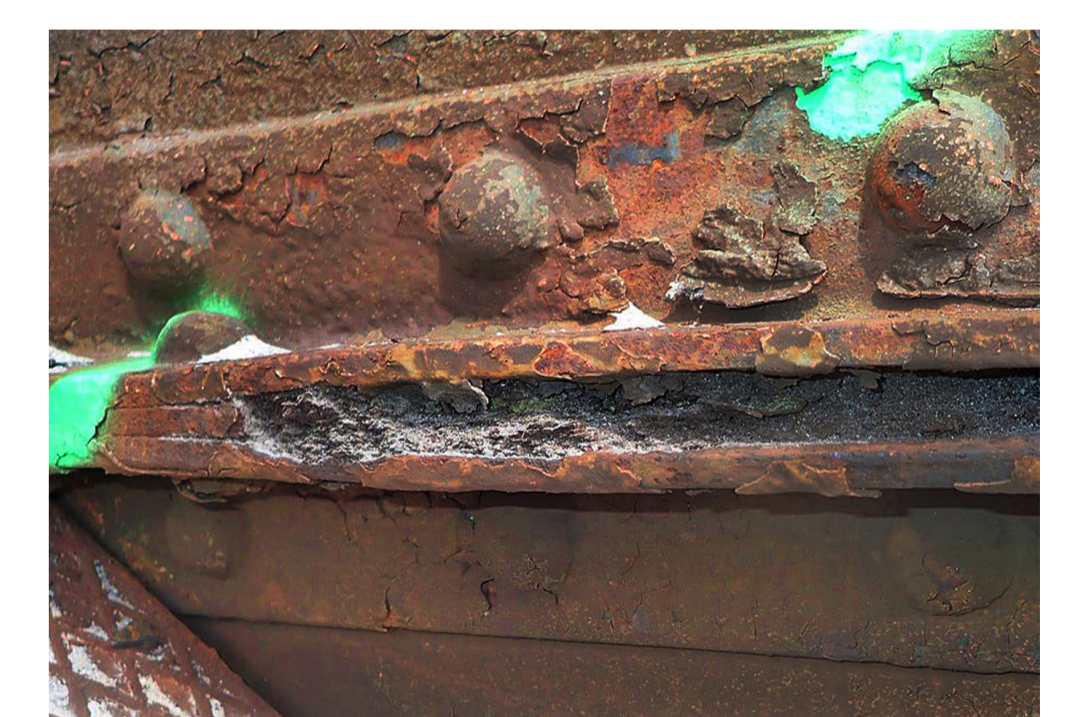
Gap between plates
