No. 48 – Prague – bridge of Svatopluk Čech

road and tram arch bridge

Technical features of the structure

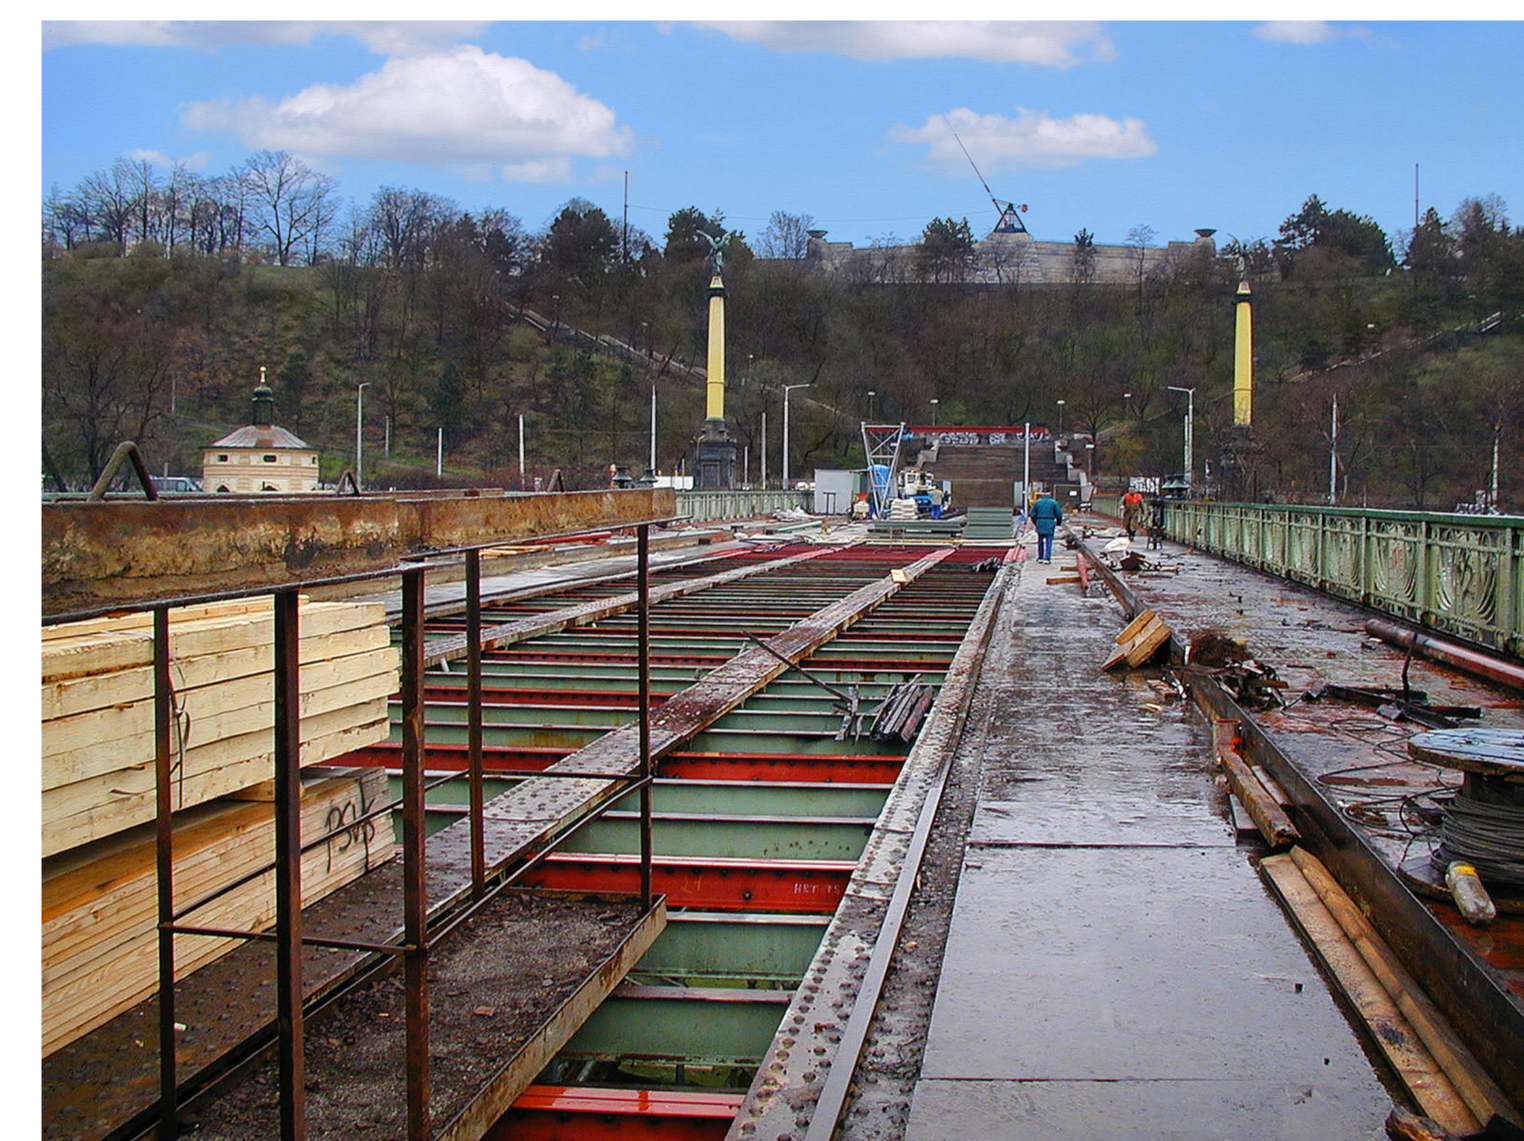
View of the bridge deck during reconstruction in 2000–2001

Some members of horizontal and transverse bracing were removed and replaced with new members of the same dimensions. The repair of the main beams consisted mainly in replacing a large number of rivets. In 1997, the left bank underpass of the bridge was rehabilitated. The steel structure of the bridge was reconstructed in 2000–2001. The subject of the reconstruction was the repair of the crossbeams and vertical bracing. In addition, new bracing was welded to the existing bridge deck plates, and the railing, expansion joints and public lighting were also repaired. In 2014, restoration work was carried out on the historic toll houses.

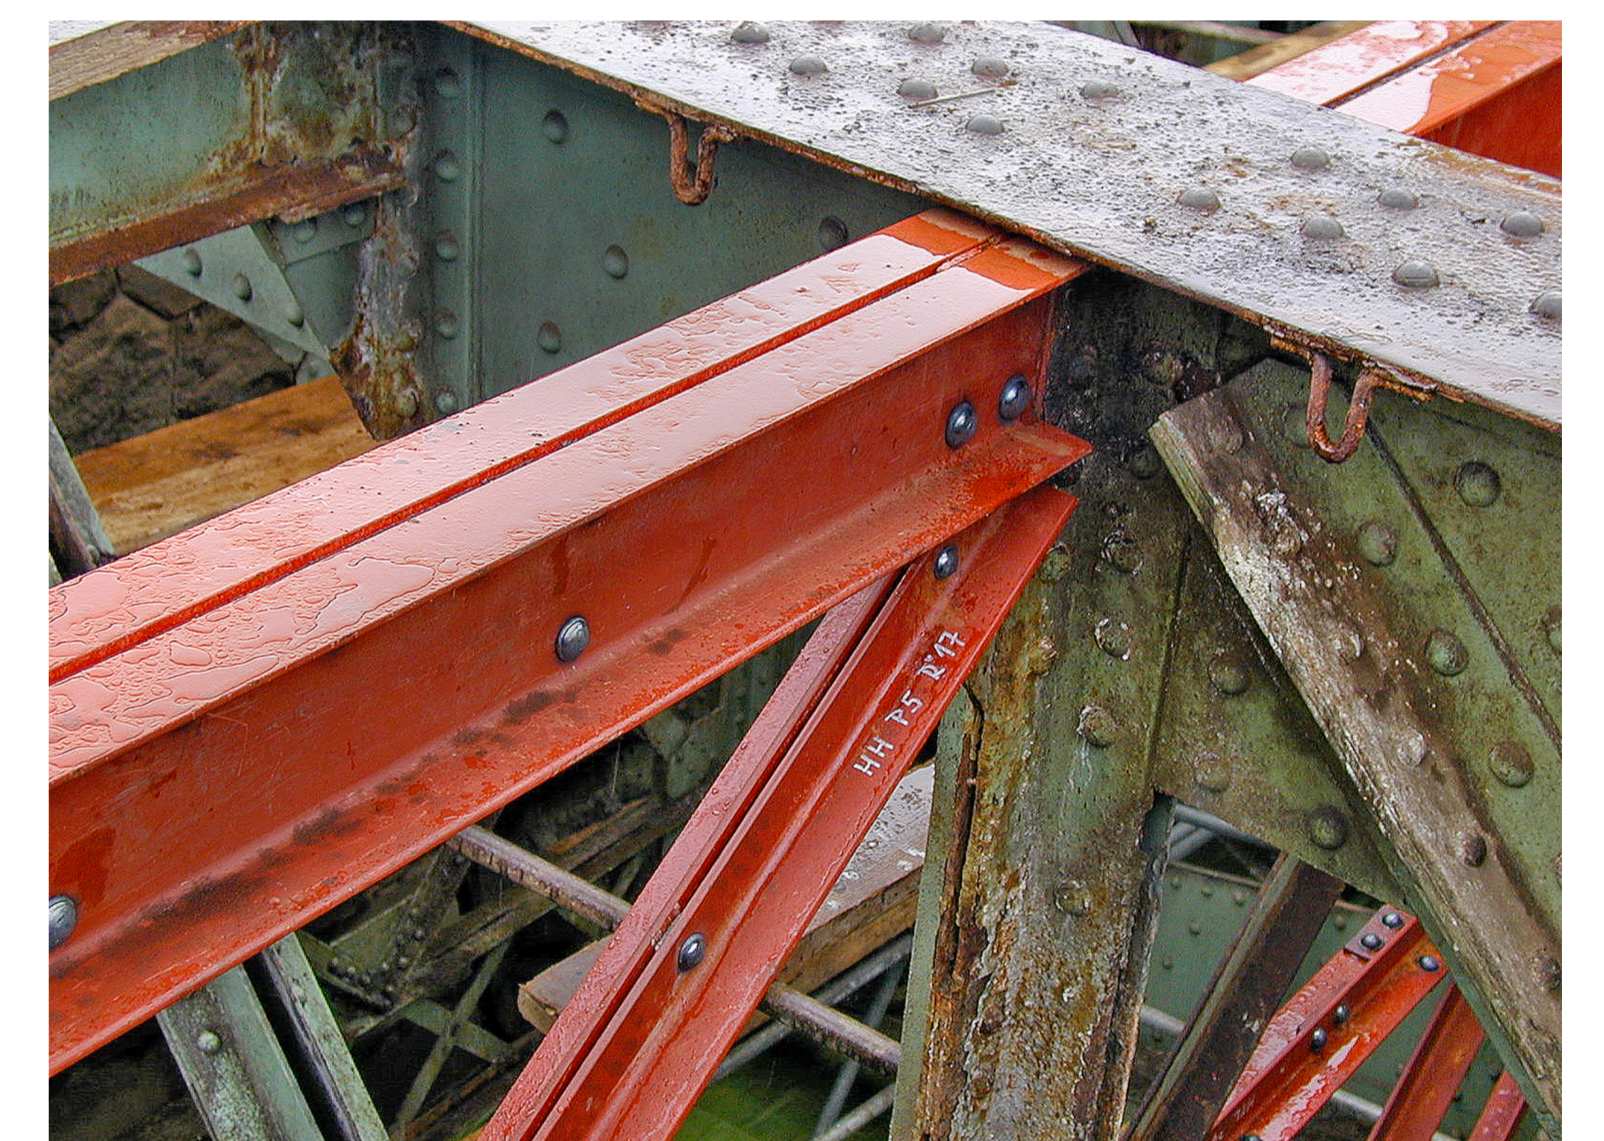
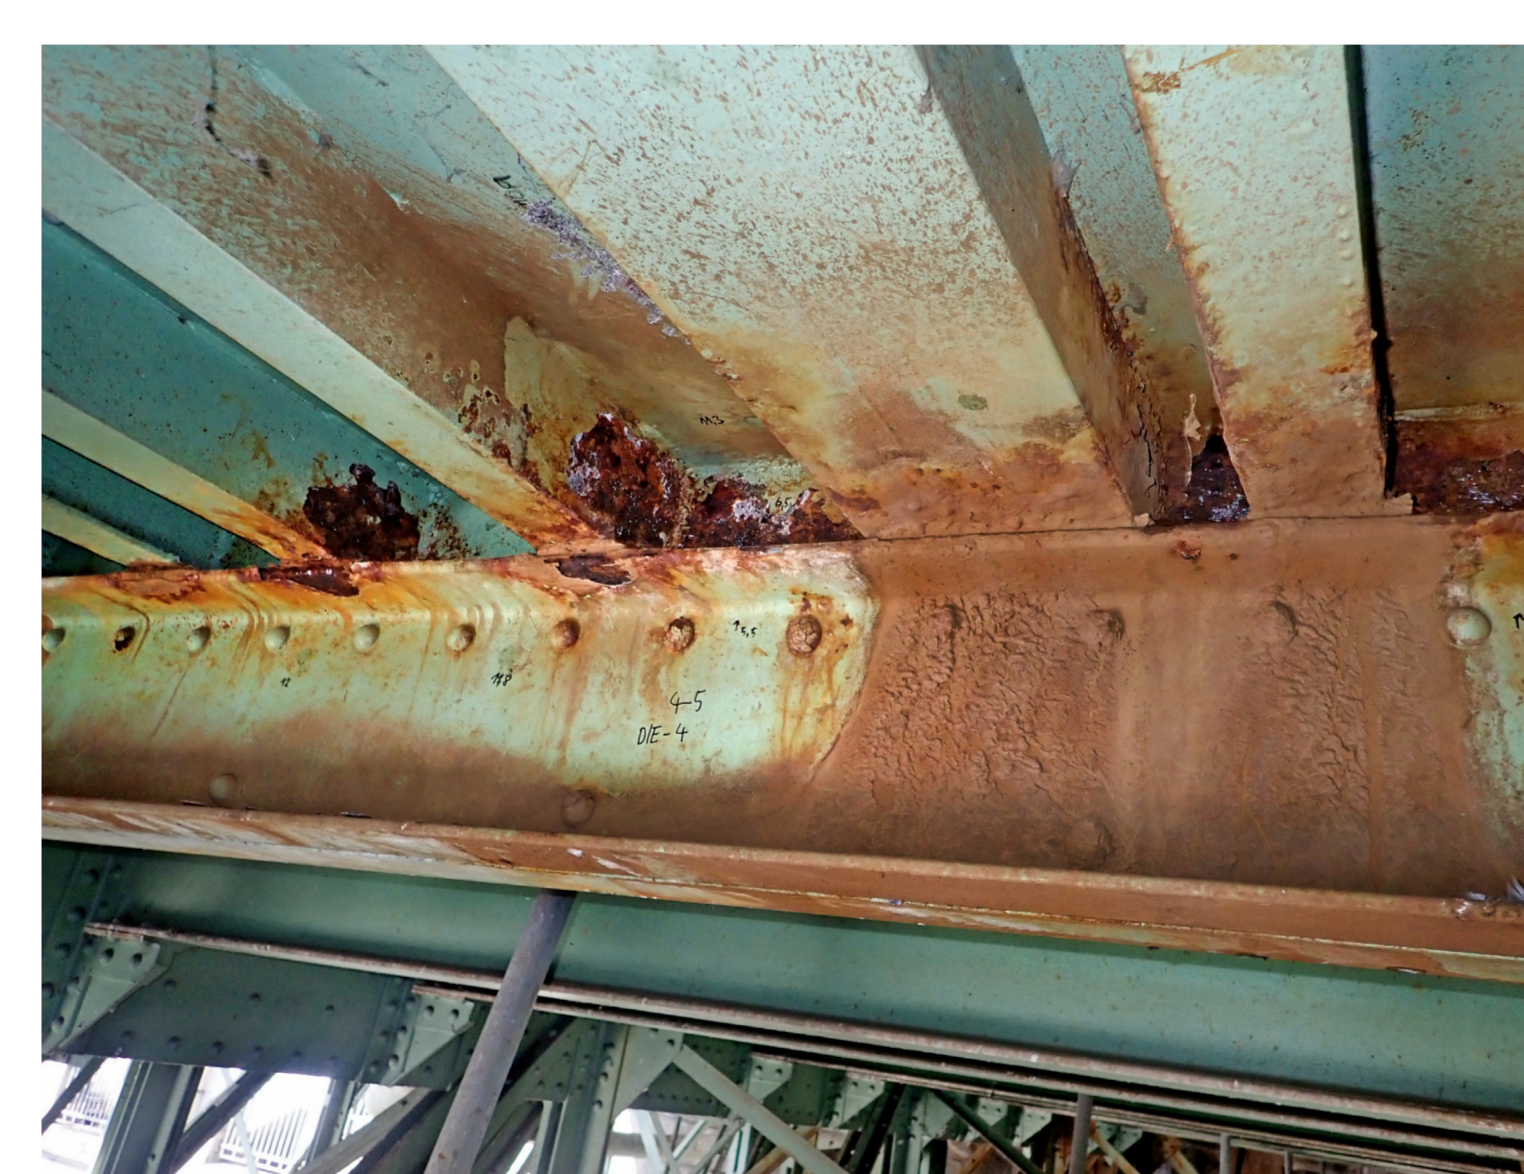
Cracks in bridge deck welds, leakage and leaching of dirt

The extensive survey of the bridge was carried out in 2020. The bridge deck and supporting members of the railing are the most damaged parts of the steel structure. The most characteristic defects are cracks in the bridge deck welds at the point of contact between the longitudinal stiffeners of the bridge deck slabs and the crossbeams. The cause of the weld defects is likely the dynamic effects from car and tram crossings, and inadequate fatigue details. For this reason, the welds are spalling off and subsequent deflections of the bridge are causing damage to the insulation. At the point of defect, clay impurities are flooded and washed away, and water causes surface and crevice corrosion. Crevice corrosion develops in the joint between the longitudinal bracing and the crossbeams. The crossbeams are formed by a pair of rolled U-sections with the webs oriented towards each other. The joint between the webs is subject to flaking, and defect of the corrosion protection leads to corrosion weakening of the U-sections. This defect is apparent in the crossbeams, where leakage occurs through the transverse joint between the deck plates. The existing supporting members of the railing structure are also severely corroded. In particular, the angles connecting the balustrade posts to the brackets are severely degraded, with severely corroded flakes spalling off the steel members. The railings and the cornice are in a state of disrepair. However, reconstruction of the railing and cornice members is currently underway, and an overall renovation is being planned.

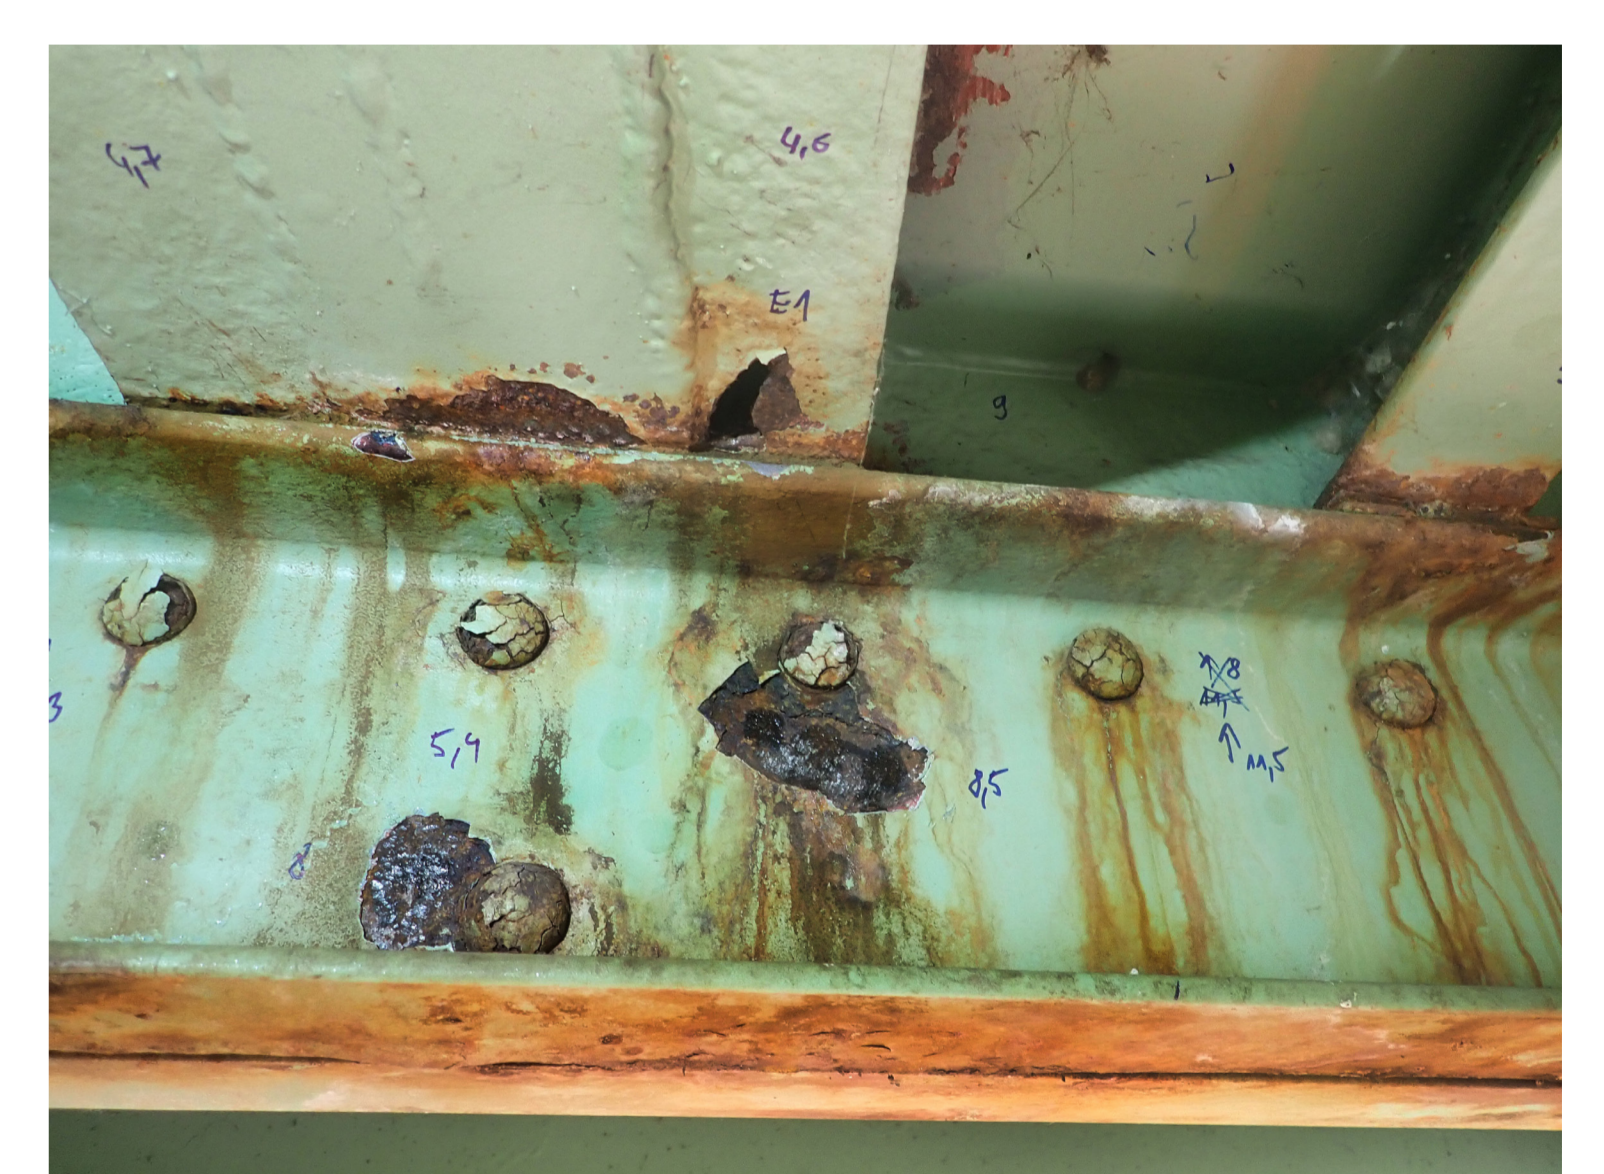
Deterioration and corrosion weakening
