# No. 57 – Ostrava – bridge of Miloš Sýkora

| road arch bridge | |

## Deterioration and corrosion weakening

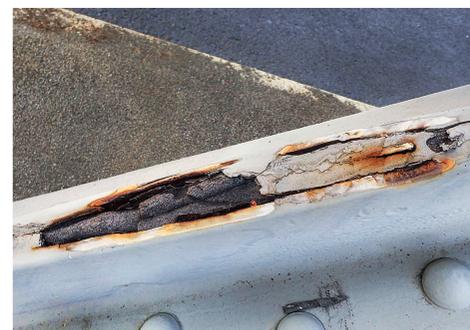
Diagonal deformation due to crevice corrosion

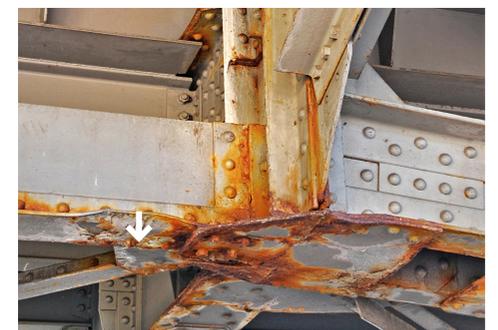
However, the most significant problem appears to be in the details of the embedded hinges fitted to the overhanging portion of the arch. Uniform corrosion was observed in this detail and there was evidence of leakage from the bridge deck through the asphalt grout sealing the passage of the truss members through the bridge deck structure. Relative displacement between the beams in this detail is causing deformation of the grout and the creation of an opening through which rain-water can flow into the structure. However, in its current state, the structure does not show any significant corrosion weakening in these details. Another cause for concern is the crevice corrosion found in some of the narrow gaps of the riveted members. There is also local deformation of the members and additional tensile stress acting on the rivet heads due to the progress of corrosion in the inaccessible gap. During the last restoration of the CPC, some of the corrosion in the details of the arch top chord was sealed and contained, a process that helped to decelerate the corrosion progress. However, the detected uniform corrosion is superficial with no noticeable weakening.

Corrosion of members in the detail of the embedded hinge, excessive def
