# No. 62 – Plzeň – bridge of Miroslav Tyrš

road arch bridge	
Plzeň Region	
Plzeň–City district	
cad. territory Doudlevice	
cultural monument	49°43'04.83"N 13°22'55.06"E

CZECH TECHNICAL  
UNIVERSITY  
IN PRAGUE

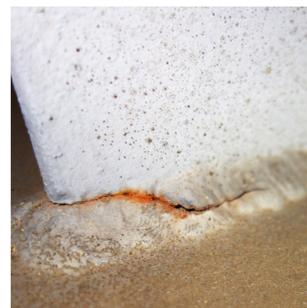
Crack in the weld

- Crack in the weld between the vertical stiffener of the crossbeam and the top flange of the arch beam
- Sheared bolt in the joint between the crossbeam and the bridge deck
- Defect of the bolt at the swinging strut
- Local deformation of some members
- Local corrosion of the bridge deck
- Recommendations for monitoring or local repairs were provided within the project activities.

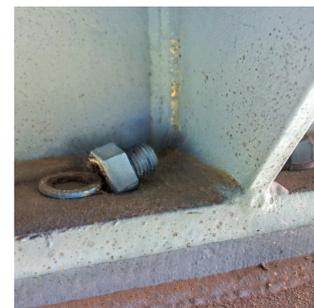
Sheared bolt

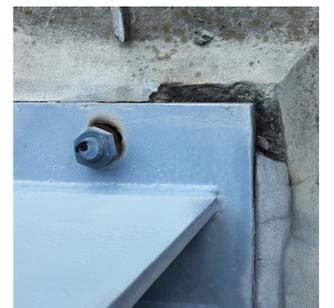
Bolt defect

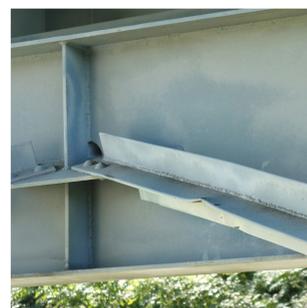
Local deformation of bracing

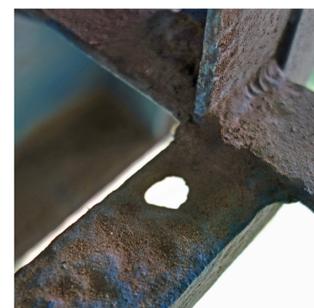
Corrosion weakening

The bridge was surveyed in 2019. The main focus of the survey was on the original 1932 steel structure. The global defect is the pitting corrosion of the arch beams. However, the corrosion weakening is small and does not affect the load-bearing capacity of the bridge. The corrosion protection of the arch girders is in good condition and therefore no further development of pitting corrosion is expected provided that the corrosion protection of the arches is regularly checked and maintained.

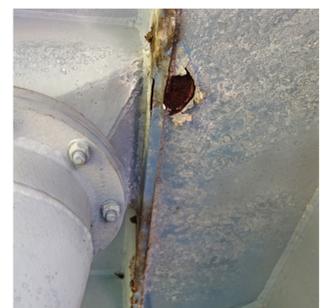
Local corrosion of bridge deck
