4.1. Fire damaged structures

Y. C. Wang

4.1.4 CASE STUDY OF A STEEL COAL FEEDING BRIDGE

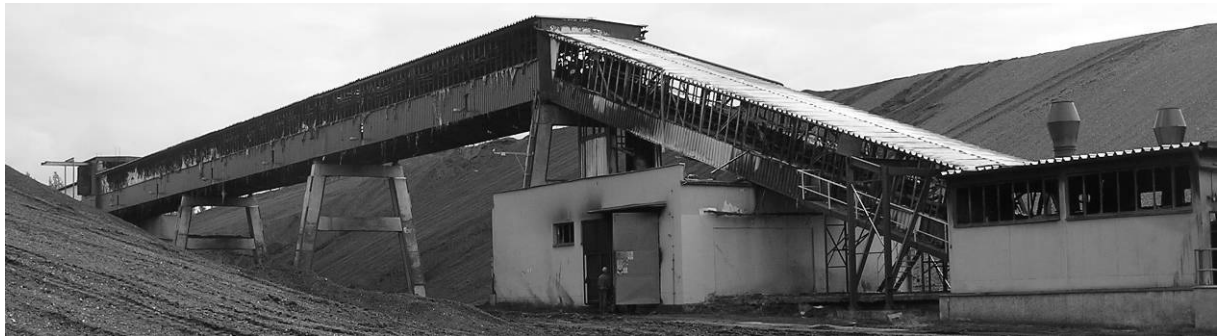
In September 2005, fire occurred on the coal feeding bridge in the Opatovice power station, Czech Republic, when unloading of a wagon hit the transport corridor, see Vácha (2006) and Figures 4.1.4 to 4.1.6. About 100 m of the concrete corridors and 120 m of the steel transport bridges (four truss bridges of span 30 m each) were affected, Coal transport infrastructure was completely burned and the bearing structure was noticeably damaged. The power station depends on coal supply so it was important that the supporting structure was reconstructed to be functional as soon as possible. The steel structure was noticeably affected by the high temperature, which was estimated to be about 1000°C, based on its colour during the fire.

Figure 4.1.4. The coal bridge after the fire.

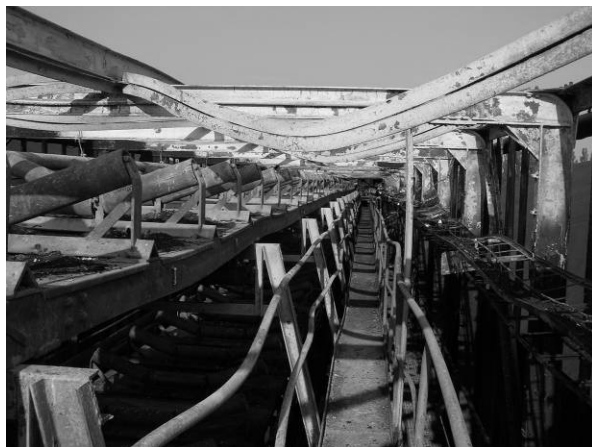
The four steel coal bridges were similar. There were 30m span trusses with upper and lower stiffening trusses. One bridge was inclined. The lateral stability of the bridge trusses was achieved by massive rigid frames spaced at 3 m. All the connections were riveted. The fire damaged all sheathing of the walls and roof. The upper part of the bridge suffered local deformations of the upper crossbeam, the truss stiffeners and the end frames, with the maximum deformations around 100 mm. The upper parts of the main trusses were deformed only at a few locations. The lower parts of the structure would not have suffered any structural damage during the fire because the surface painting still remained after the fire. As shown in Figure 4.1.4, the inclined bridge was the most damaged. The total deflection of the unloaded structure reached from L/600 to L/500.

Figure 4.1.5. Deformed upper stiffening truss.

- The upper truss stiffeners and the upper crossbeams were changed, see Figure 4.1.7;
- The upper parts of the props of the end stiffeners were changed as well;

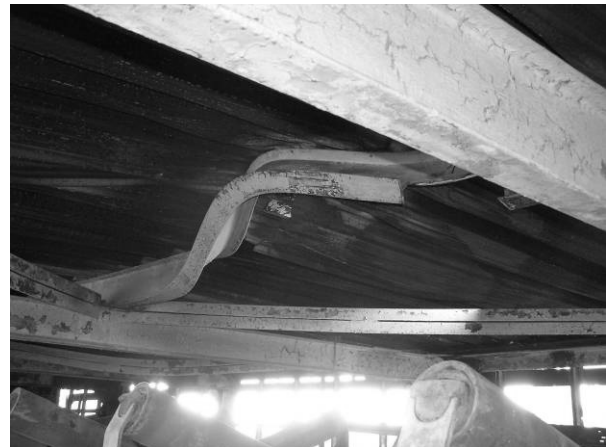
Figure 4.1.6. Deformed purlins.

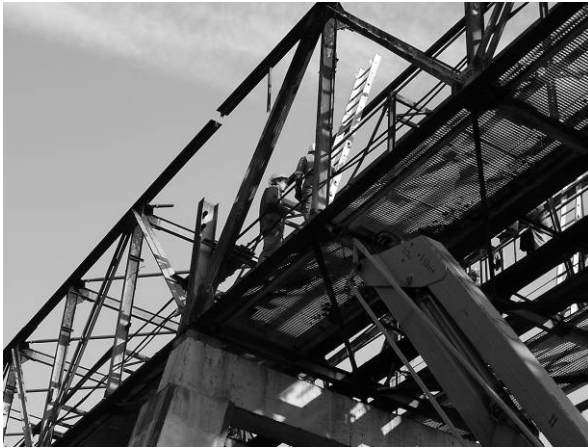
Figure 4.1.7. Replacing of the end frame.

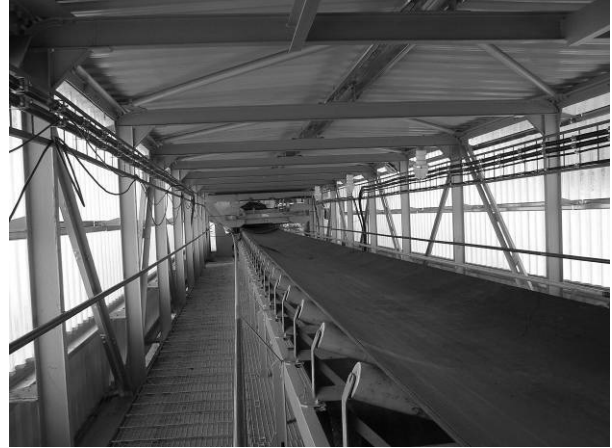
Figure 4.1.8. View into the reconstructed bridge.

- One deformed diagonal member in the lower stiffening truss was changed at each horizontal bridge, see Figure 4.1.8;
- For the inclined bridge, all the lower cross beams and lower stiffening trusses were replaced;

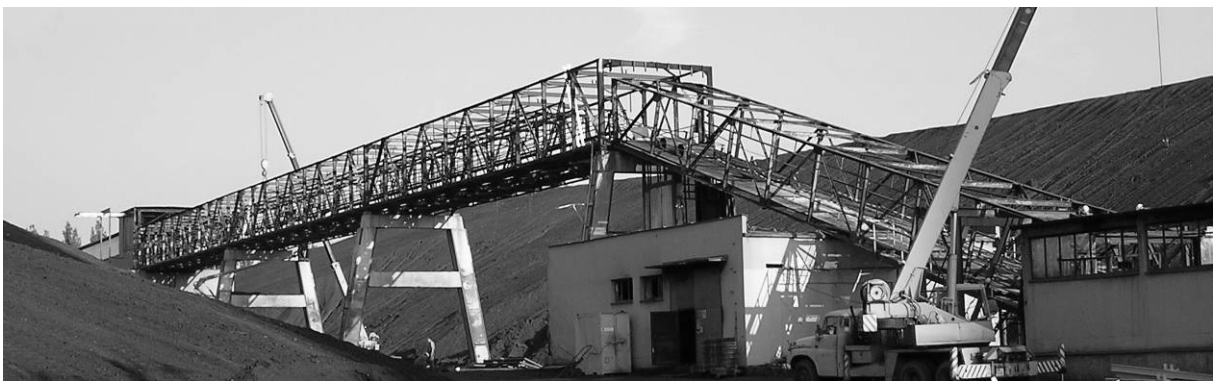
Figure 4.1.9. The uncovered bridge during its reconstruction.

- Based on detailed calculation, a few riveted connections were strengthened by welding on site;
- After the reconstruction, the structure was loaded by an operational test, which proved that the structure recovered its full static behaviour, see Figures 4.1.9 and 4.1.10.

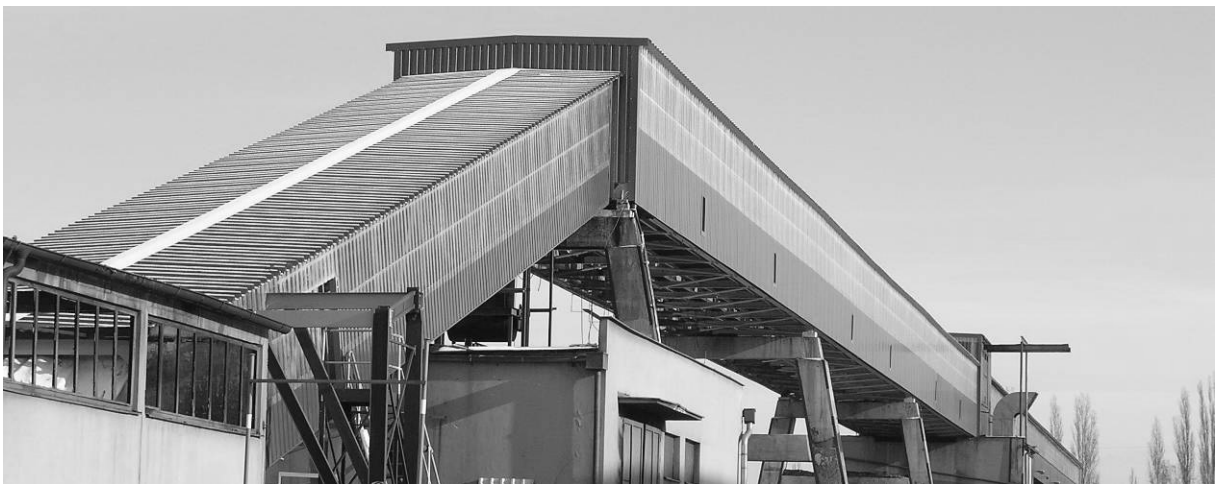
Figure 4.1.10. The reconstructed bridge during proof of behaviour by loading test.
