COST Action TU 904

“St. CIRIL and METHODIUS” UNIVERSITY
FACULTY OF CIVIL ENGINEERING
SKOPJE - MACEDONIA

**EXAMINATION, ASSESSMENT AND REPAIR
OF RC STRUCTURE OF BUILDING
DAMAGED IN FIRE**

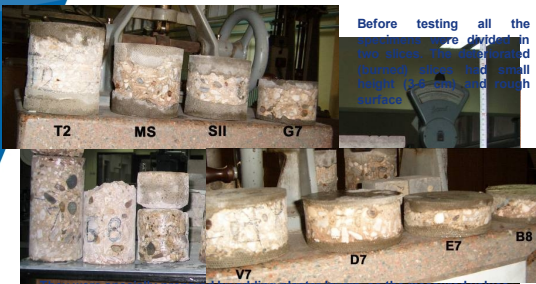
Before testing all the specimens were divided in two slices. The deteriorated (burned) slices had small height (30 cm) and rough surface

They were specimen prepared by adding plaster layers on the damaged places for the compressive strength were reduced with decreasing depending on the shape and height (h) of the deteriorated concrete specimens
