# No. 04 – Červená nad Vltavou – railway bridge

railway truss girder bridge

South Bohemia Region, Písek district

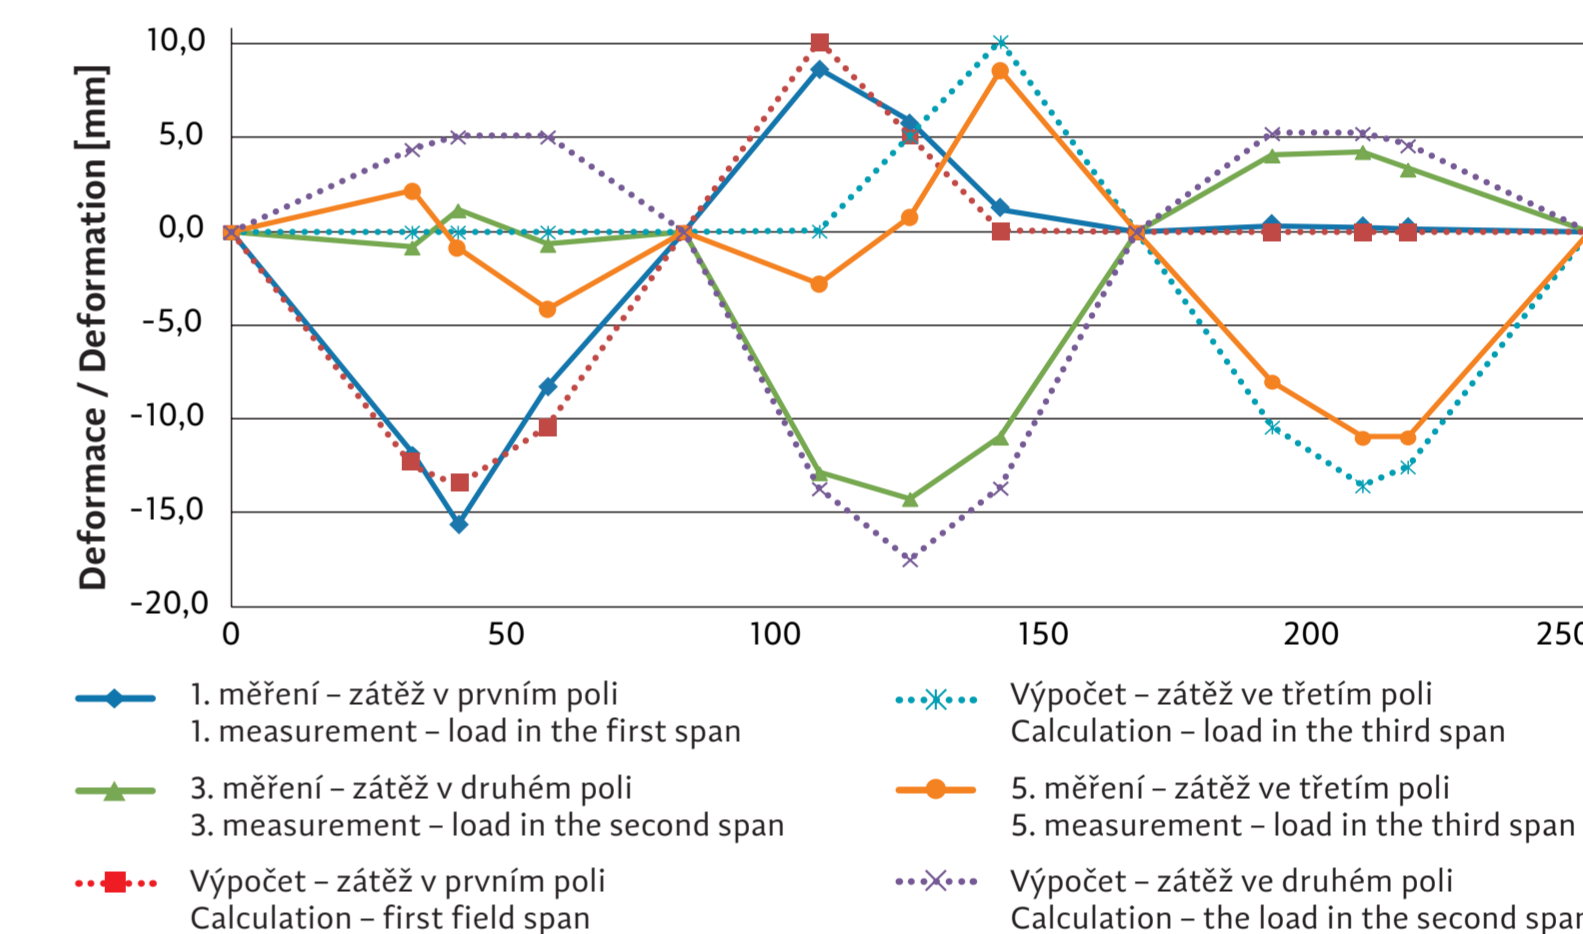
The bridge is currently being monitored according to SŽ Regulation S5, together with the construction of a new railway bridge nearby. A number of measurements and tests were carried in-situ in 2015. These included a static load test and a dynamic test using 751 series "Bardot" locomotives. As a part of the static load test, a series of strain measurements were carried out to determine the stresses in the bridge members. The results of the dynamic test were the natural modes and frequencies. The results were used to validate the numerical model and subsequently contributed to keep the bridge in limited service.

Measured vertical deflections

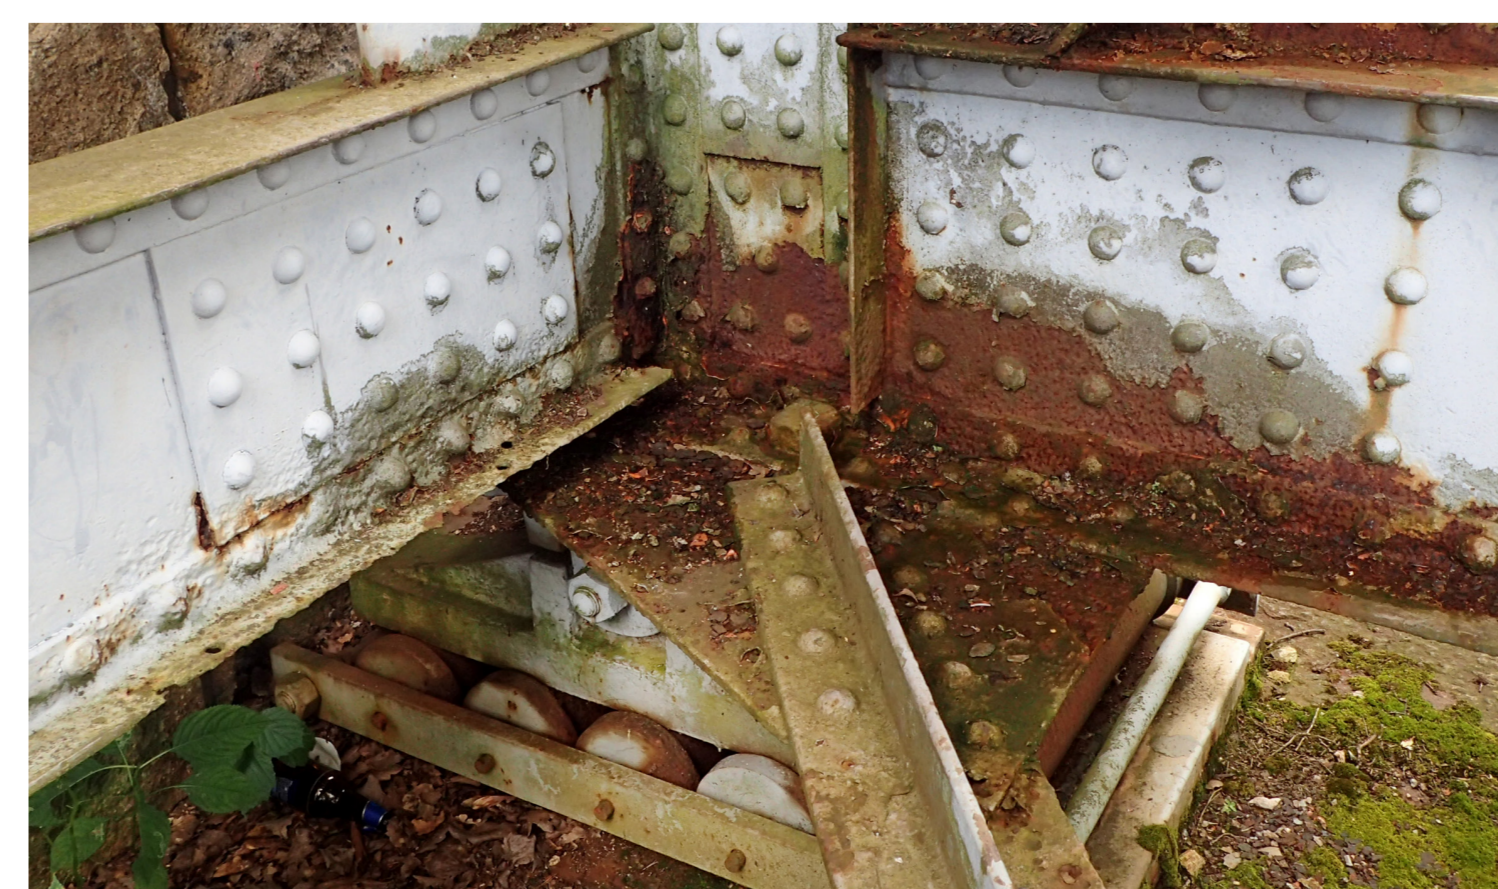
The detailed inspection revealed failures limiting the service life of the bridge. In the narrow space of the gap between the angles, dirt is settling and the constant moisture accelerates the corrosion process, thus weakening the entire flange system. This affects all pier verticals and most of the tensile diagonals. Other members significantly weakened by corrosion are the stringers. Based on the analysis by SUDOP Praha, structural deficiencies found in the structural system significantly affect its behaviour. These are caused by the lack of knowledge and limited technologies in 1889, and can be considered as "inherent defects". In many cases, structural modifications are impossible due to technical reasons. In particular, the lack of horizontal bracing, the low torsional stiffness.

Corrosion damage above abutment

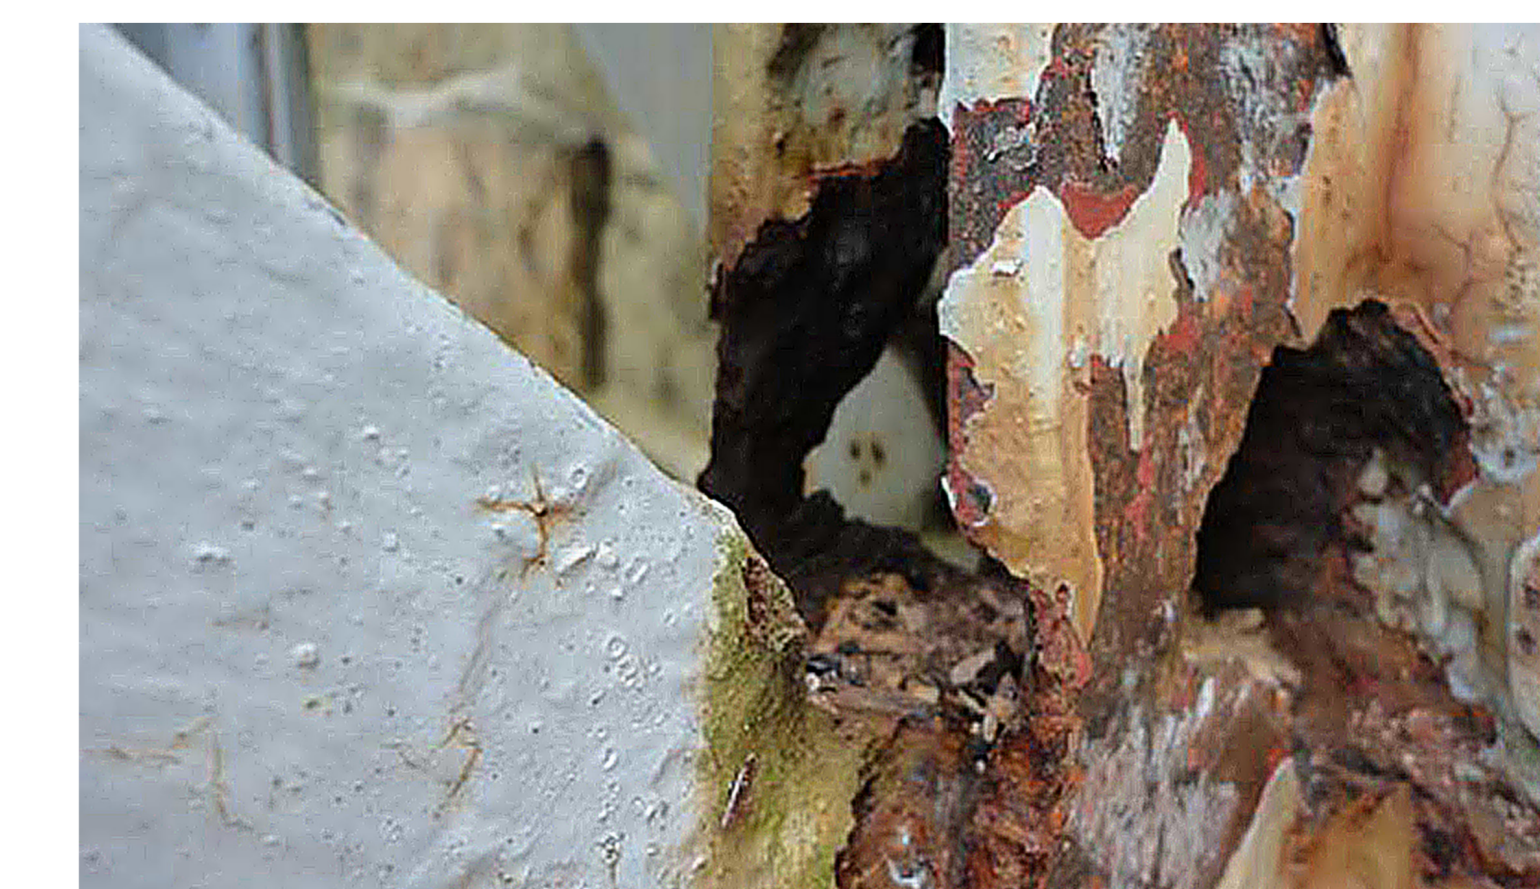
Corrosion of flanges
