Some problems of timber structures solved by forensic control

Milan Vašek

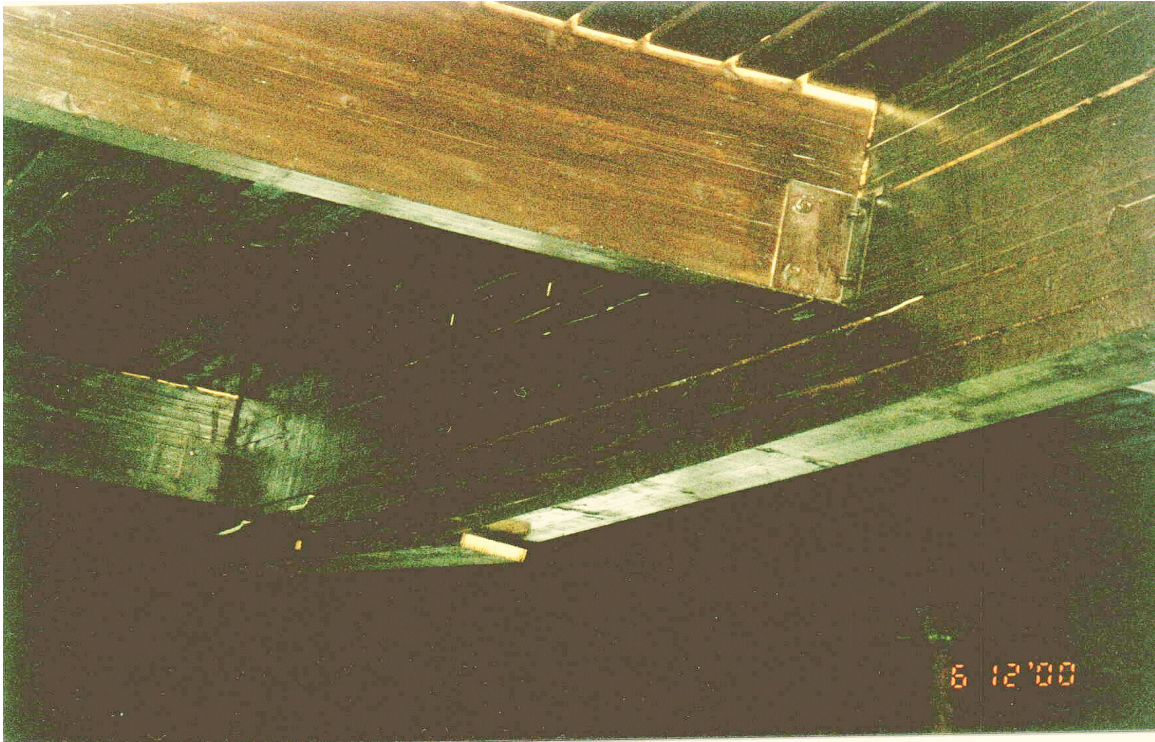
Fig.2 Delaminated roof beam and purlins

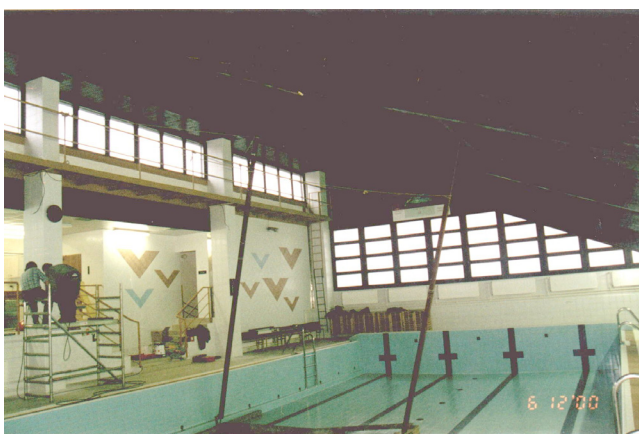
Fig.3 Temporary supports of purlins

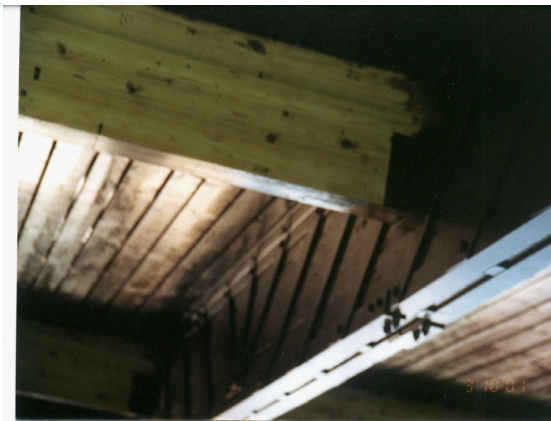
Fig.6 The built up truss strengthening system

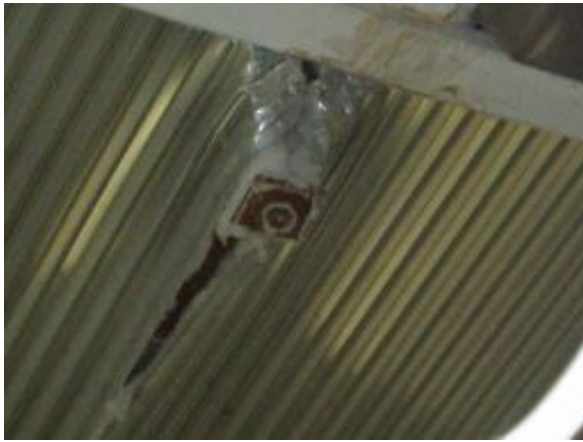
Fig.8 The broken ceiling, the ceiling hanger broke the aluminium sheet

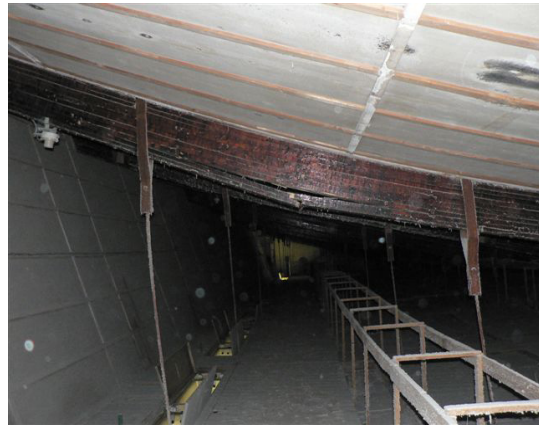
Fig.9 The deflected beam, rupture of lamellas, shear cracks

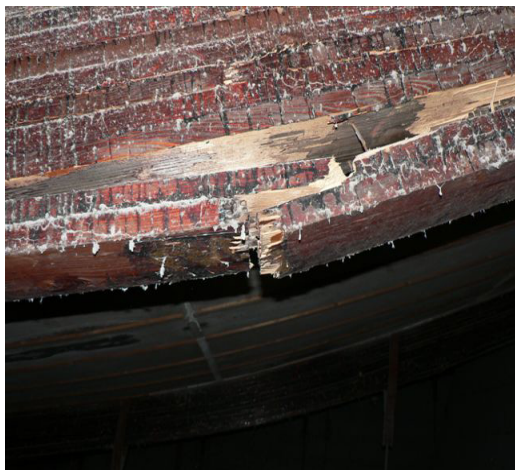
Fig.10 Cracked lamella, not correct layer of the glue

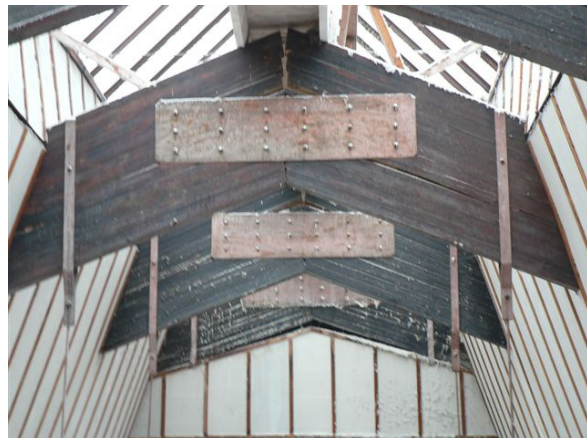
Fig.11 Assumed hinge in the middle of the roof frame, cracks on compressed heads of beams

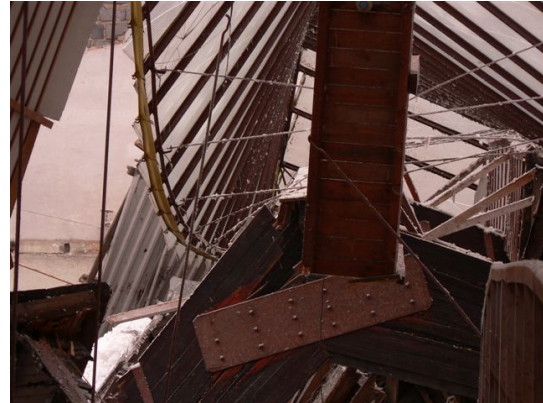
Fig.13 Destroyed roof after the fall down

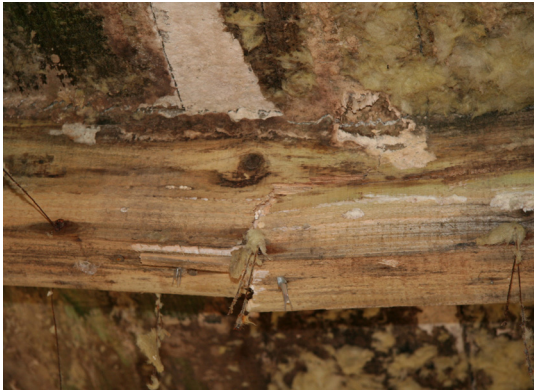
Fig.14 Broken timber beam because of the biological corrosion

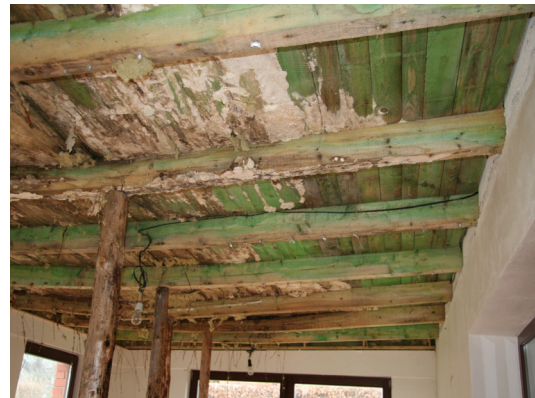
Fig.15 Timber roof system destroyed by the sponge colony

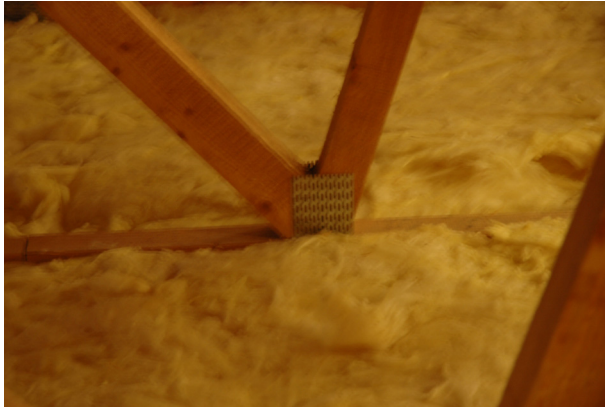
Fig.18 Bad realization of gangnail connection – thin sheet and bad position of the gangnail
