4.1. Fire damaged structures

4.1.4 CASE STUDY OF A STEEL COAL FEEDING BRIDGE

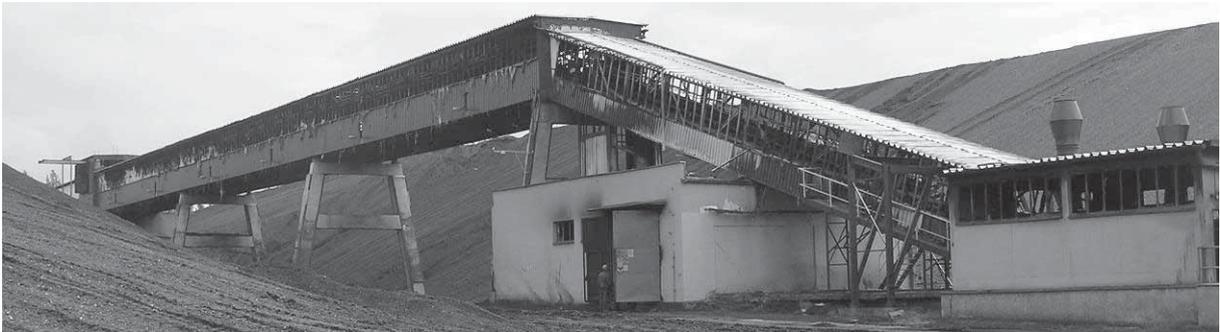
In September 2005, fire occurred on the coal feeding bridge in the Opatovice power station, Czech Republic, when unloading of a wagon hit the transport corridor, see Vácha (2006) and Figures 4.1.4 to 4.1.6. About 100 m of the concrete corridors and 120 m of the steel transport bridges (four truss bridges of span 30 m each) were affected, Coal transport infrastructure was completely burned and the bearing structure was noticeably damaged. The power station depends on coal supply so it was important that the supporting structure was reconstructed to be functional as soon as possible. The steel structure was noticeably affected by the high temperature, which was estimated to be about 1000°C, based on its colour during the fire.

Figure 4.1.4. The coal bridge after the fire.

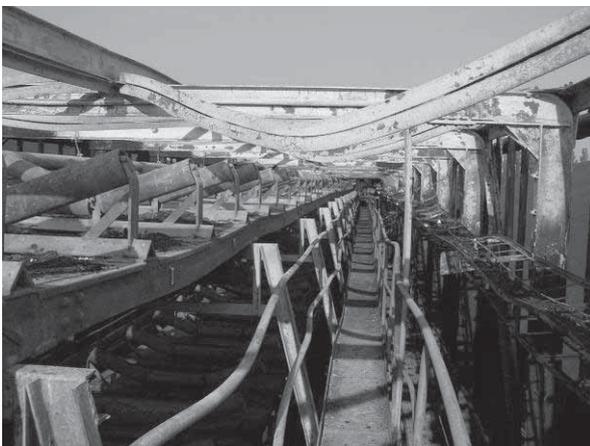
The four steel coal bridges were similar. There were 30m span trusses with upper and lower stiffening trusses. One bridge was inclined. The lateral stability of the bridge trusses was achieved by massive rigid frames spaced at 3 m. All the connections were riveted. The fire damaged all sheathing of the walls and roof. The upper part of the bridge suffered local deformations of the upper crossbeam, the truss stiffeners and the end frames, with the maximum deformations around 100 mm. The upper parts of the main trusses were deformed only at a few locations. The lower parts of the structure would not have suffered any structural damage during the fire because the surface painting still remained after the fire. As shown in Figure 4.1.4, the inclined bridge was the most damaged. The total deflection of the unloaded structure reached from $L/600$ to $L/500$.

Figure 4.1.5. Deformed upper stiffening truss.

- The upper truss stiffeners and the upper crossbeams were changed, see Figure 4.1.7;
- The upper parts of the props of the end stiffeners were changed as well;

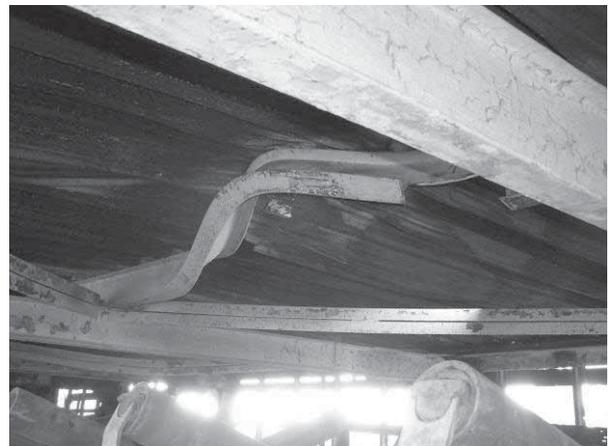
Figure 4.1.6. Deformed purlins.

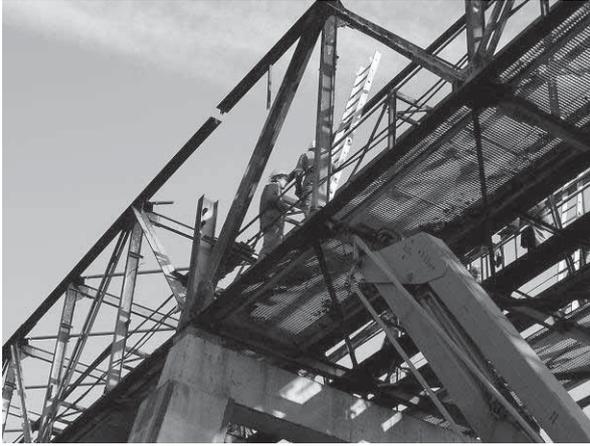
Figure 4.1.7. Replacing of the end frame.

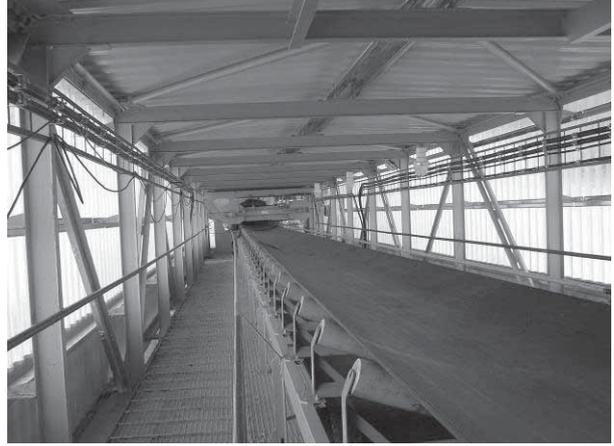
Figure 4.1.8. View into the reconstructed bridge.

- One deformed diagonal member in the lower stiffening truss was changed at each horizontal bridge, see Figure 4.1.8;
- For the inclined bridge, all the lower cross beams and lower stiffening trusses were replaced;

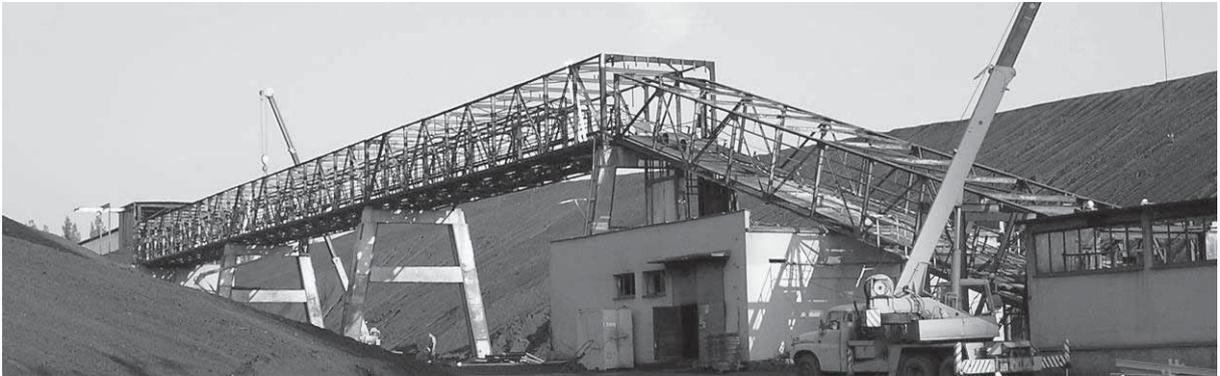
Figure 4.1.9. The uncovered bridge during its reconstruction.

- Based on detailed calculation, a few riveted connections were strengthened by welding on site;
- After the reconstruction, the structure was loaded by an operational test, which proved that the structure recovered its full static behaviour, see Figures 4.1.9 and 4.1.10.

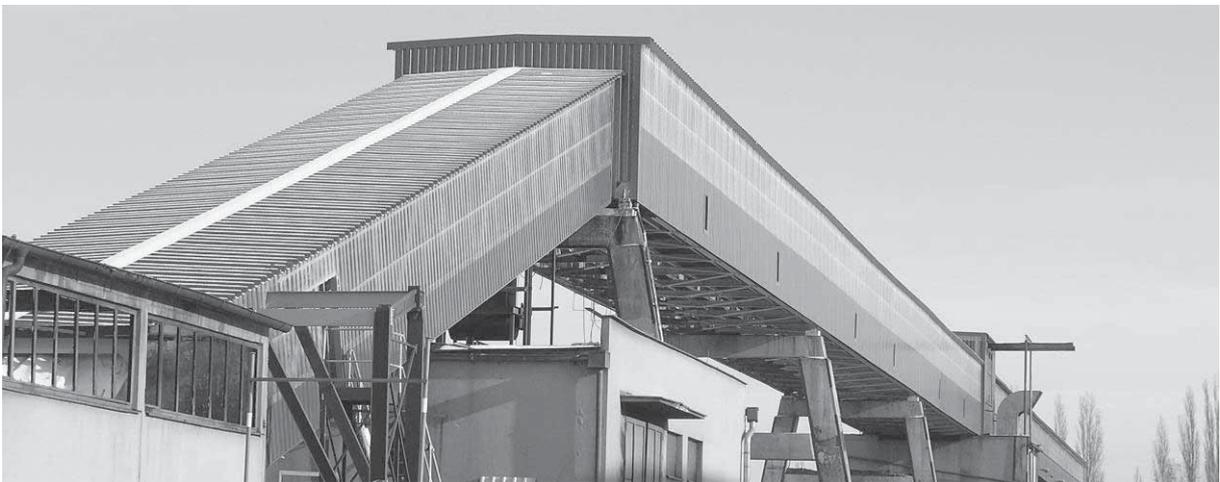
Figure 4.1.10. The reconstructed bridge during proof of behaviour by loading test.
