**TENSILE MEMBRANE ACTION AND ROBUSTNESS
OF STRUCTURAL STEEL JOINTS UNDER NATURAL FIRE
EC FP5 HPRI – CV 5535**

**Cardington Fire Test
January 16. 2003**

David Moore, František Wald, Aldina Santiago
BRE Watford, CTU in Prague, Coimbra University

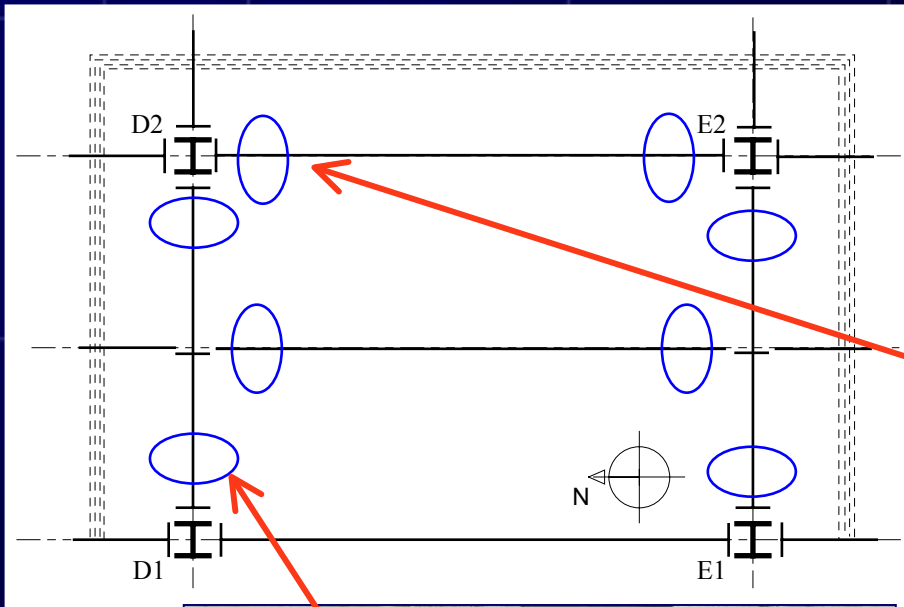
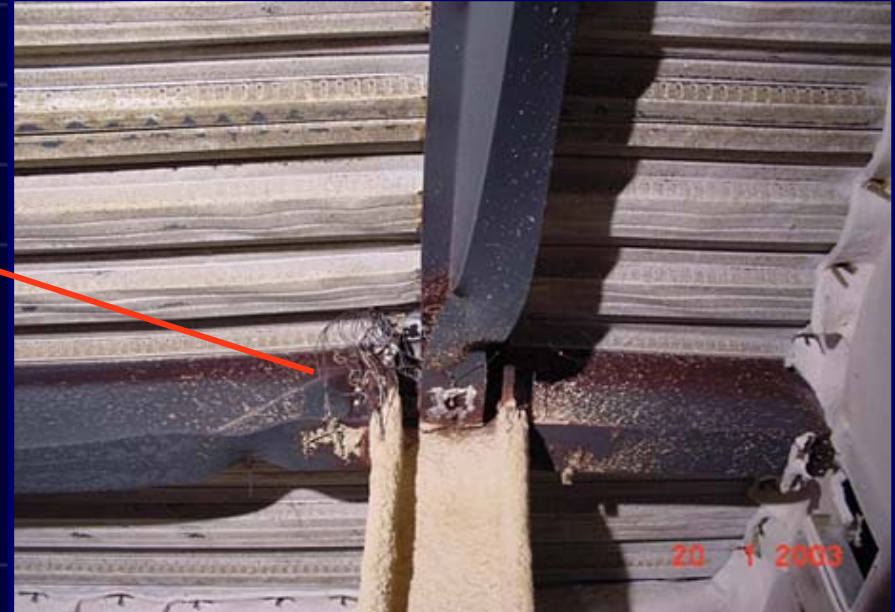
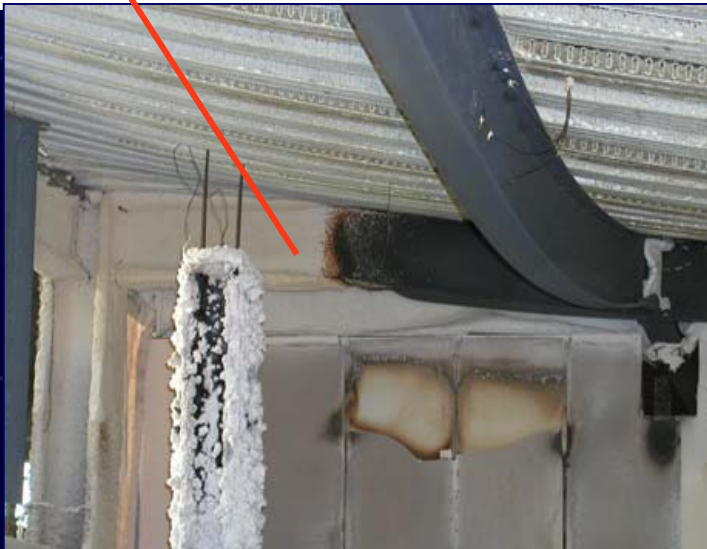
Local Buckling of Beam Lower Flanges

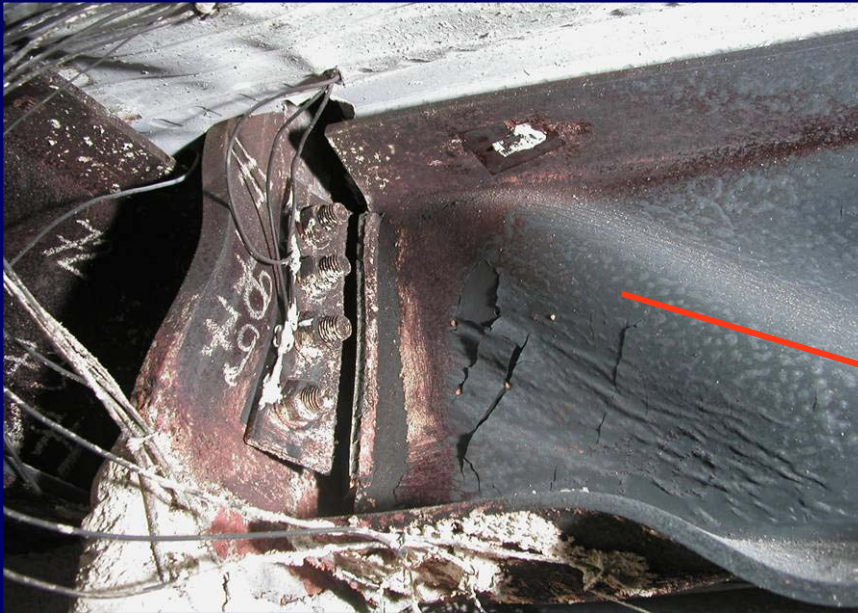
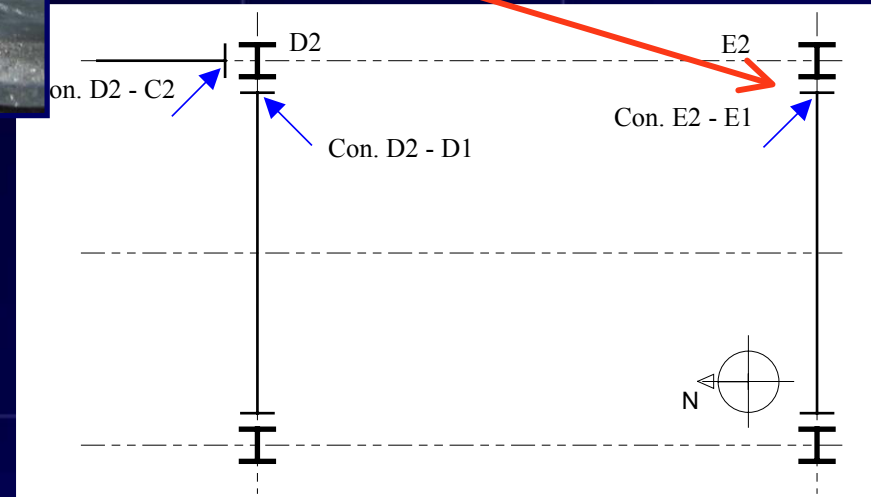
Fracture of End-Plates

- Fracture of end plates
- Elongation of holes in fin plates
- Integrity of composite slab
- Collapse of structure not reached
 - Mechanical load 56%
 - Fire load 40 kg/m²

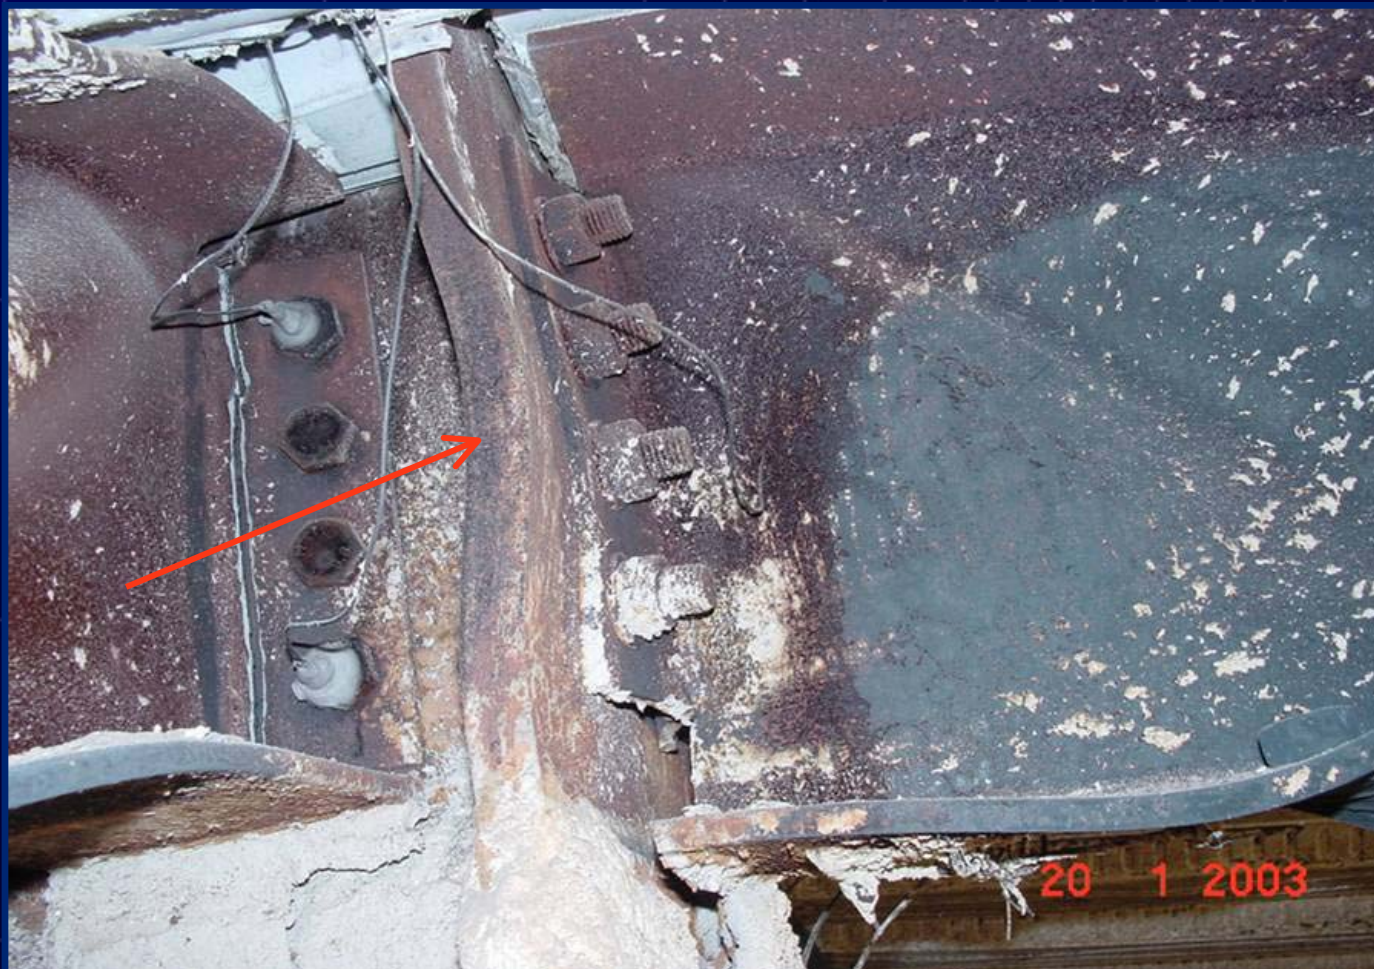
Column Flange Buckling

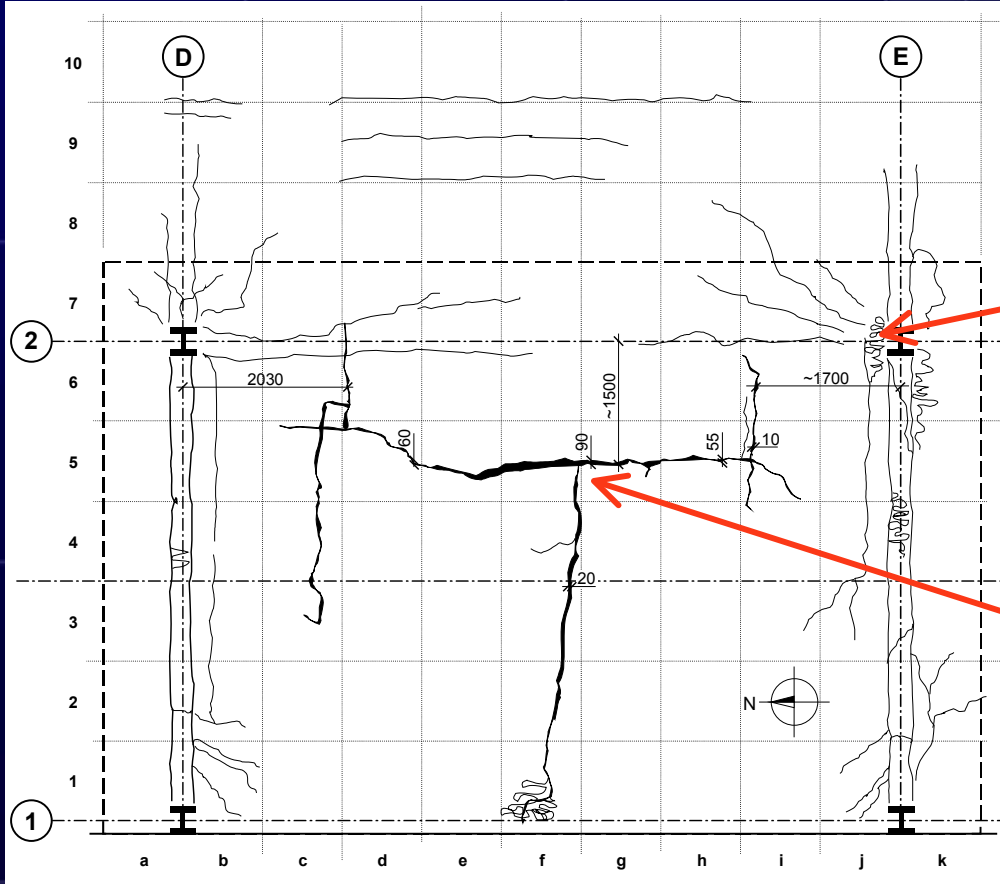
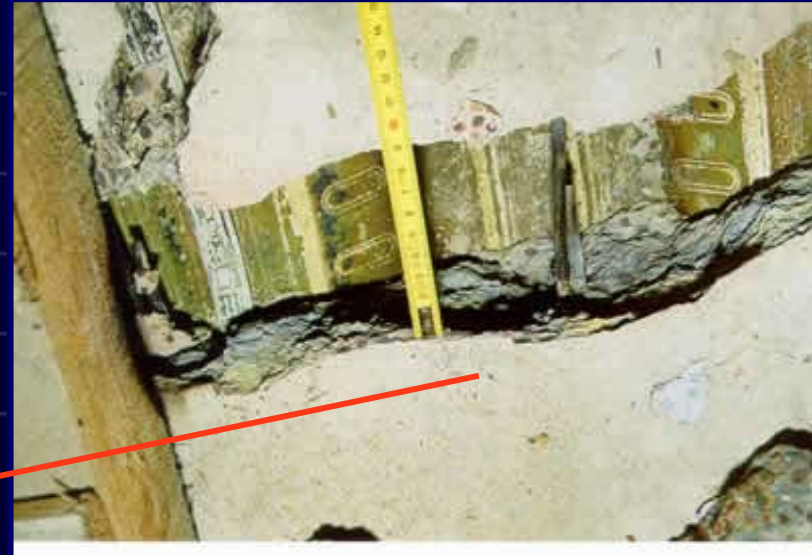
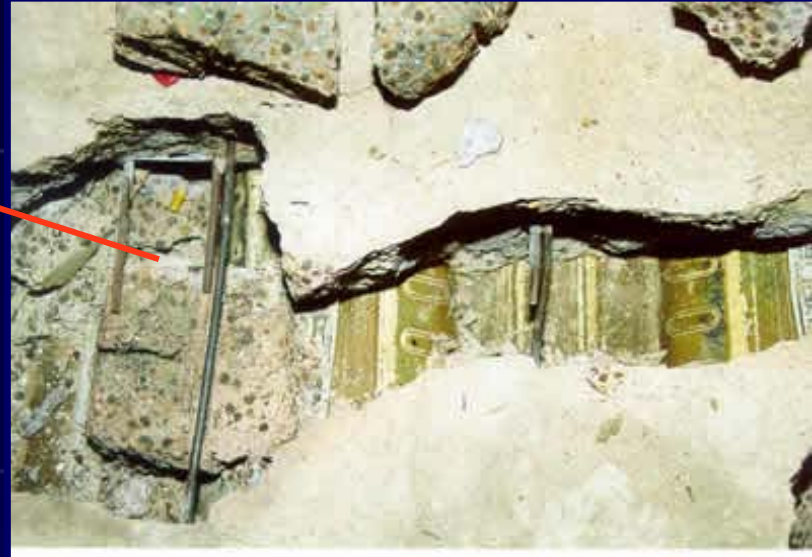
Concrete slab cracking

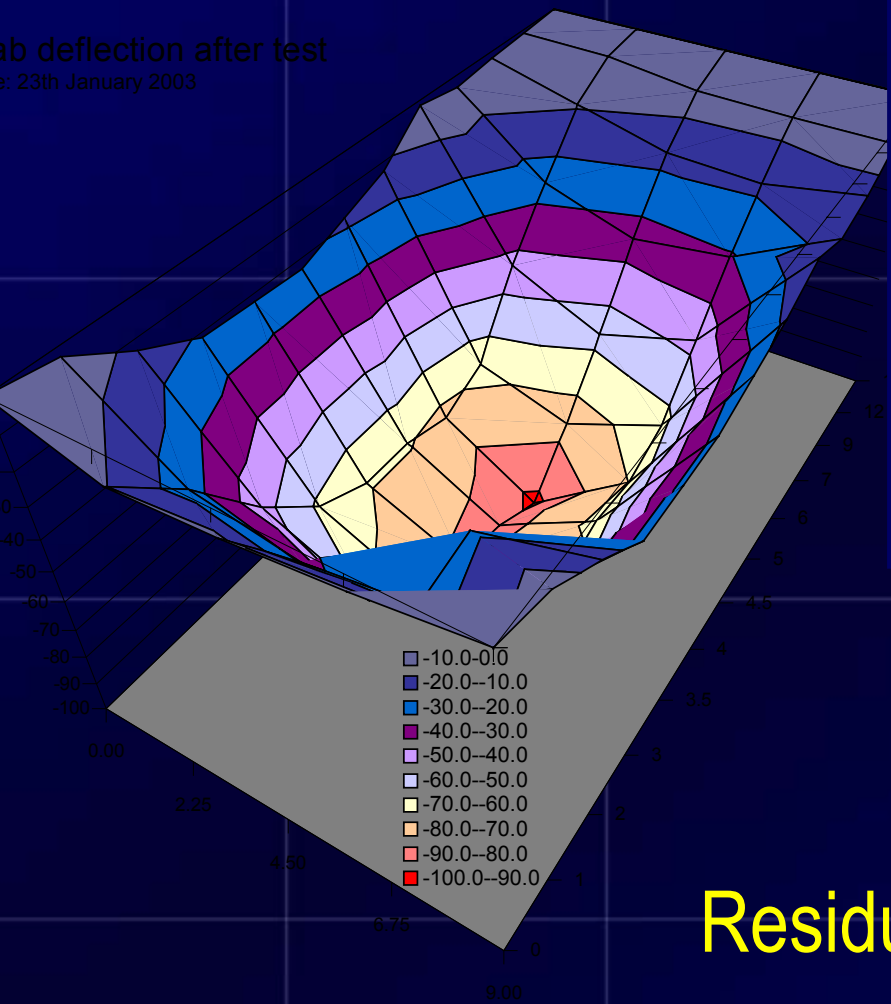
Concrete slab deformation

Slab deflection after test
Date: 23th January 2003

Residual deformation max 925 mm
