30 EXAMINATION, ASSESSMENT AND REPAIR OF FIRE DAMAGED RC STRUCTURE OF „REFINERY-OKTA“ IN SKOPJE

In November 2008 a part of the structure of “Refinery–Okta” in Skopje, Macedonia, was in fire and the last three spans were completely burned. According to the damages recorded in situ, it was found out that fire caused severe damage to the reinforced concrete bearing structure. For realization of the repair project of the RC structure, nonlinear and transient thermal analysis, nonlinear stress-strain analysis of the frame structure and experimental determination of the residual concrete strength after action of fire were recommended. Results obtained by this analysis are presented in this paper. The global repair recommendations are given, also.

31 EXAMINATION, ASSESSMENT AND REPAIR OF RC STRUCTURE OF BUILDING DAMAGED IN FIRE

A twenty storey building structure was in fire and two apartments at the seventh and eighth floor were completely burned. According to the damages recorded in situ, it was found out that fire caused severe damage to the reinforced concrete bearing structure. Based on the data gathered through detailed visual survey of the bearing structural elements, nonlinear a

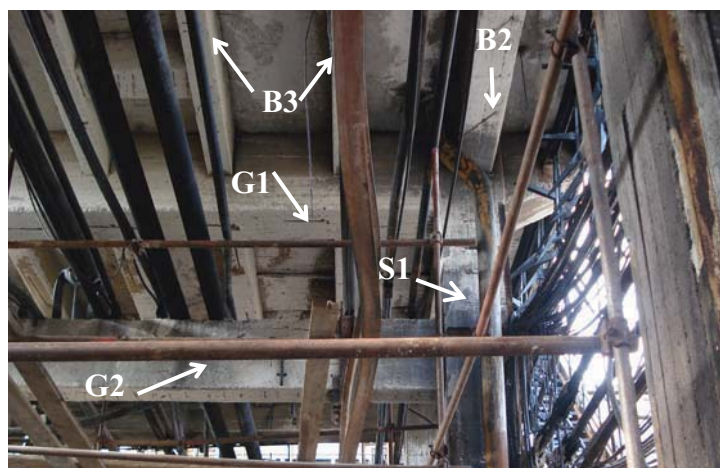
Due to the openness of the space and the continuous supply of oxygen and oil, the flames spread high under the slab and the columns were exposed to lower temperatures. These elements were not visually damaged, cracks were not recorded and the concrete color was rose-red, that indicates temperatures less than 600°C .

Fig. 30.1 Disposition of the beams in the second span and change of concrete color due to chemical reaction

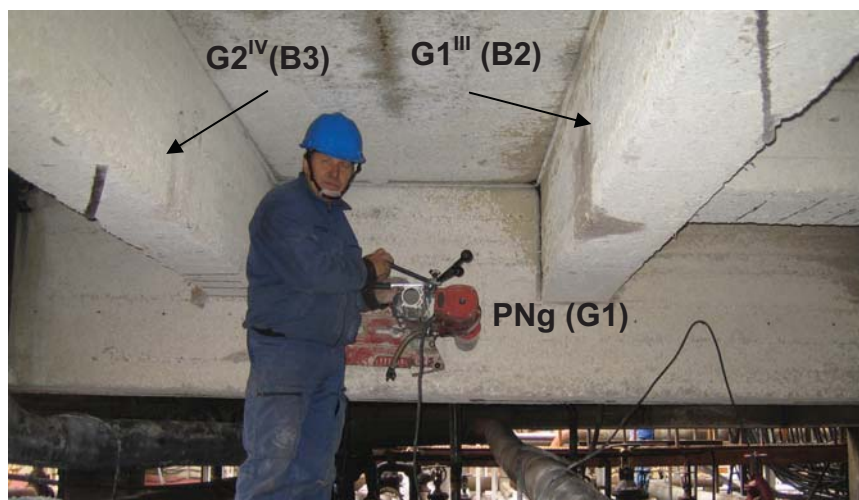
Temperature over 400°C causes reduction of the compressive strength and other mechanical properties of concrete and this process is irreversible (the strength of concrete does not recover in the cooling phase). The mechanical properties of hot welded steel (reinforcing bars) decrease as well, but in the cooling phase they increase again. According to these statements and for realization of the repair project of the RC structure, experimental and numerical determination of the residual concrete strength was recommended. Based on previous Schmidt hammer testing results, the locations of the eight concrete specimens, taken only from lateral side of the RC beams, were defined (Fig. 30.2).

Fig. 30.2 Locations where the concrete specimens were taken from the beams of the second span and change of concrete color due to chemical reaction

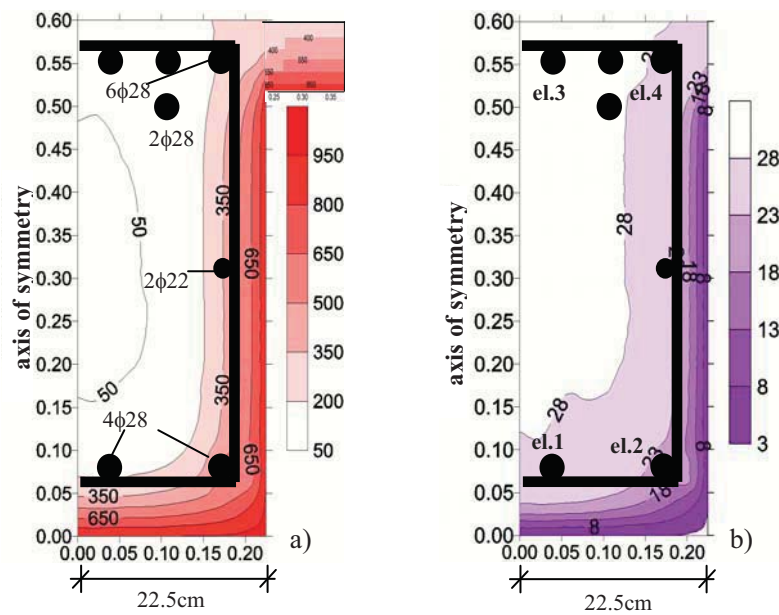
The results of the nonlinear thermal analysis are presented by graphs. The isotherms in the cross section of the beam B2, at moment $t = 1.5$ hour, are presented on Fig. 30.5a. The beam was fired only from the bottom and lateral sides but, because the space was open, at the opposite side (over the slab) the temperature was proportional to the temperature under the slab (approximately 25% of the temperature reached under the slab) and the beam was heated from both sides, but not with the same intensity.

Fig. 30.5 a) Isotherms in the cross section of the beam B2 ($t=1.5$ hours),
 b) residual concrete strength after cooling phase

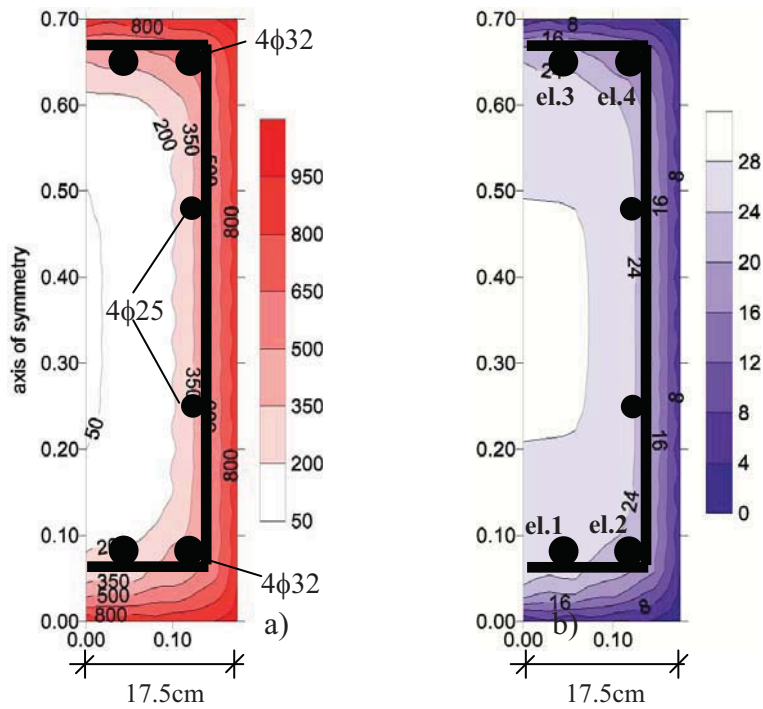
Fig. 30.7 a) Isotherms in the cross section of the beam G2 (t=1.5hours),
 b) residual concrete strength after cooling phase

Crane beams G2 were exposed to fire from all sides, it caused symmetrical cross section temperature field (Fig. 30.7) and temperature induced stresses were lower than for the other beams. During the cooling period the stresses in reinforcement changed the sign too, but the residual stresses were less than 30% of the yielding strength for steel at room temperatures. Therefore the repair of the beams G2 was not recommended.

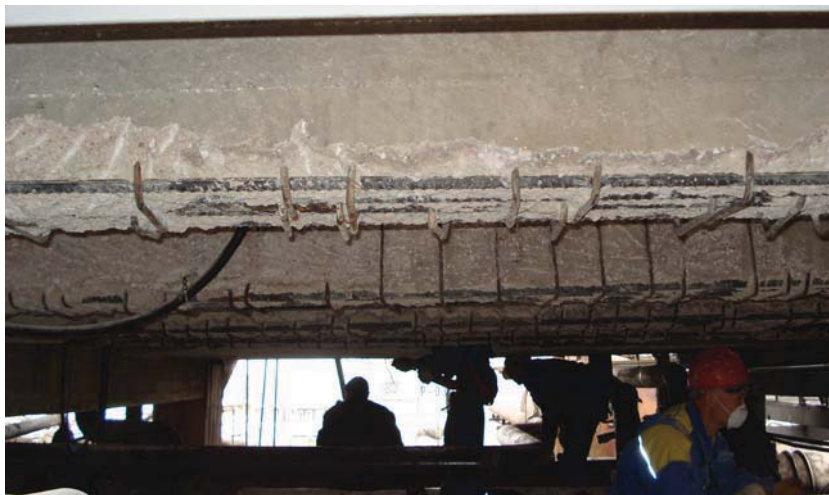
Fig. 30.13 Elimination of the deteriorated (burned) concrete layers up to the main reinforcement

The first step of the suggested repair of beams B2 and B3 (in longitudinal direction) was elimination of the deteriorated (burned) concrete layers up to the reinforcement (Fig. 30.13). For that purpose 3-4 cm thick layers, from the lateral side, and 6-7 cm thick layers, from the bottom side, were removed. Before casting the opened sections were cleaned with running water.

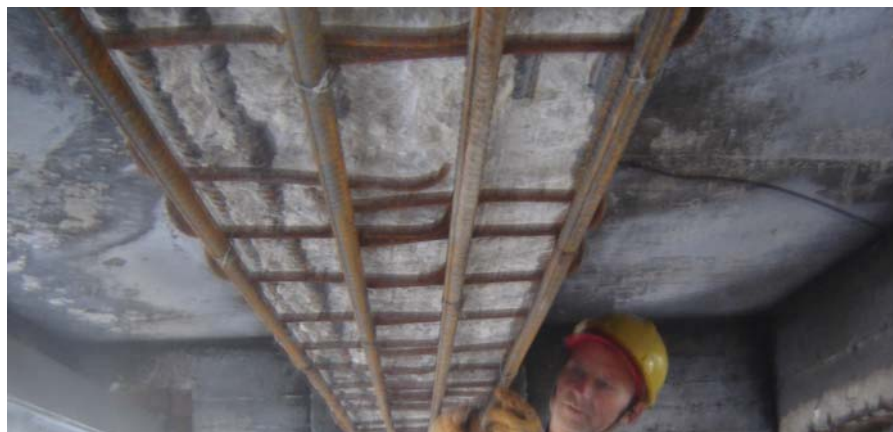
Fig. 30.14 Repair of the beam B2 at the second spam.

The yield reinforcement at the corners of the beams, with total area of 12 cm², was “covered” by additional reinforcement (4Ø20, RA 400/500), placed under the existing stirrups (Fig. 30.14). The additional open stirrups Ø8/20 cm (GA 240/360) were welded to the existing stirrups. Welding between the new ribbed reinforcement and existing smooth stirrups was not recommended for two reasons: the additional reinforcement had higher yield strength and the existing smooth stirrups had residual plastic deformations. The jacketing with new 3cm thick concrete layer was made with sprayed concrete MB 30.

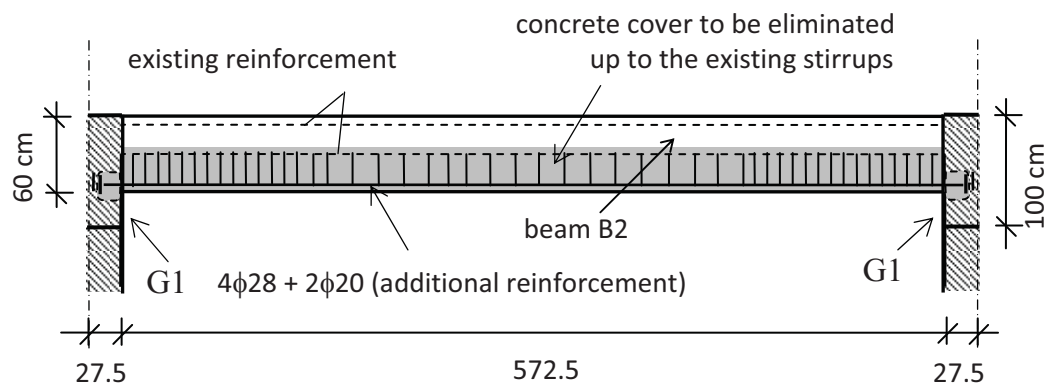
Fig. 30.15 Repair details of beam B2.

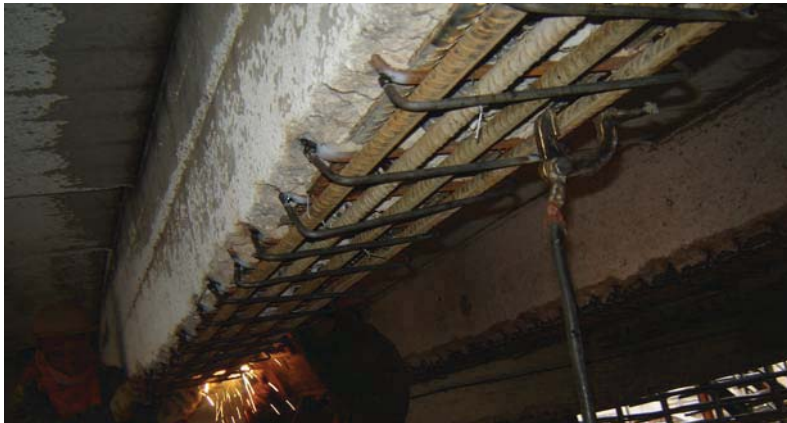
Fig. 30.16 Additional stirrups of beam B2, welded for the existing one.

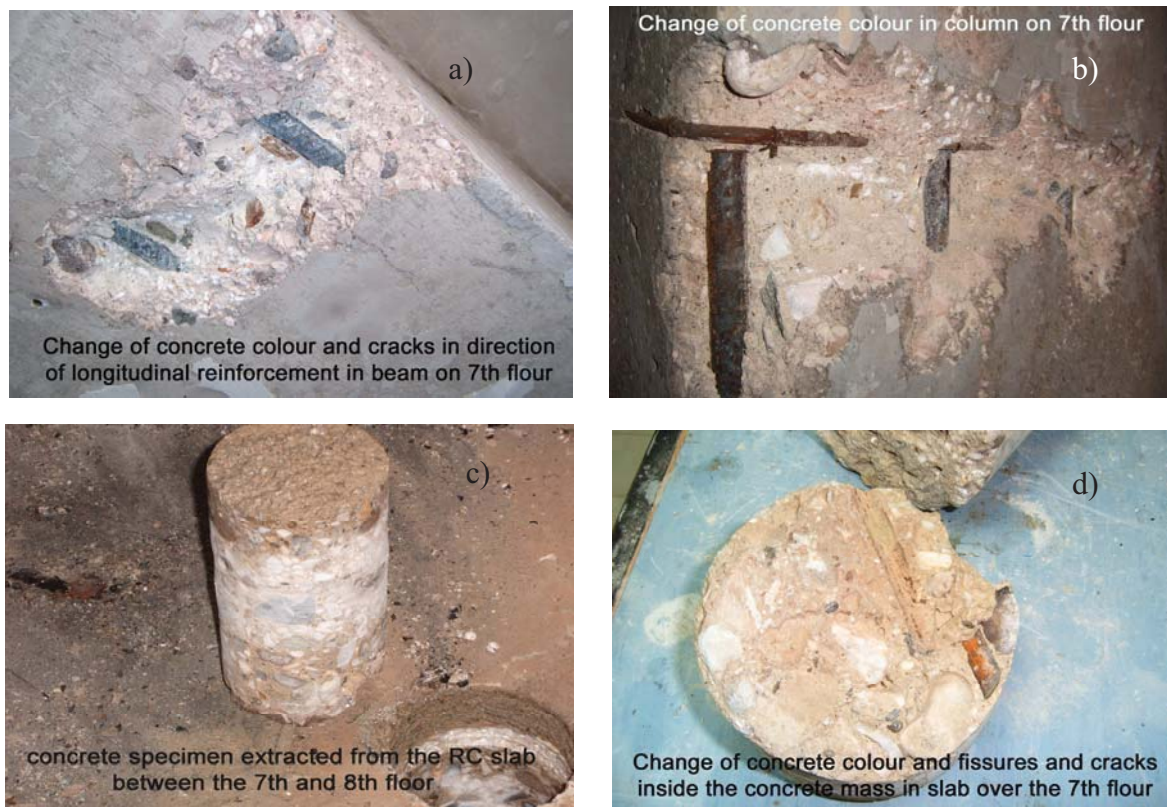
- change of concrete color (red, grey-yellow, yellow, Fig. 31.1)
- fissures and cracks inside the concrete mass (Fig. 31.1d)
- cracks along main reinforcement in columns, beams and slabs (Fig. 31.2)
- crushing of concrete and falling off of concrete parts along the edges of linear elements up to the reinforcement (Fig. 31.2d)

Fig. 31.1 Change of concrete color and characteristic damages of RC elements, recorded in situ

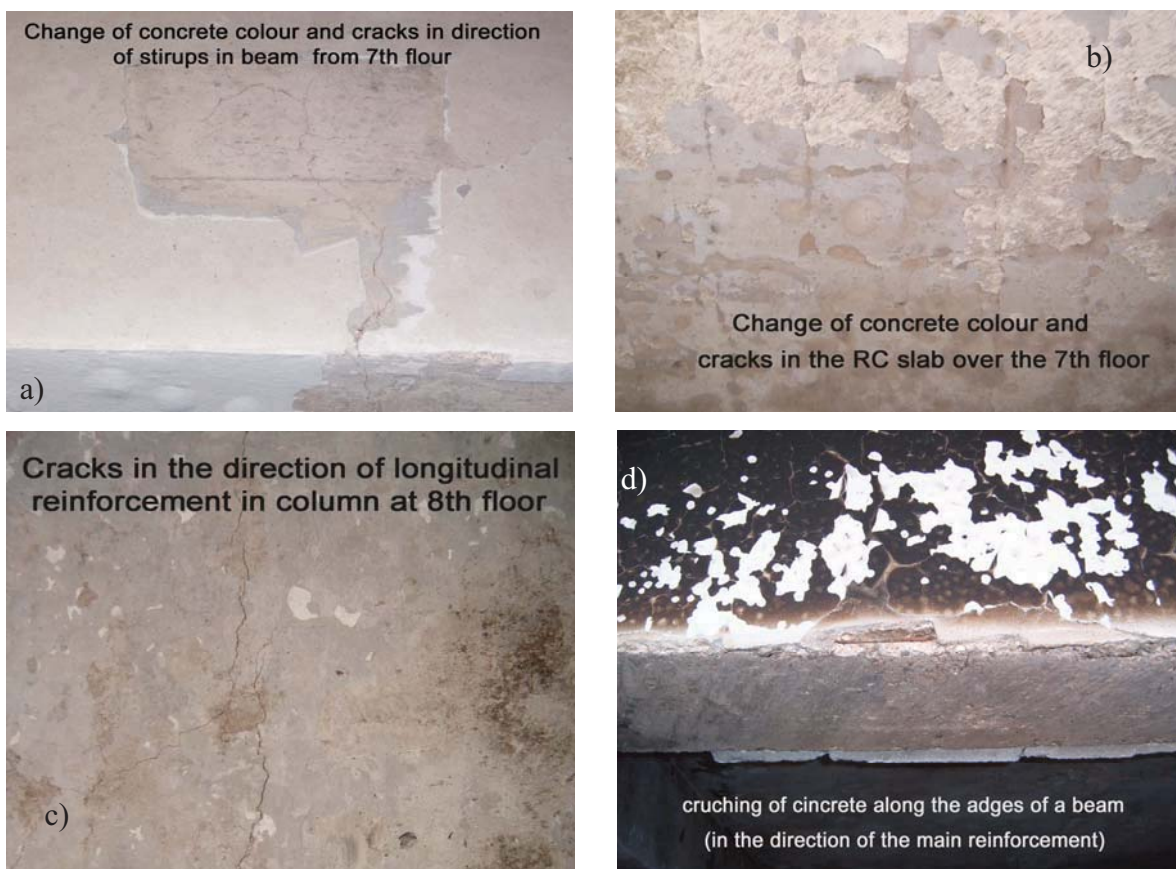
Fig. 31.2 Cracks along main reinforcement in columns, beams and slabs, recorded in situ

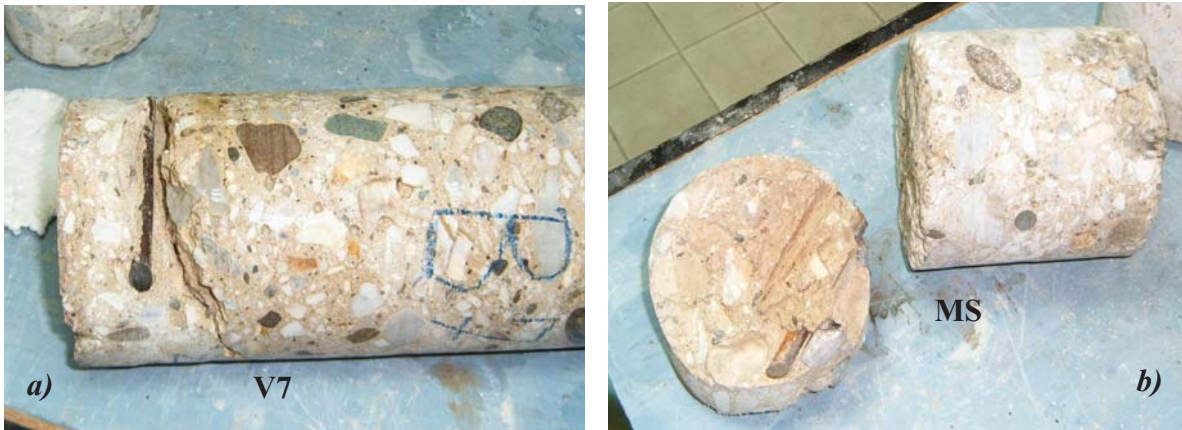
The concrete specimens taken from the RC walls (B8, V7, G7, D7, E7 in Tab. 31.1) were exposed to fire from one side. The corresponding surface layers (3-5cm thick) had changed the color (red, grey-yellow, yellow) and were more deteriorated than the inner layers (fig.3a). The RC slabs over the 7th floor were fire exposed from both sides, but they were covered with 1cm thermal isolation and 4cm lean concrete (Fig. 31.1c and Fig. 31.3b), that directly influenced upon the cross section temperature field, therefore the specimens taken from these slabs (T2, MS, CII) were deteriorated only from one side (the bottom side), too.

Fig. 31.3 Deterioration of surface layers of specimens

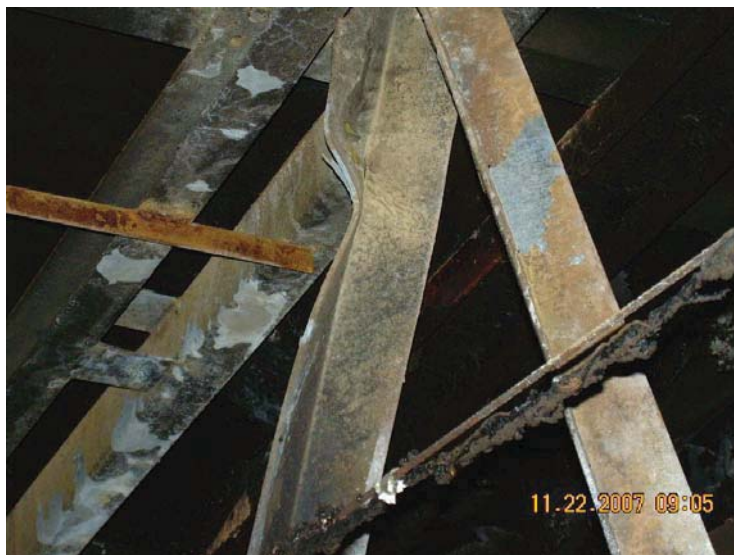
Fig. 32.1.4

and fragments of upper chords was also found in other roof trusses, more distant from the source of fire.
