road arch bridge	
South Bohemia Region	
Písek district	
cad. territories Orlík nad Vltavou, Kostelec nad Vltavou	
buffer zone*	49°30'18.77"N 14°11'1.902"E

CZECH TECHNICAL
UNIVERSITY
IN PRAGUE*protection zone of the Orlík State Chateau (protected since 3 February 1977); no longer individually protected;
(protected as a cultural monument 3 May 1958 - 31 December 1987)

History

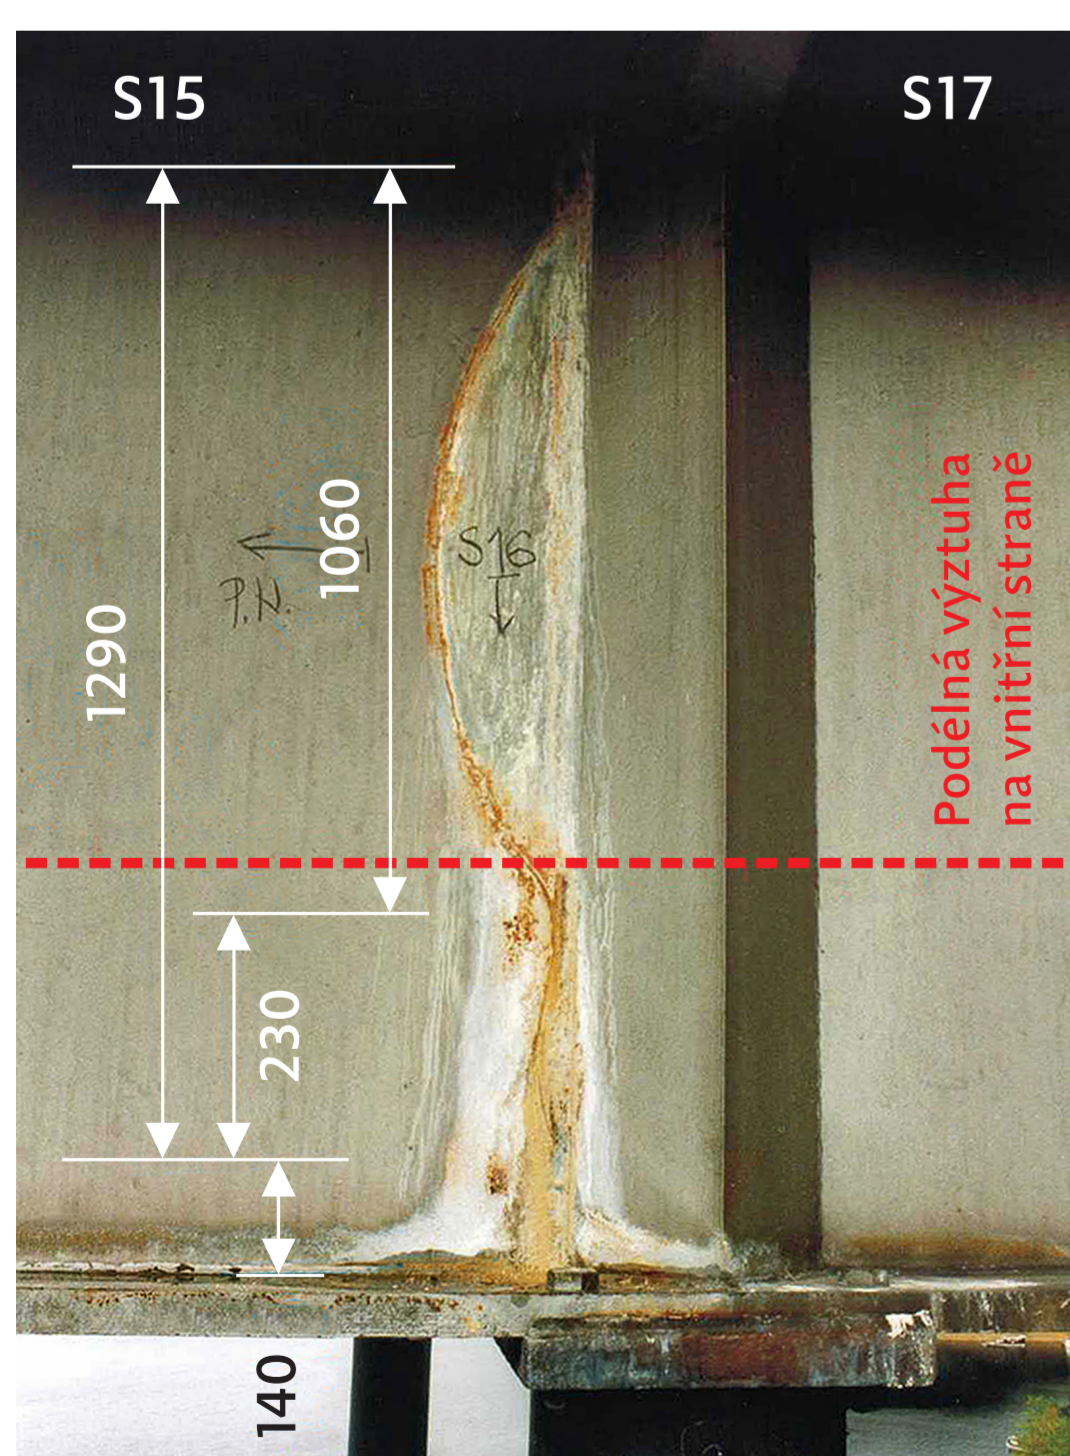
View of the web with a crack

In 1998, vertical cracks were found in the longitudinal beam supports (due to leakage into the closed cavities and repeated freezing of water) and the bridge was closed to all traffic for a short period of time as a precautionary measure until emergency repairs were carried out. In the following year, three new movable inspection footbridges were installed under the bridge deck and on the arches to allow for regular inspection, and the load-bearing capacity of the bridge was also re-assessed.

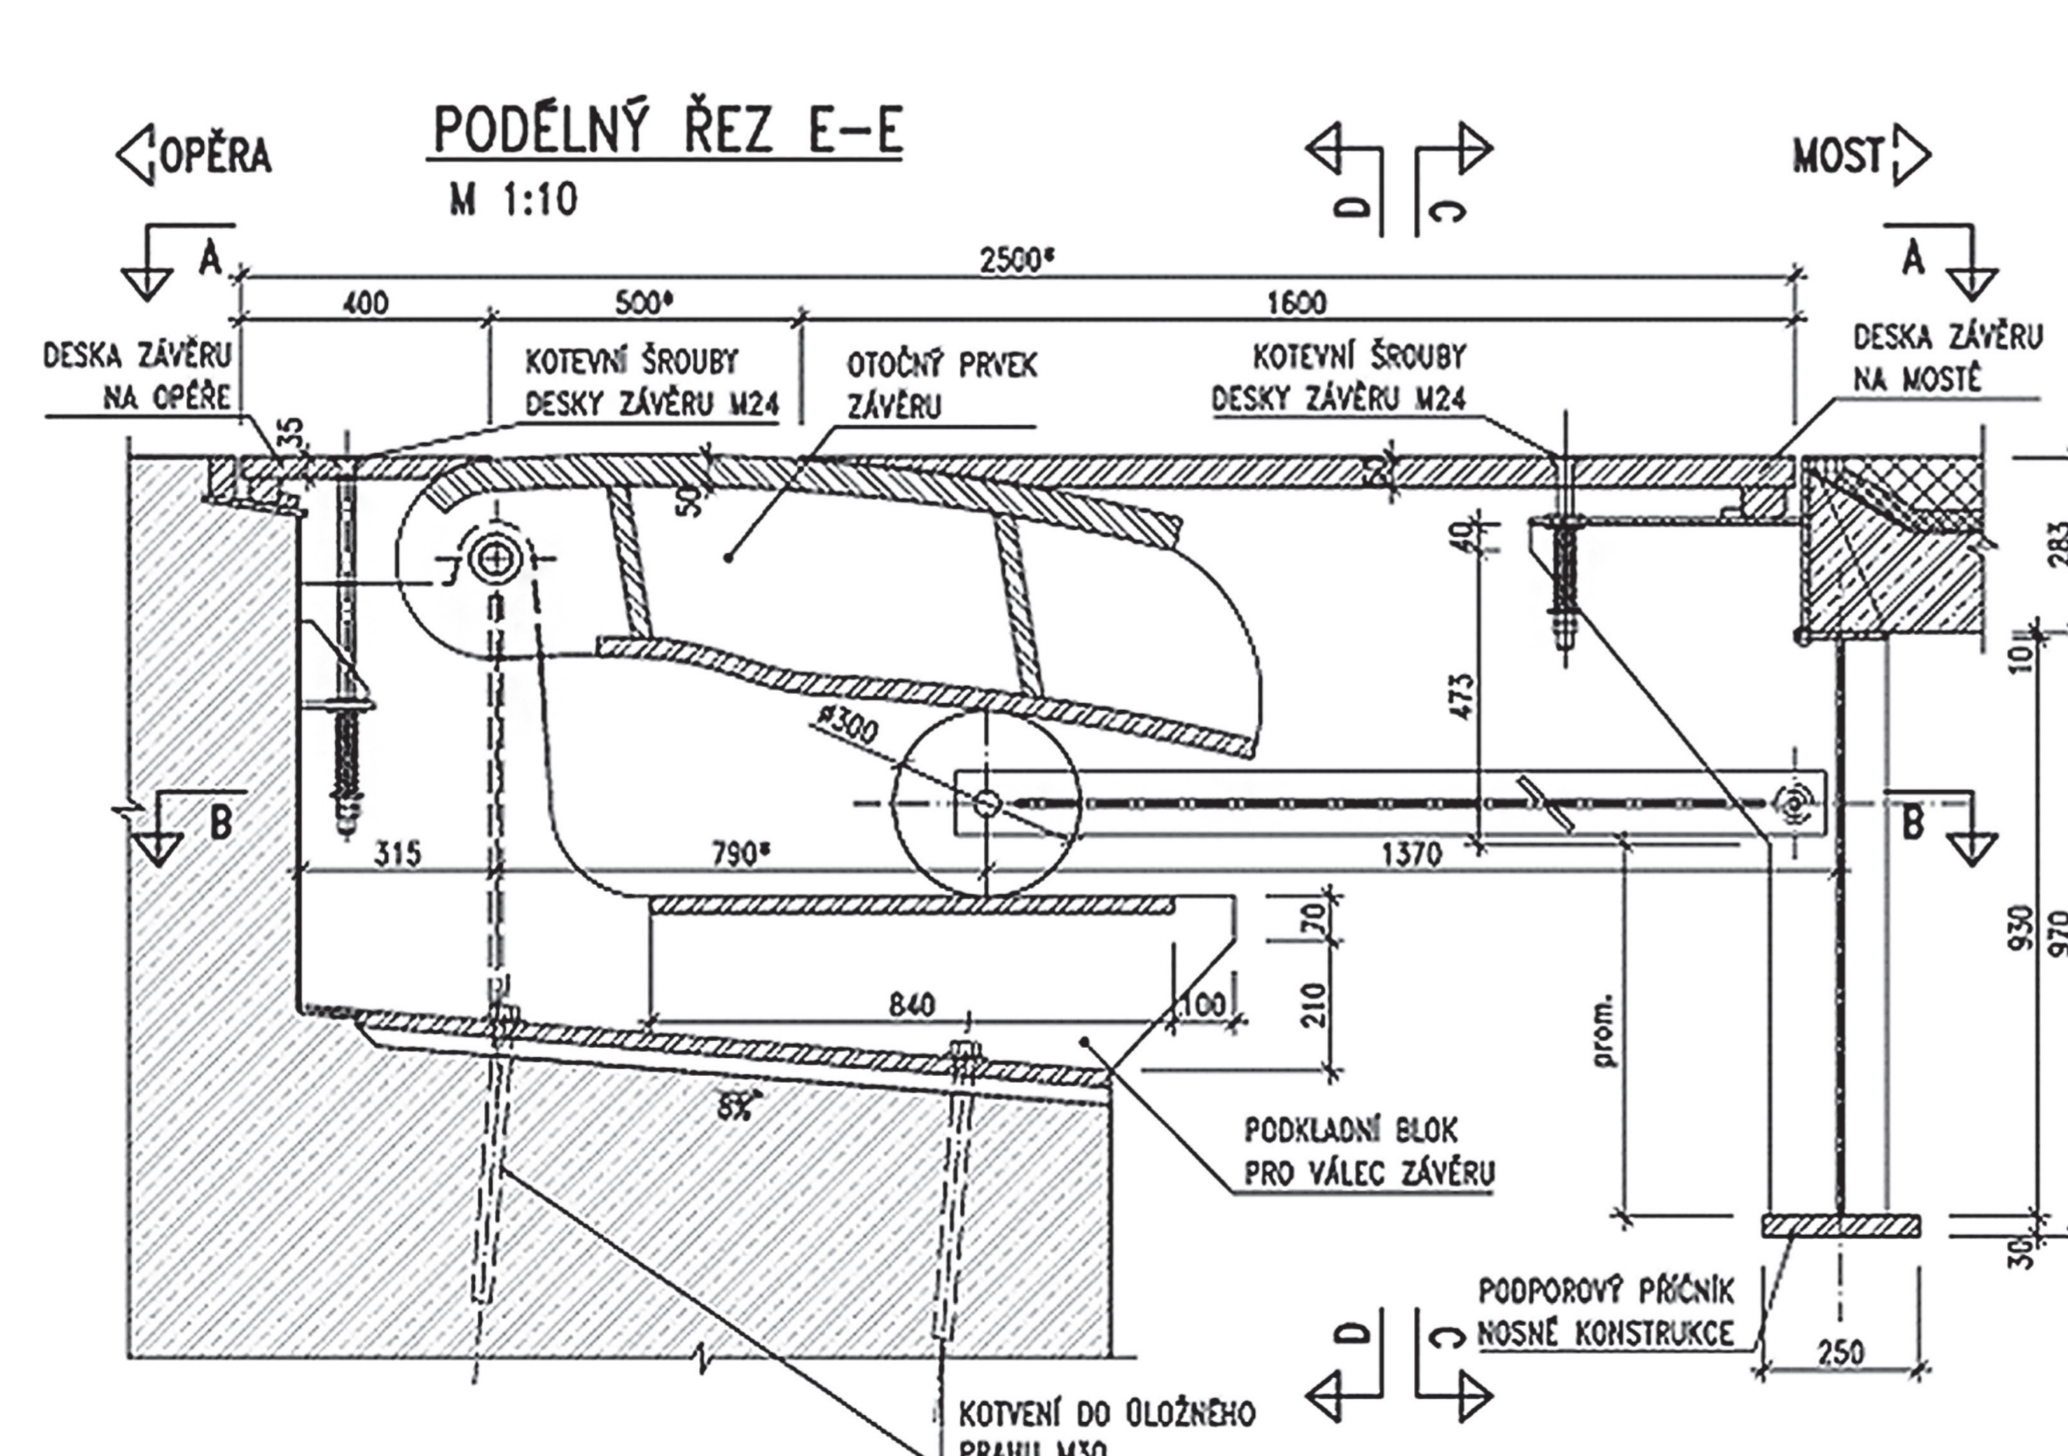
Original expansion joints supported by cylinders

The results of the regular inspections indicated serious damage and non-functionality of the expansion joints, degradation of the concrete of the upper parts of the abutments, corrosion of the end girders, and non-functional drainage. The diagnostic survey carried out in 2008 included a description of the defects, recommendations for repair, and the expansion joints were required to be replaced. In 2010, vehicles over 13 tonnes were restricted to cross the bridge due to defects in the bridge abutments. The 2011 supplementary diagnostic survey proposed demolition of the upper part of the abutments, a method of rehabilitation for the pylons and arch footings was provided, and complete removal of the bridge deck slab along the main girders in a width of 2.0 m was proposed. The additional diagnostic survey included tests of material properties, testing of the concrete surface resistance against water and de-icing salts diffusion, and determination of carbonation progress.

The main objective of the reconstruction was the replacement of the expansion joints, new upper parts of abutments, renewal of the waterproof insulation of the bridge deck slab, replacement of the cornice beams and railings, renewal of the corrosion protection of steel structure and rehabilitation of the concrete parts of the bridge.

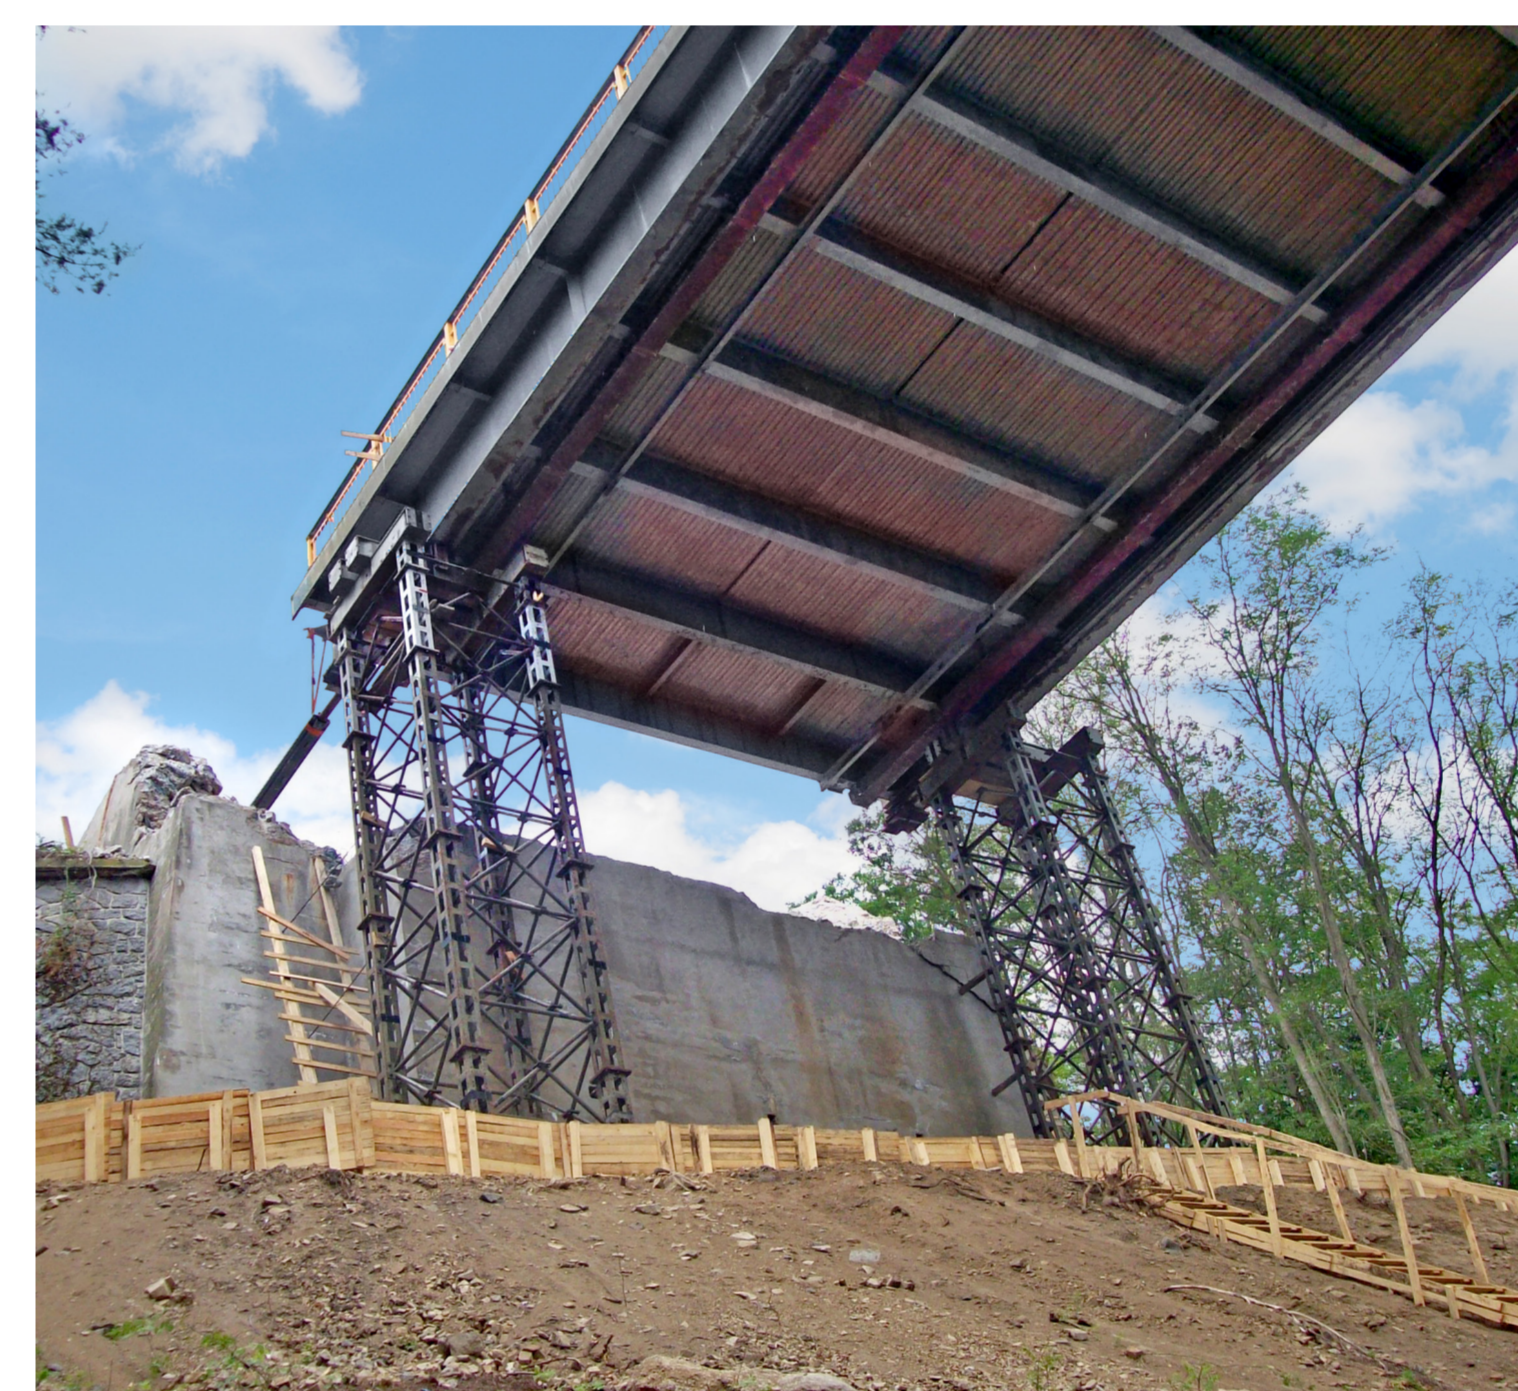
Demolished upper part of the abutment

- Repair and rehabilitation of the substructure (demolition and new abutment sections, full concreting of pylon shafts, rehabilitation of chambers of the pylon heads, etc.).
- Repair of the bridge superstructure and bridge deck (removal of the bridge deck, demolition of part of the bridge deck slab, modification of the transition area behind the abutments, new pavement layers, new expansion joints, rehabilitation of the corrosion protection, etc.).
- Renovation of corrosion protection of arches and props.
- Bridge equipment.

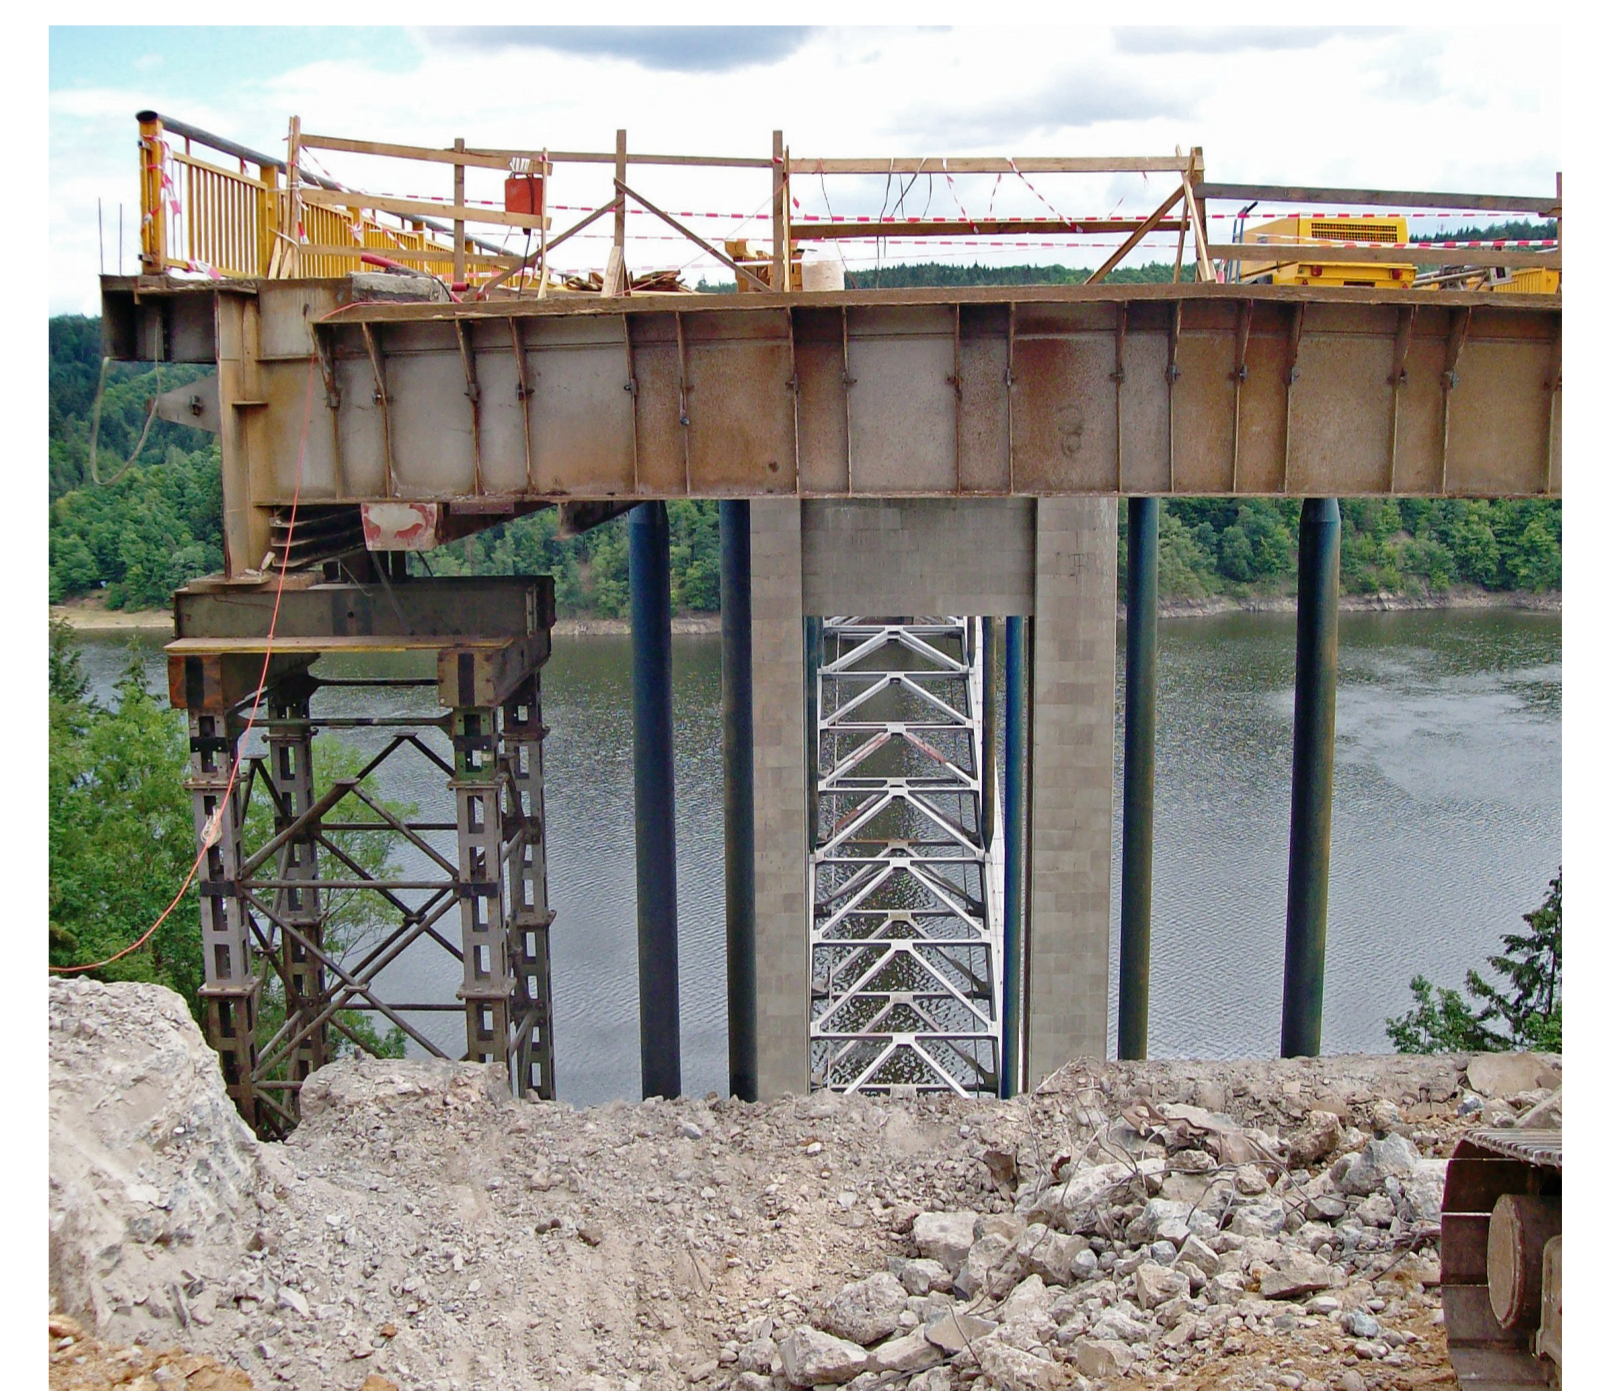
End crossbeam before reconstruction
