INTRODUCTION

As part of a commercial analysis of a high-rise office building a lateral buckling failure mechanism was observed in the long span cellular floor beams. This type of failure had not been observed in similar buildings and hence a parametric study was initiated to discover the root cause.

The building under consideration is a proposed high-rise office tower in the City of London. The study concentrated on a portion of the floor system, chosen as a representative worst case for detailed investigation.

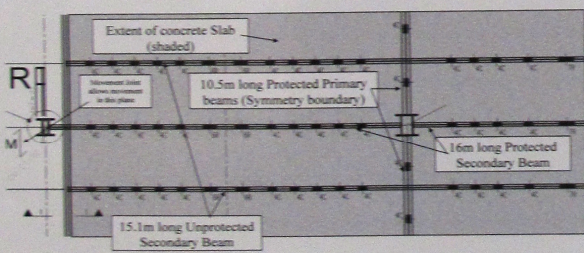
Structural Fire Protection

The structural fire analysis of the model was primarily intended to assess the robustness of the floor system assuming a reduced level of structural fire protection compared to code requirements. In this case, primary and secondary beams attached to columns were provided with 90 minute protection while intermediate secondary beams were left unprotected. It has been shown in a number of recent analyses of tall office buildings that this type of fire protection layout is a safe and efficient alternative to "code compliant" generic solutions. The analysis presented here was conducted in order to gain an understanding of the response of the building to fire under this engineered structural fire protection scheme. Such detailed knowledge of the building would not be gained from merely applying standard fire protection. The analysis utilized cutting edge modelling techniques and the latest ABAQUS FEM software.

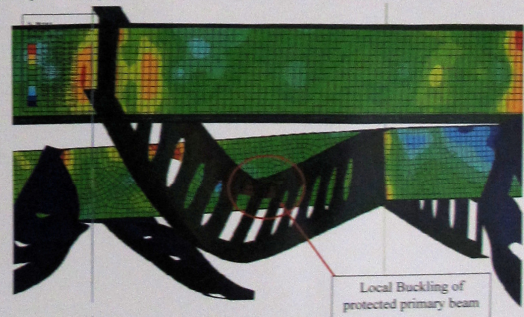
Structural Response

The primary response identified by the analysis is the significant lateral deformation of the protected primary beam, as indicated below which shows the deformed shape of the beam at the onset of failure. Local buckling of the top flange and upper web are also evident.

This behaviour occurred towards the end of the heating phase, starting at approximately 45 mins into the design fire. At this point, the temperature of the bottom flange was approximately 375°C while the web was at 400°C. This temperature is significantly lower than the temperature that a beam would normally be expected to fail (Usually 620°C). The resulted in twisting of the entire protected beam which led to failure of the connections between the beams and the megaframe (external perimeter) column, and subsequently collapse of the floor system.

A parametric study was conducted on a section of a unique high-rise office building that was indicating a lateral failure mechanism. The analysis indicated that the root cause of the instability was related to the depth of the sections combined with the relatively narrow flanges.

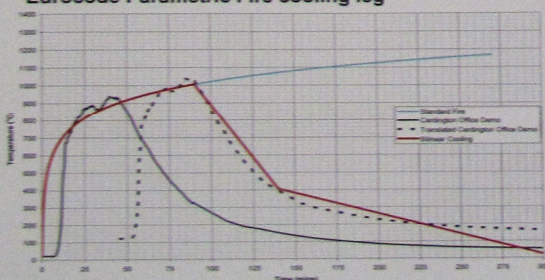
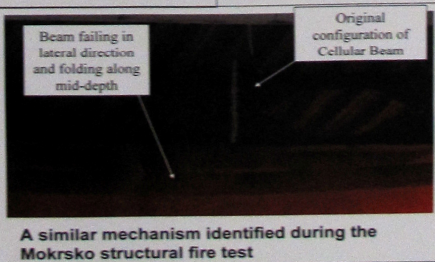
Design Fire

- Severe full floor involvement
- Bi-linear cooling considered more realistic than Eurocode Parametric Fire cooling leg
