Techniques for the evaluation of concrete structures after fire

Case study

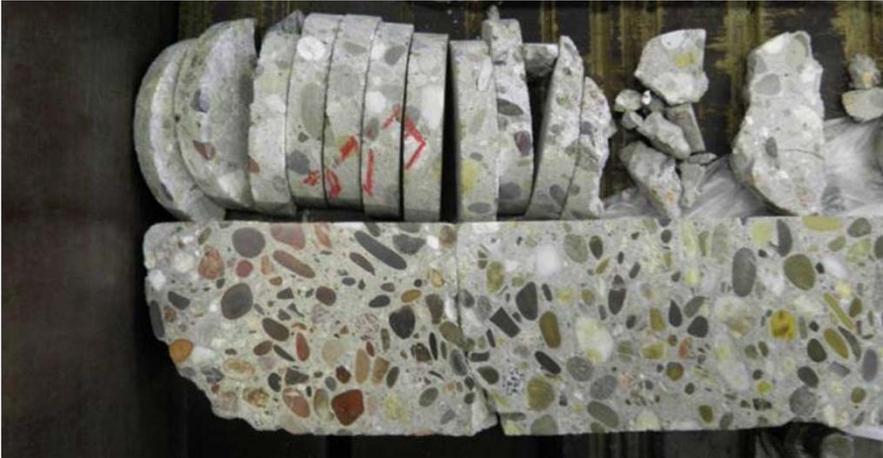
Colour measurement

red (300-600°C)
whitish grey (600-900°C)
yellow (900-1000°C)

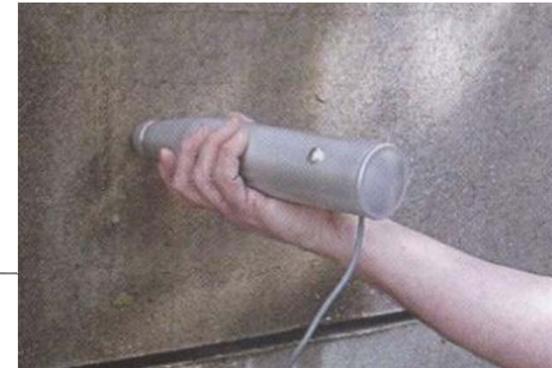
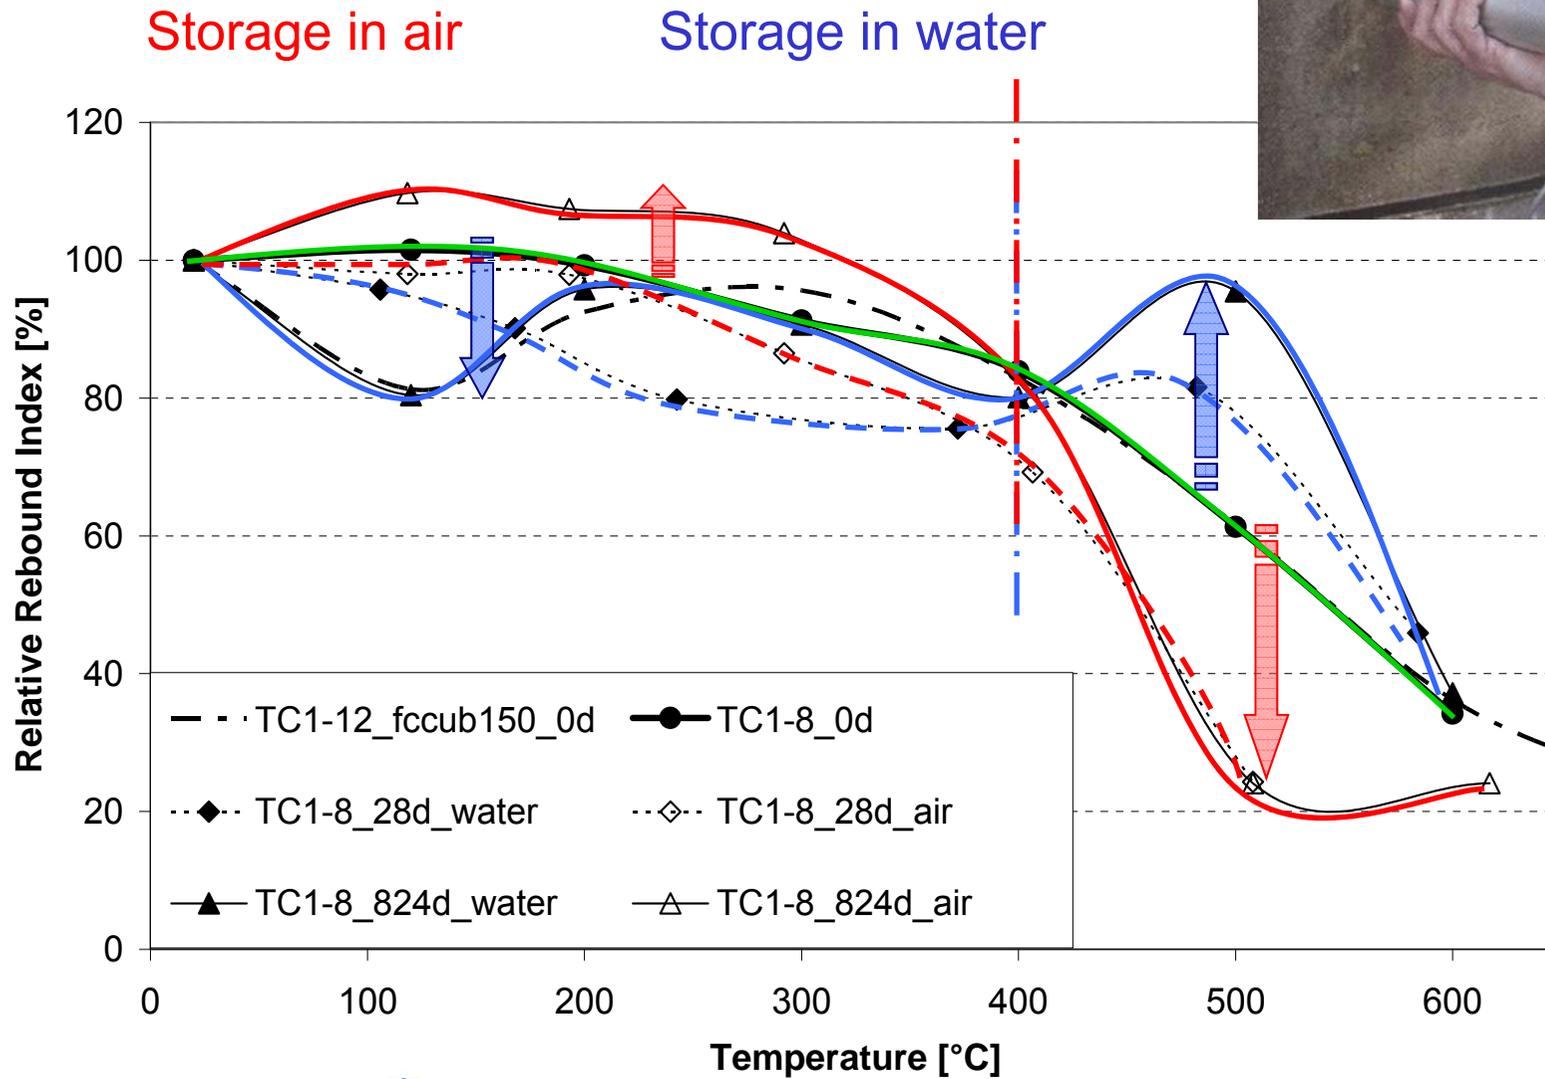
Schmidt Rebound Hammer

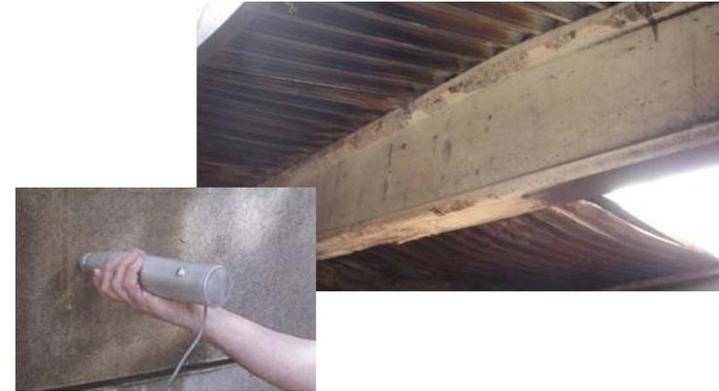
Test results

$RI_T/RI_{20^\circ C} \geq 0.85$: superficially damage
 $0.85 \geq RI_T/RI_{20^\circ C}$: further investigation necessary

Test location		Direction of measurement	Average	Standard deviation	$RI_T/RI_{20^\circ C}$ [-]
Reference girder	web	side	45.6	2.0	1.00
	flange	side	44.3	2.5	1.00
	flange	bottom	50.9	1.0	1.00
Location 1	web	side 1	36.8	1.8	0.81
	web	side 2	41.2	1.1	0.90
	flange	side 1	30.8	2.3	0.70
	flange	bottom	44.8	1.1	0.88
Location 2	web	side 2	38.0	1.4	0.83
	flange	side 2	30.0	5.7	0.59
	flange	bottom	39.6	1.7	0.78
Location 3	web	side 1	41.0	2.4	0.90
	flange	side 2	44.6	1.3	0.98
	flange	bottom	47.8	4.1	0.94
