**FACULTY OF CIVIL
ENGINEERING
CTU IN PRAGUE**

Training School COST Action TU 1406 on Bridge Quality Control

COST ACTION TU1406: QUALITY SPECIFICATIONS FOR ROADWAY BRIDGES, STANDARDIZATION AT A EUROPEAN LEVEL

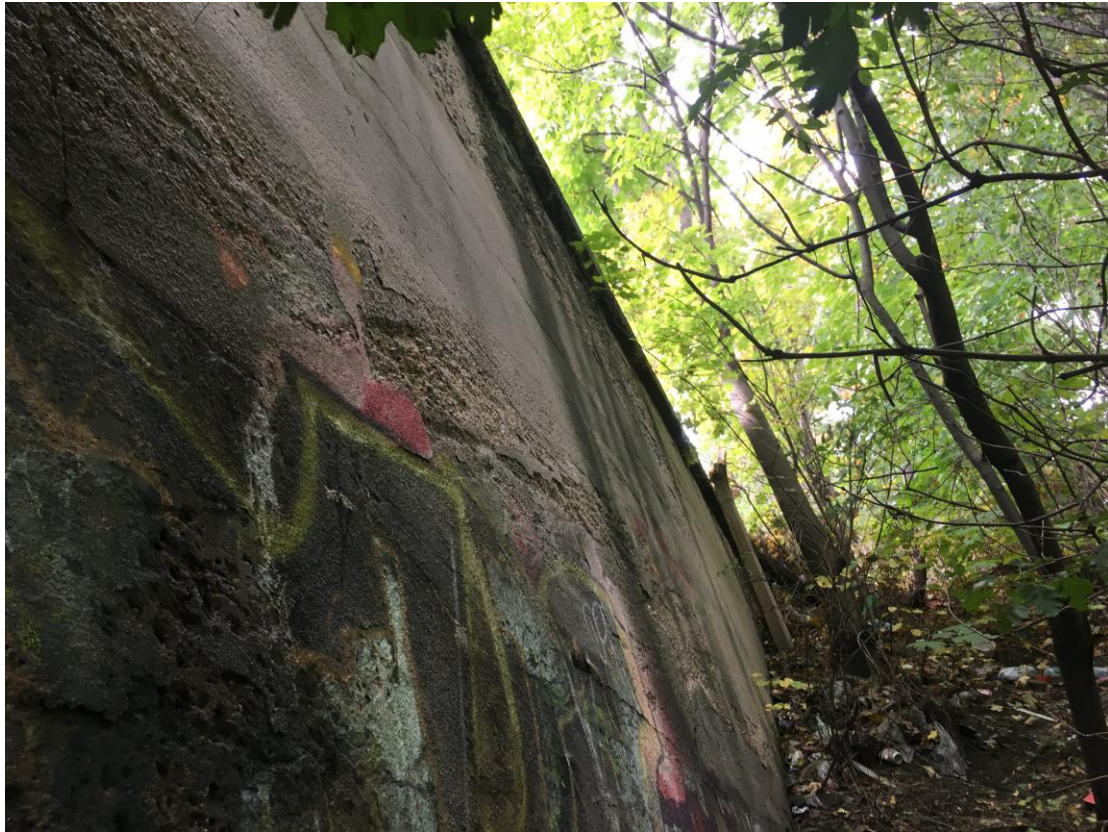
Figure 2.1-16 – Loss of cement matrix at wingwall

Wing walls have minor damages (e.g. loss of cement matrix in Figure 2.1-16) and there are no exposed reinforcing bars.

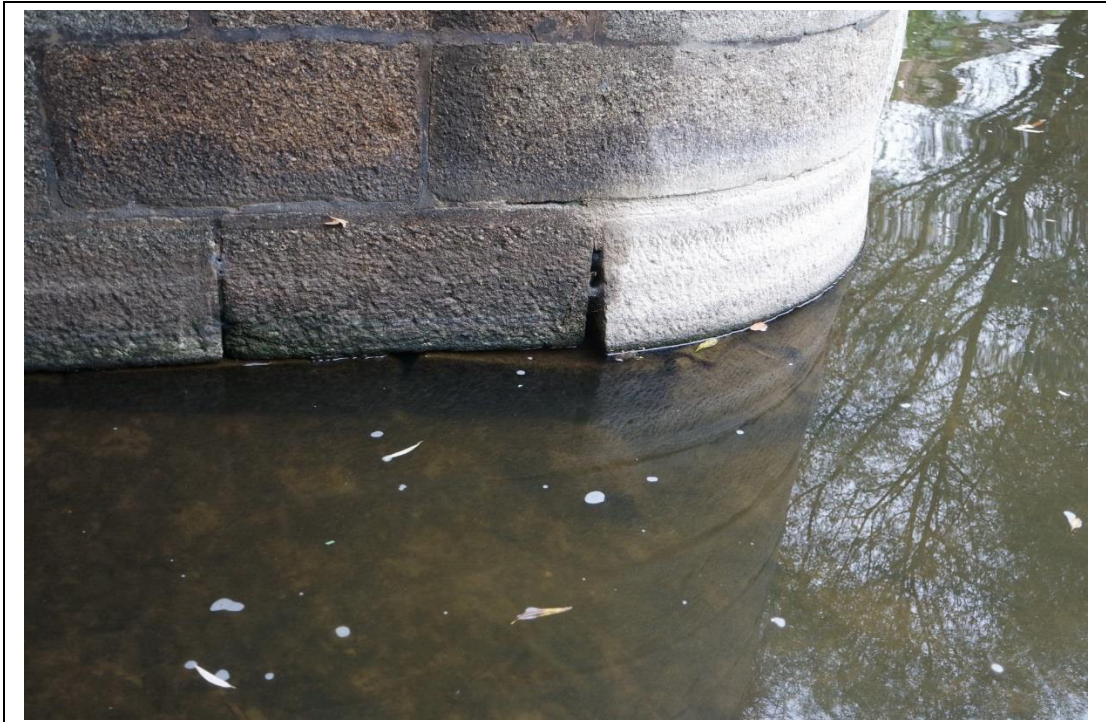
Fig. 9 Scour of the pier (upstream side)

2.2.1. SCOUR OF SUPPORTS

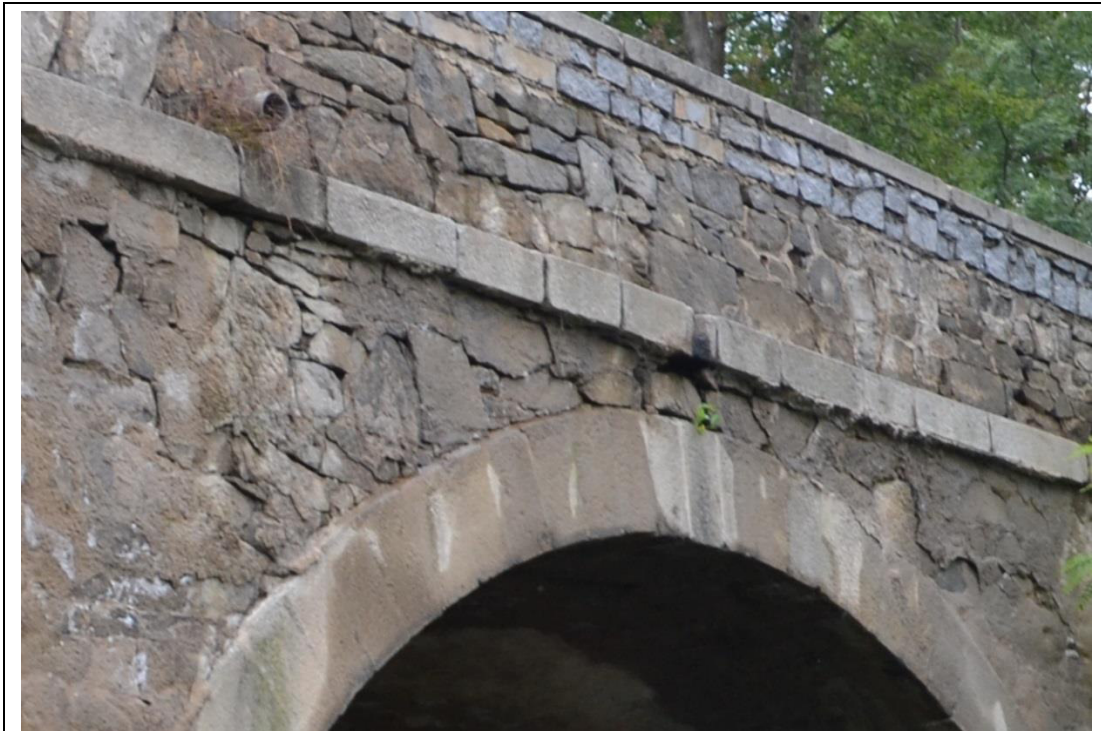
Fig. 11 Horizontal fracture of the spandrel wall over span 2 (upstream side)

2.2.2. FRACTURES OF SPANDREL WALL

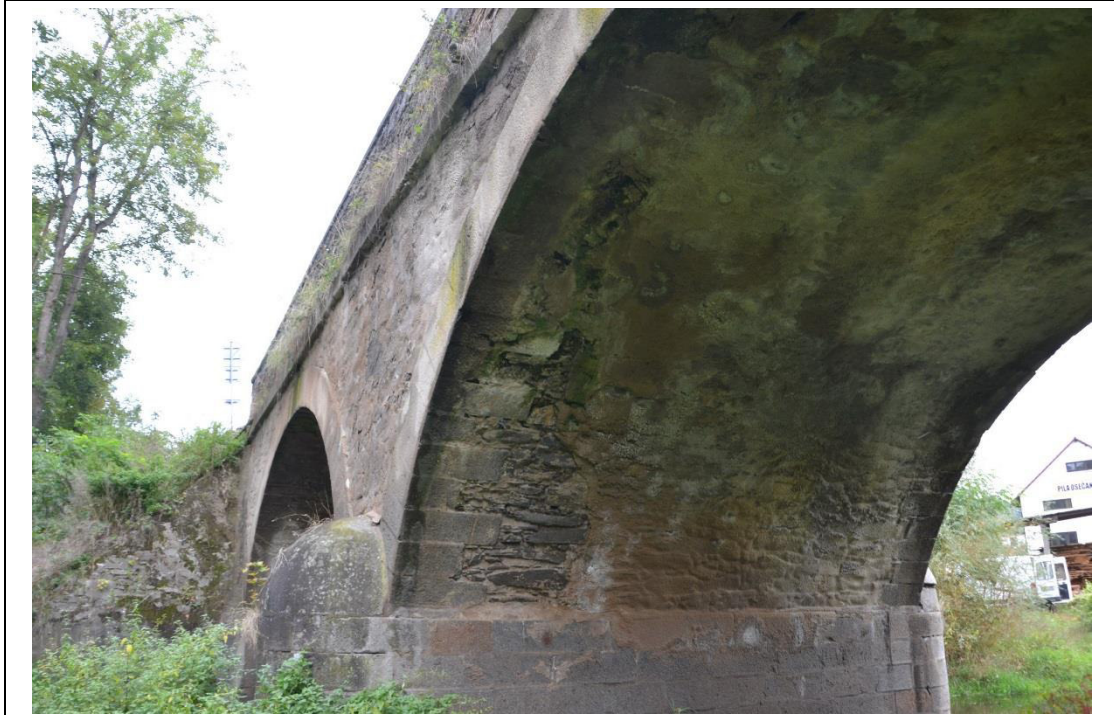
Fig. 15 Leaching in the arch in span 1

2.2.3. DAMAGE WATERPROOFING OF THE ARCH AND SPANDREL WALLS

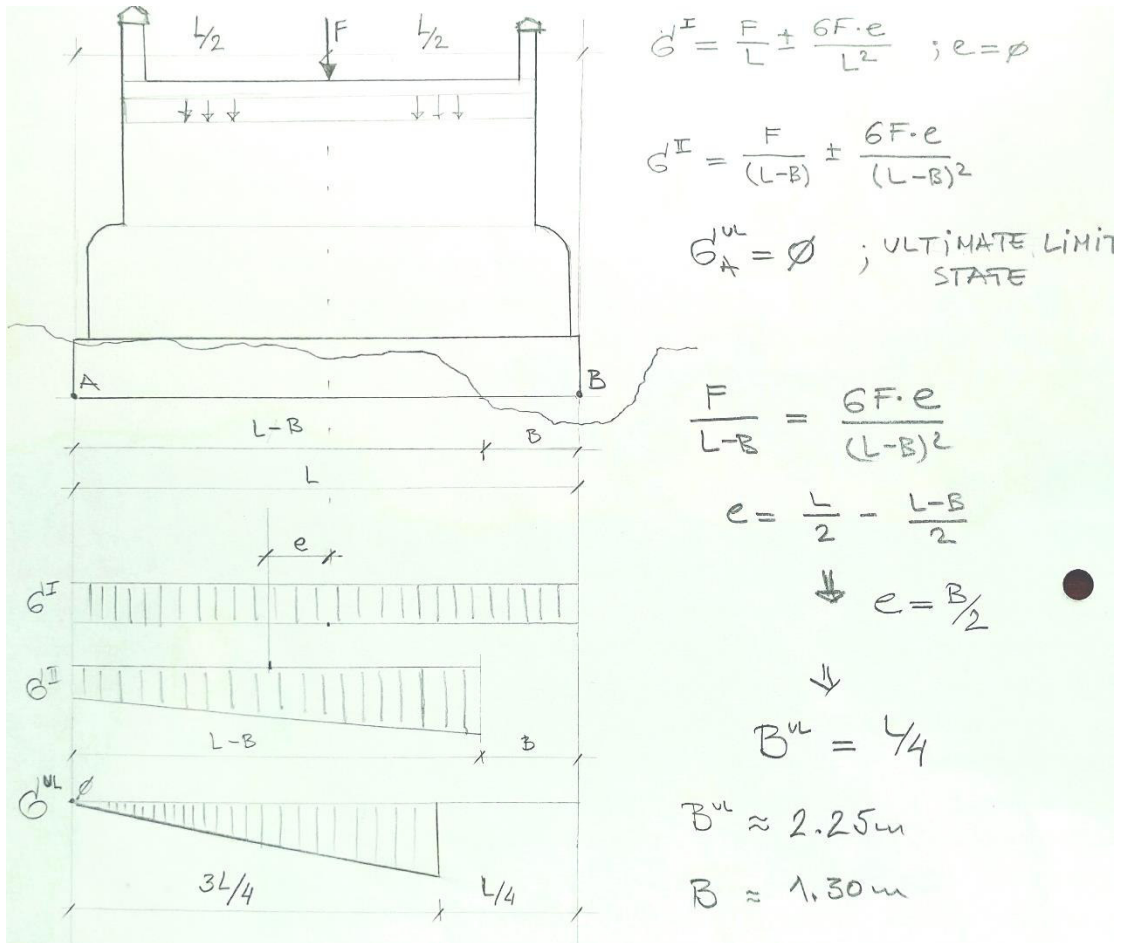
Considered as the most probable failure mode is settlement of the pier foundation due to scour. Assumed ULS of the foundation at settlement is related to occurrence of lifting of one of the edges of the it. It may occur when the width B of the scour is reaching $\frac{1}{4}$ of the length of the foundation according to the scheme below.

Estimated critical B value of the scour is equal to 2,25 m. The current measured value of the scour is 1.30 m. Thus, the adopted value of the reliability for the considered failure mode is 3.

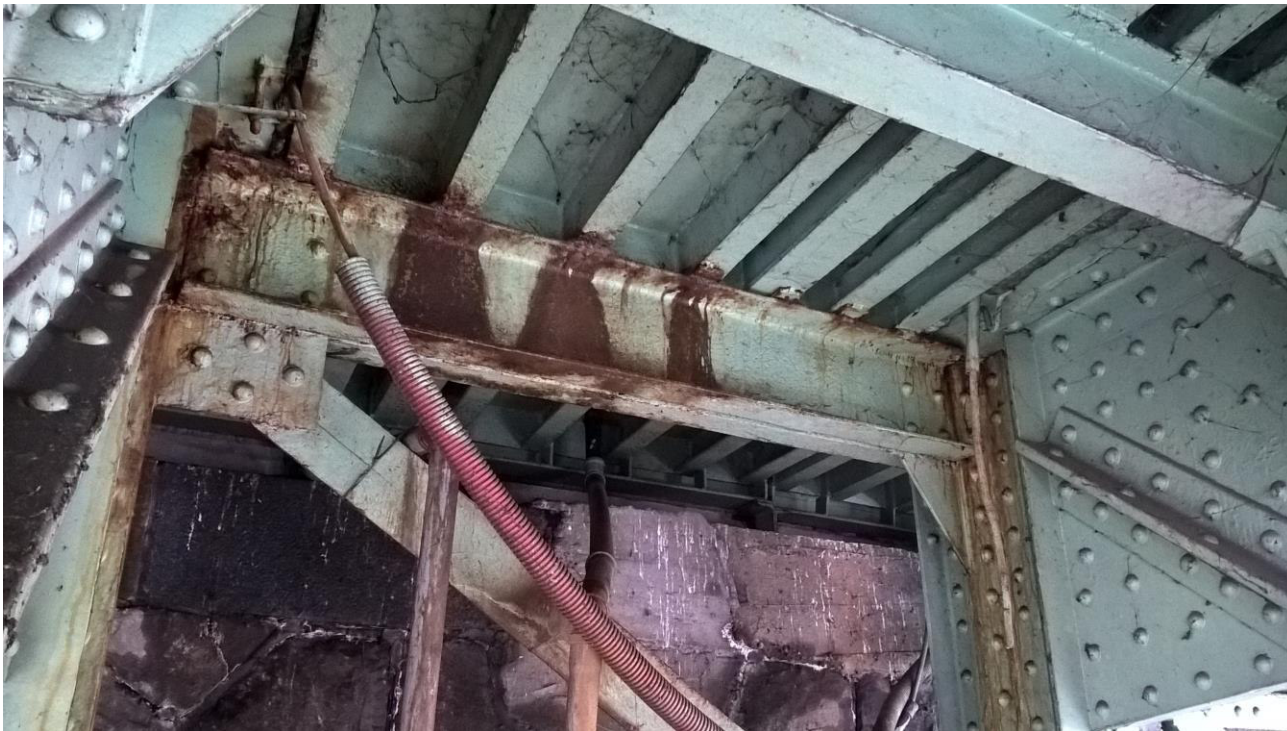
- Deck (Orthotropic Plates)
 - Liquid through joints

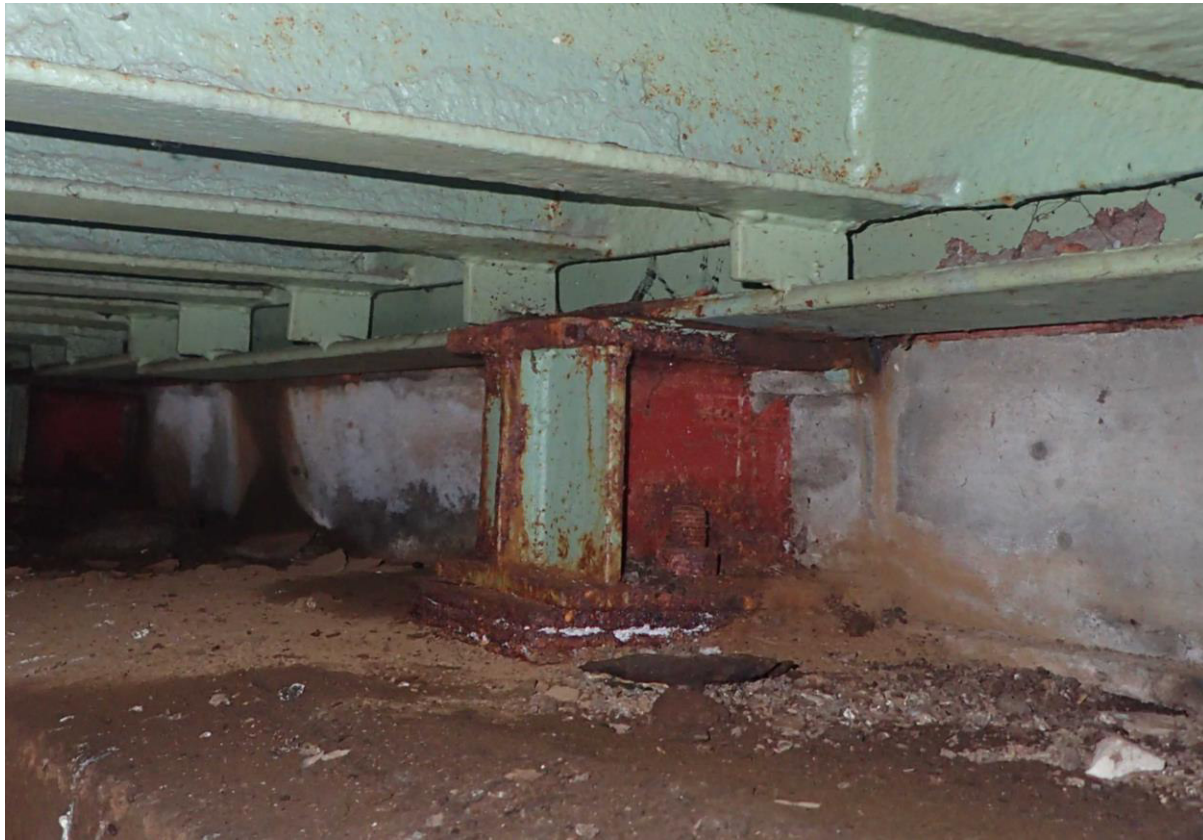
- Upper Bearings
 - Corrosion

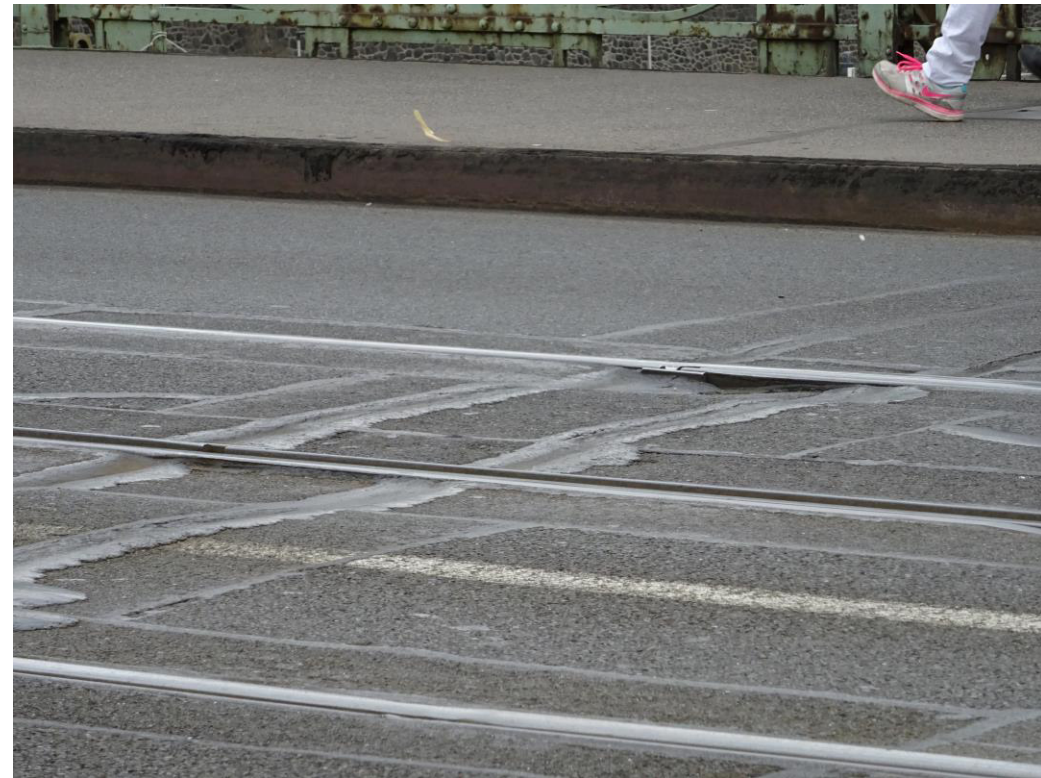
- Pavement: Rails – joint connection
 - Inappropriate design for switch device
