Action COST C 26

Experimental and numerical investigations on the Mustafa Pasha Mosque large scale model

Prague, 30-31 March 2007

PROHITECH - "*Earthquake protection of historical buildings by reversible mixed technologies*"

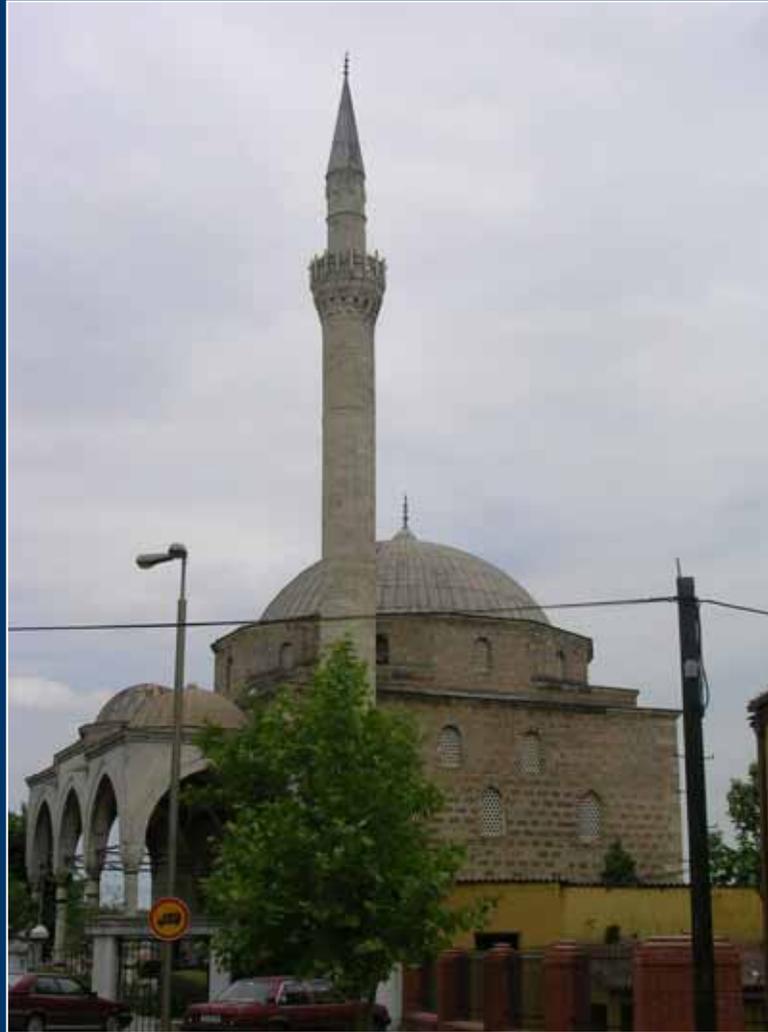
Mustafa Pasha mosque (1492), Skopje

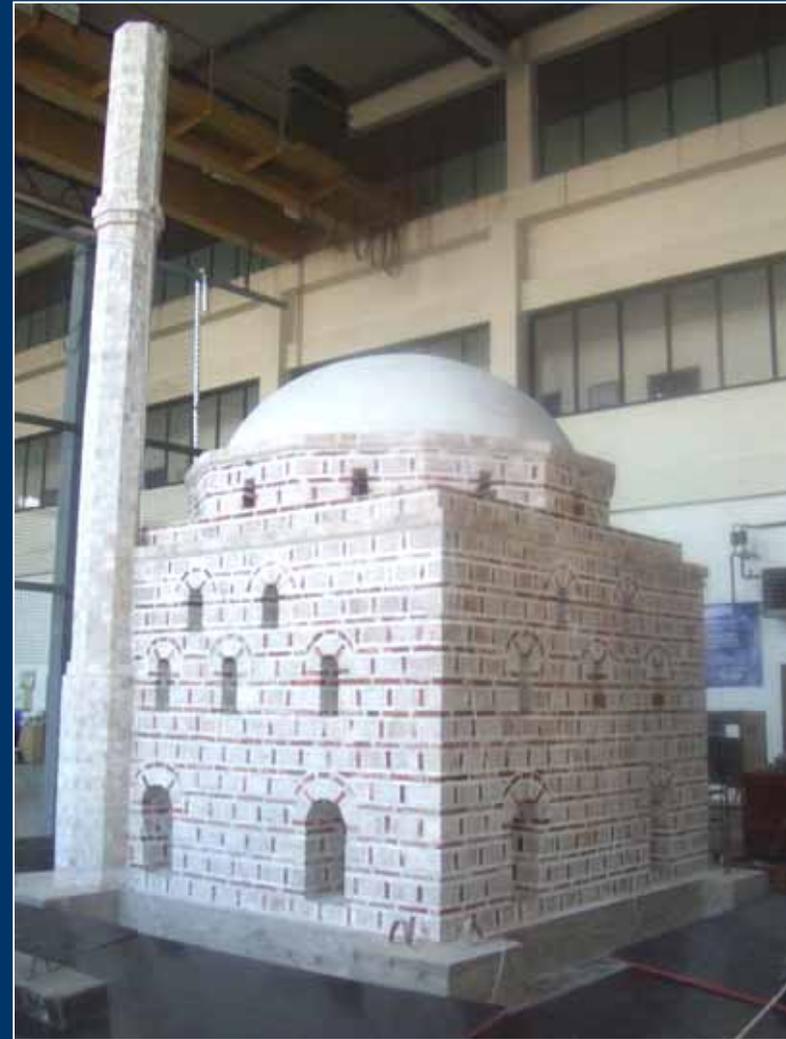
Mosque model, length scale 1:6

- "gravity forces neglected" modeling principle, using the same materials as in the prototype: stone, bricks and lime mortar.

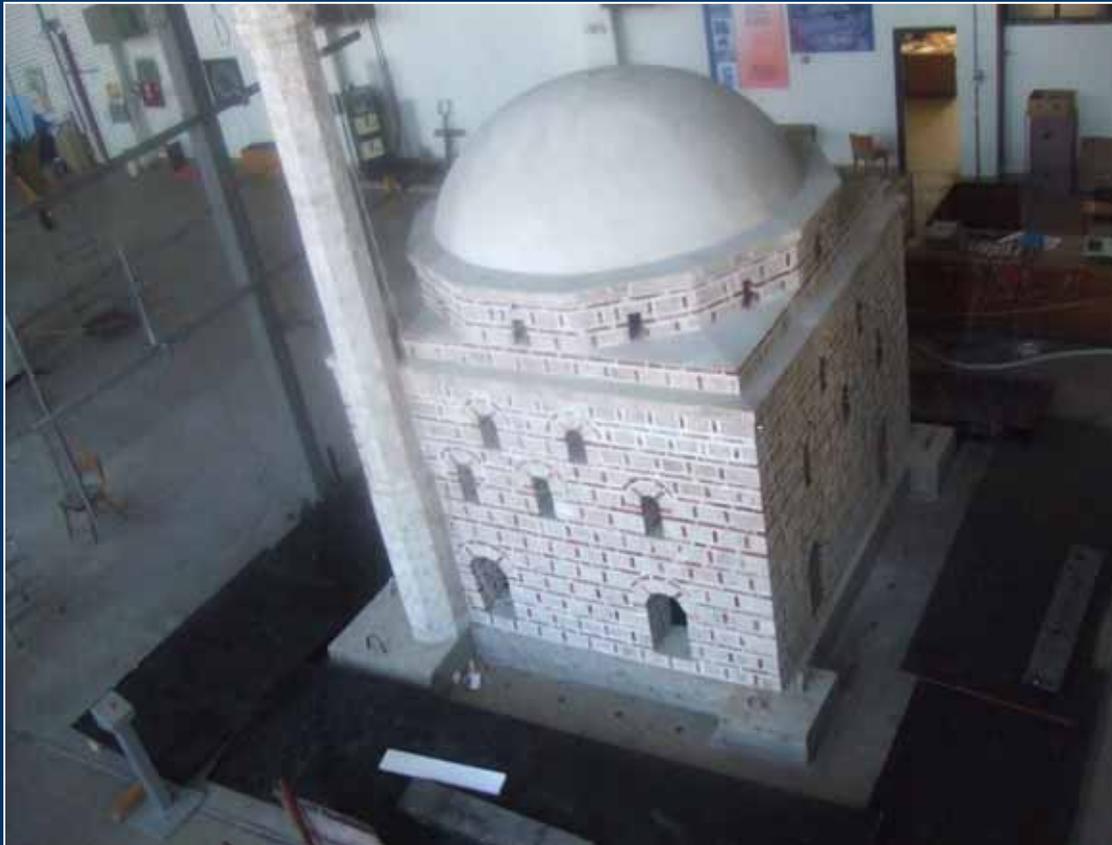
- The main objective of this testing was to investigate experimentally the effectiveness of proposed reversible technology for strengthening of this type of historical monuments.
- Bi-axial seismic shaking table in the Dynamic Testing Laboratory of the Institute for Earthquake Engineering and Engineering Seismology in Skopje.

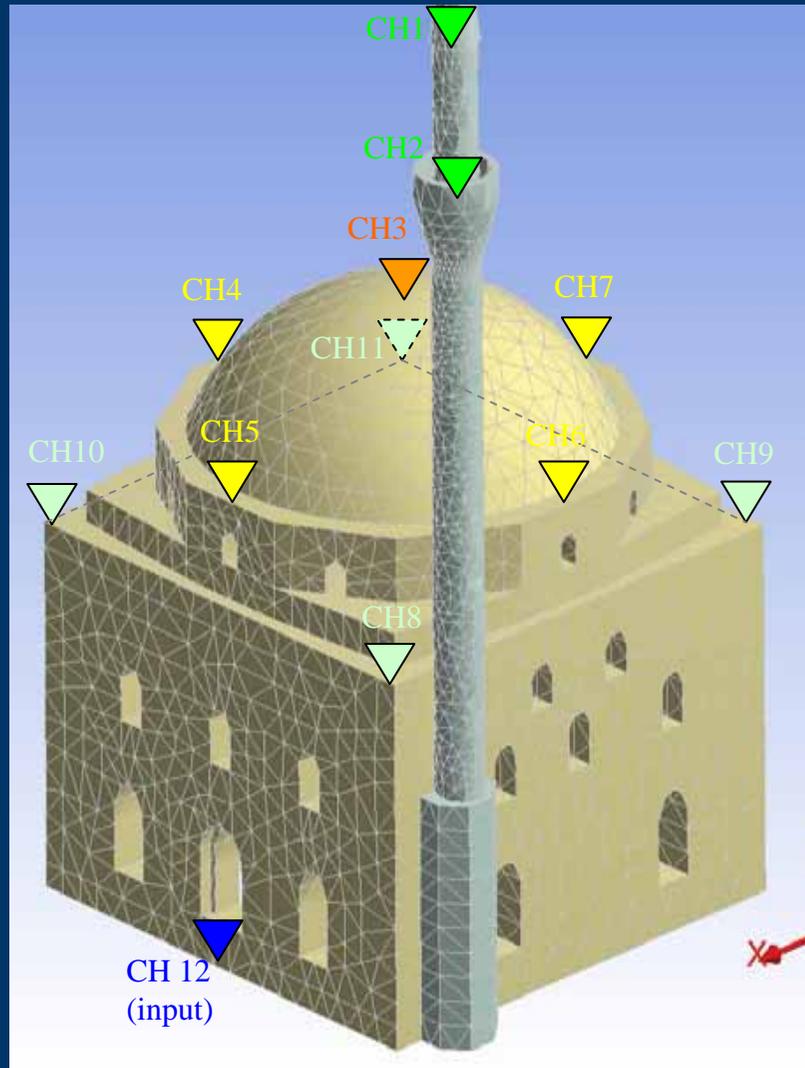
Instrumentation of the model

accelerometers

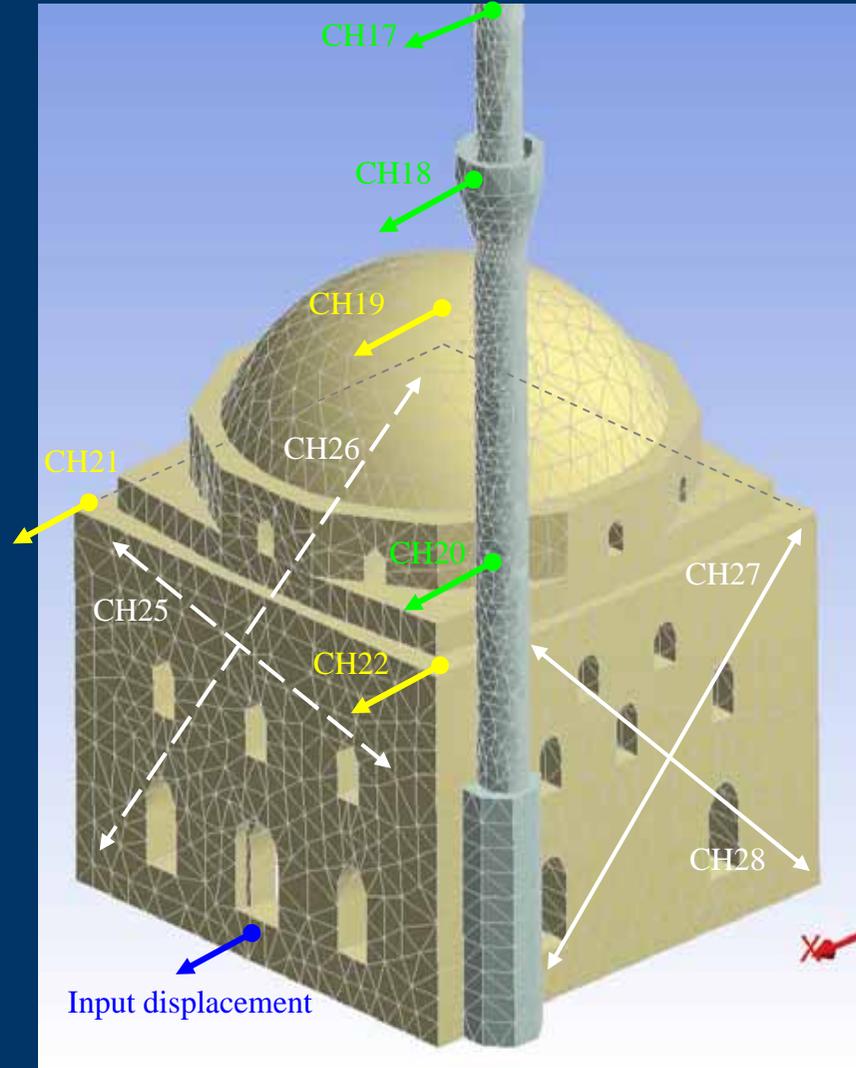
displacement transducers

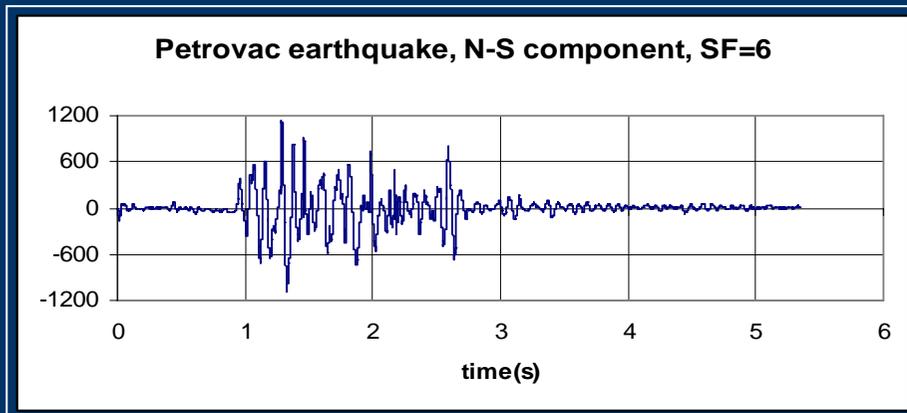
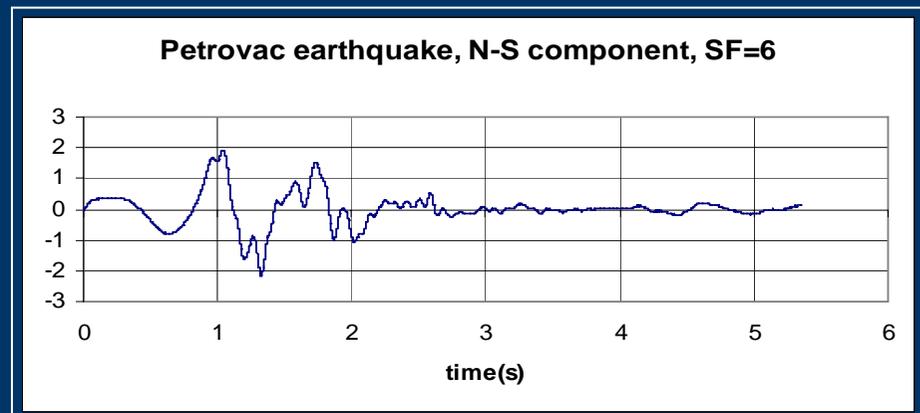
Time histories of acceleration and displacement, earthquake excitation
Petrovac, 1979, N-S component , scaled by 6

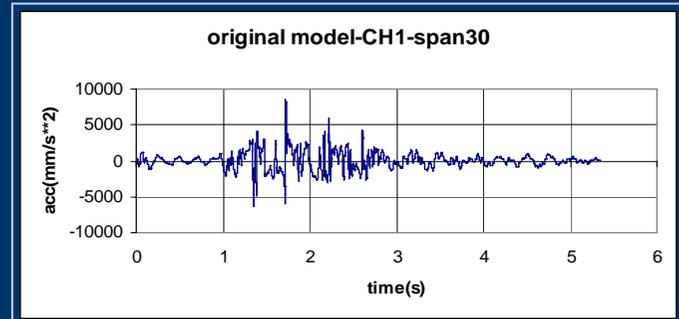
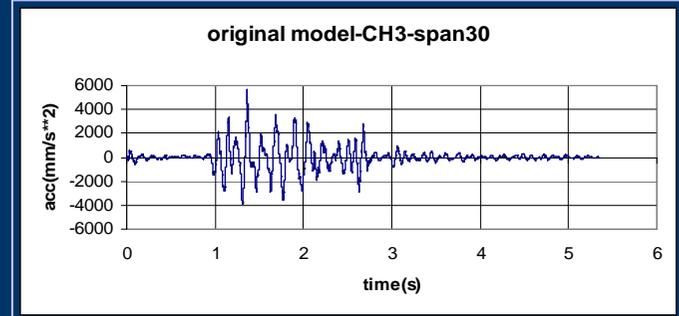
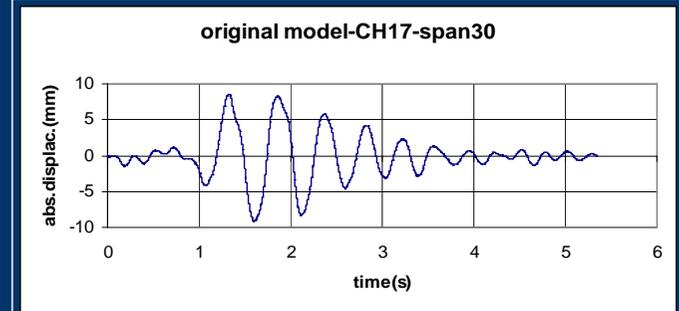
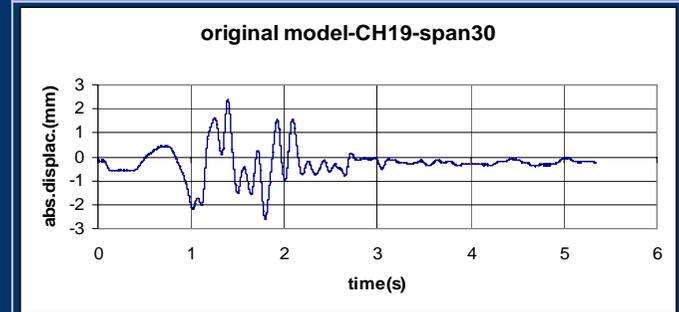
Response parameters - test with input intensity 10%g

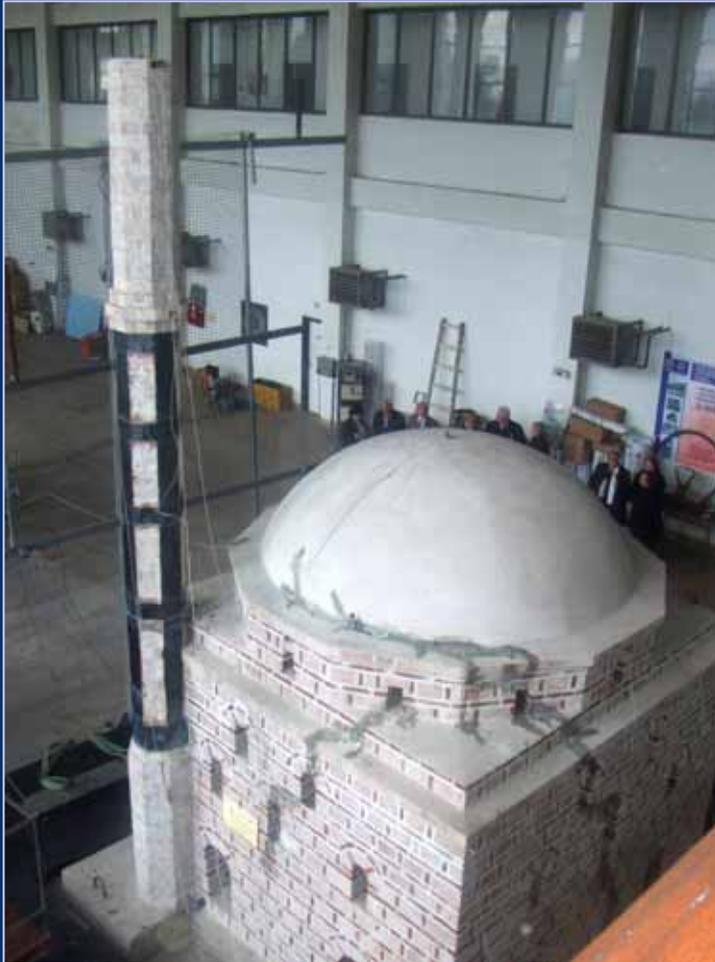
STRENGTHENING OF THE MINARET

Application of CFRP wrap upon a layer of epoxy glue:

- on four sides along the length of the minaret in vertical direction;
- at four levels along the height of the minaret in horizontal direction;
- at the minaret base

Such a strengthening enabled stiffening of the minaret and increasing of its bending resistance

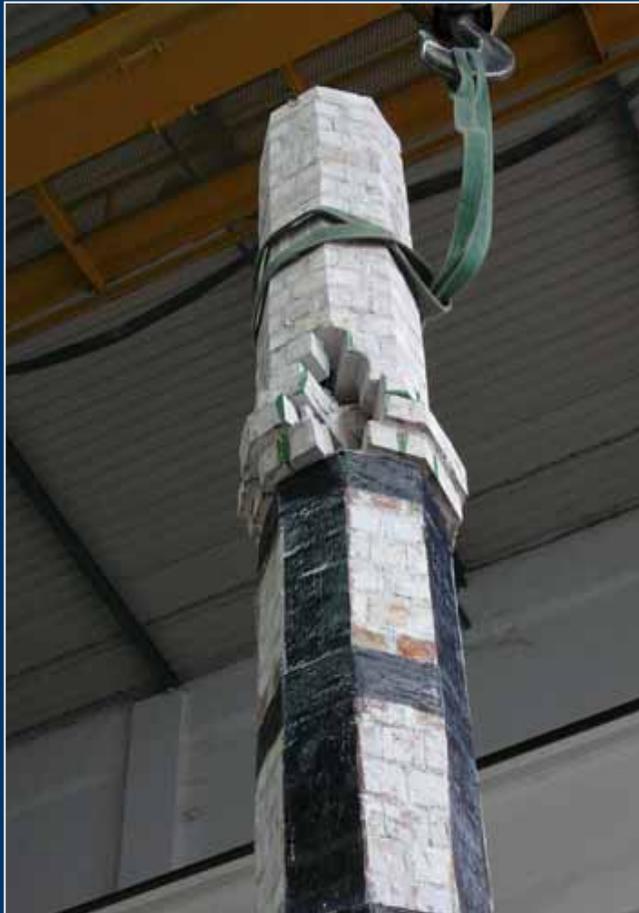
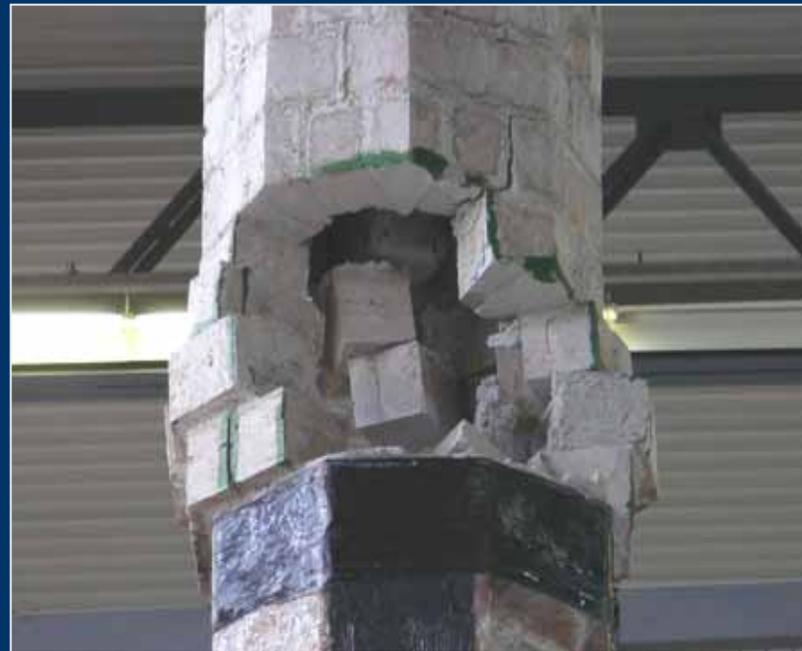
Collapse of the upper part of the minaret

test No	span	input acc (g)	top acc. (minaret)	top acc. (dome)	input displac. (mm)	top displac. (dome)	comment
1	30	0.2	0.65	0.4	2.24	2.3	
2	40	0.28	0.82	0.6	3.3	3.3	
3	50	0.34	1.7	0.7	4.0	4.0	Cracks on the minaret
4	60	0.42	-	1.0	4.7	5.0	First cracks on the mosque
5	70	0.49	-	0.88	5.48	6.4	Collapse of the minaret
6	80	0.53	-	0.9	6.1	7.5	
7	90	0.58	-	1.0	7.0	8.9	
8	120	0.65	-	0.96	9.1	12.4	
9	150	1.05	-	1.1	11.4	14.7	
10	180	1.4	-	0.7	13.9	18.8	
11	200	1.5	-	0.54	15.3	22	Heavy damage of the mosque

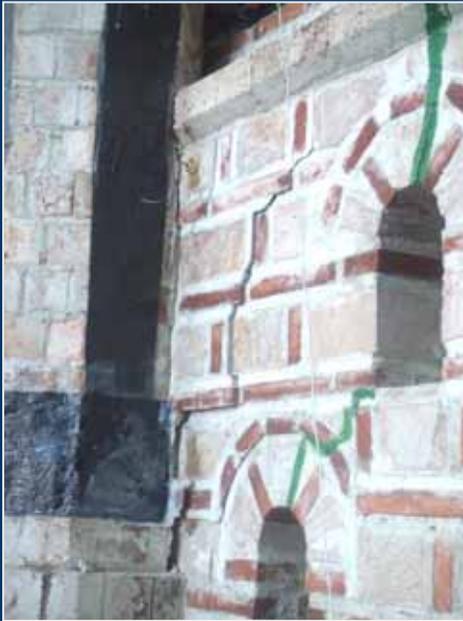
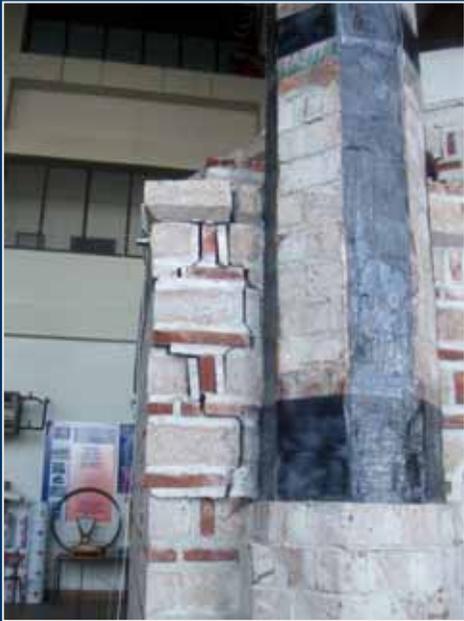
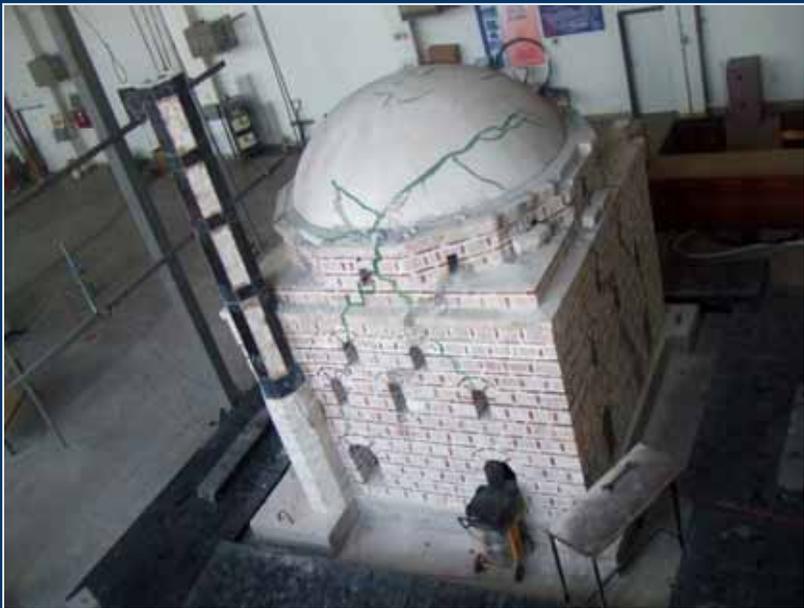
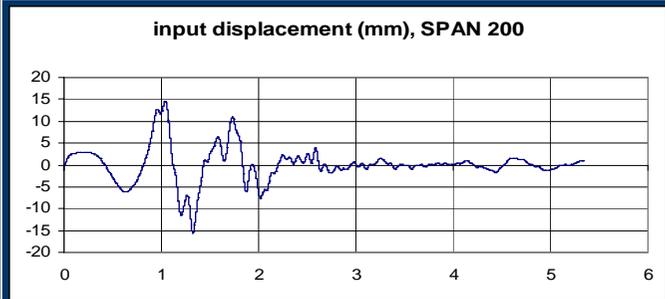
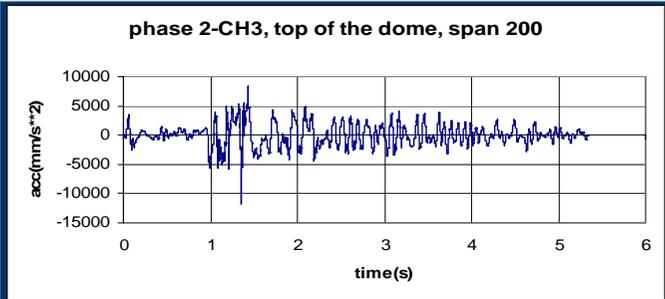
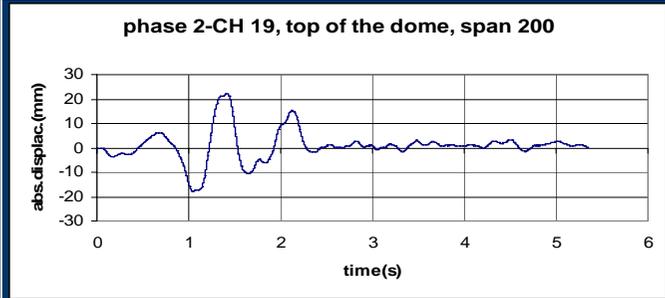
Response parameters - test with input intensity 1.5g

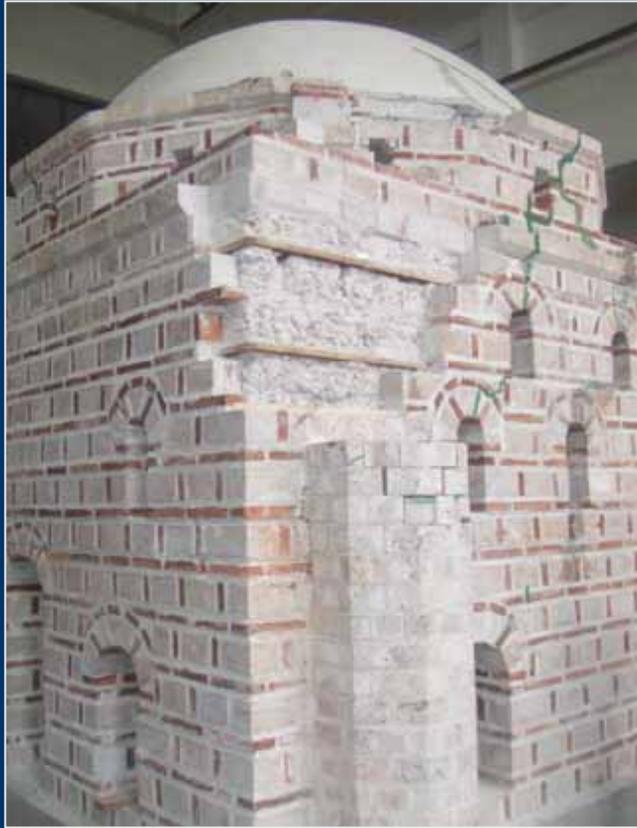
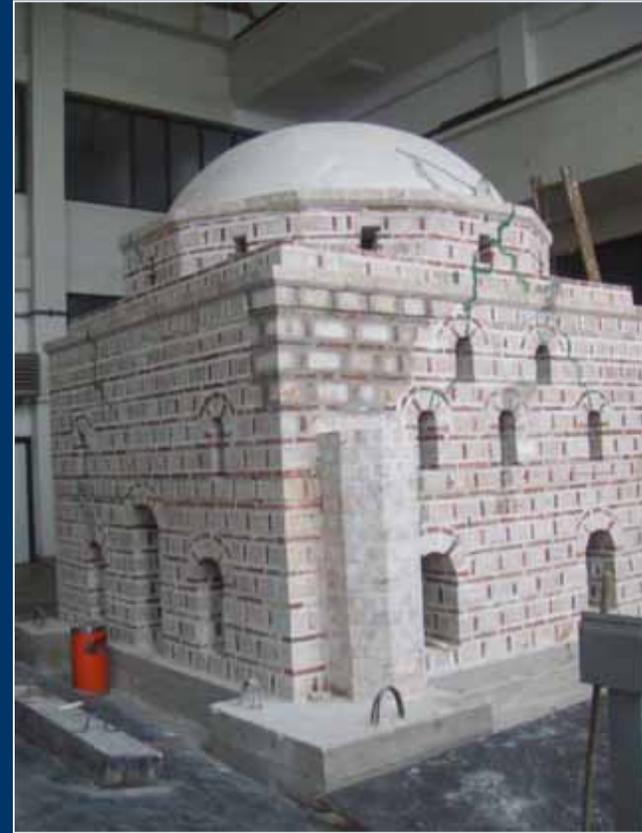
Rebuilding of the damaged part after phase 2 testing

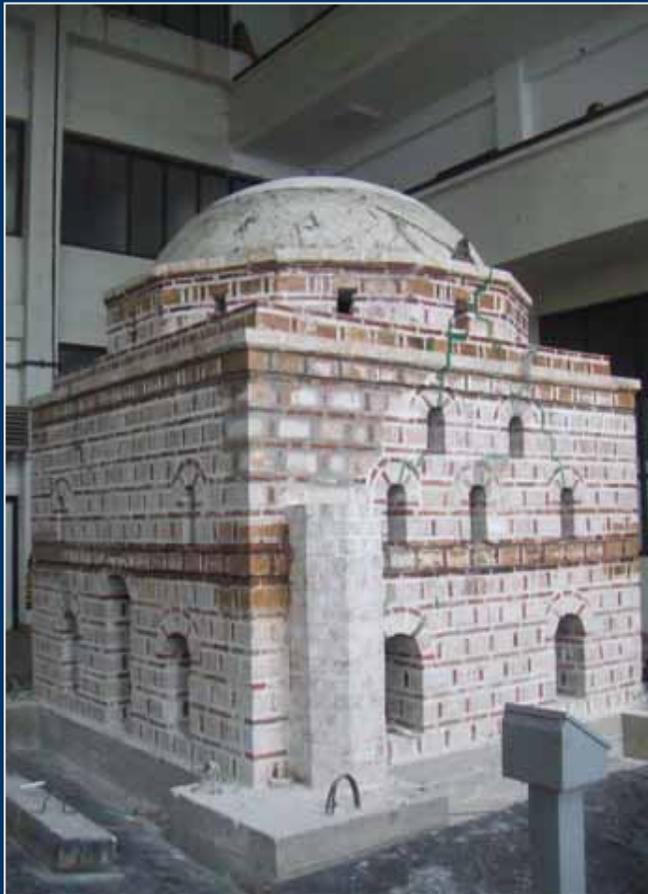
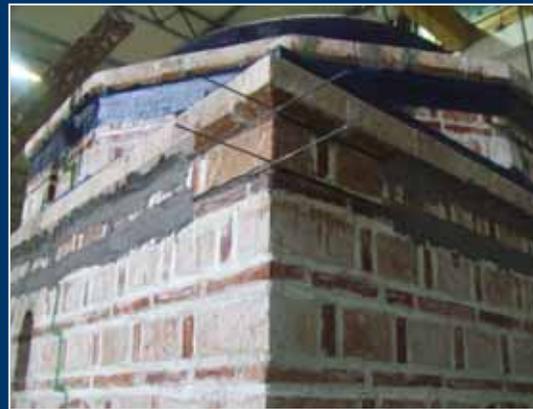
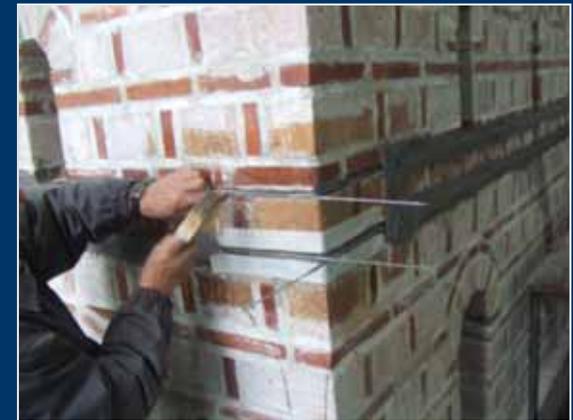
- The main adopted principle in strengthening of the model was that the methodology to be applied be reversible and invisible.
- Incorporation of carbon rods in two longitudinal mortar joints around the four walls at two levels ;

the grooved part of the joint was filled with epoxy resin

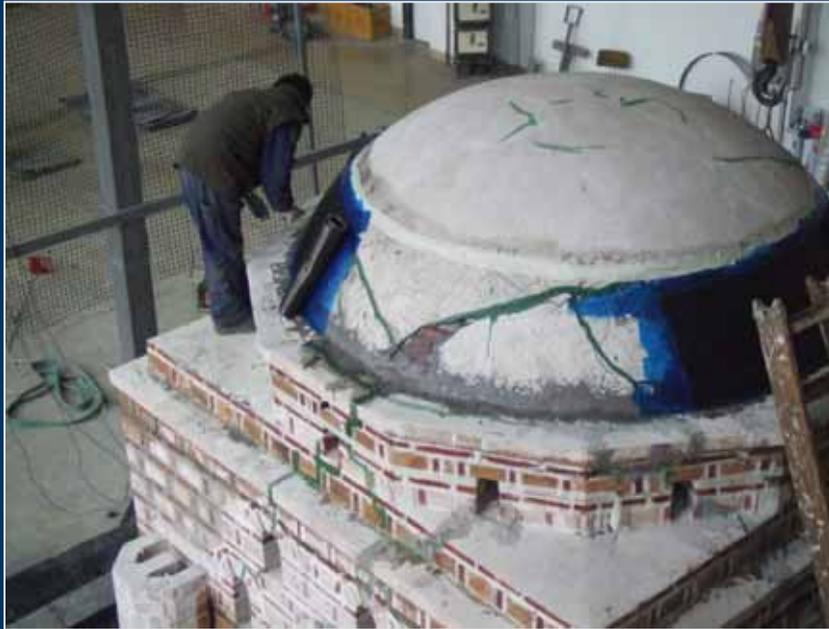
- Formation of a horizontal belt course at the base of the dome by use of a CFRP wrap

The formation of the horizontal belt courses enabled **better integrity of the tambour and the dome base and prevented “opening” of the dome** which was the most common reason for occurrence and prolongation of cracks in the bearing walls.

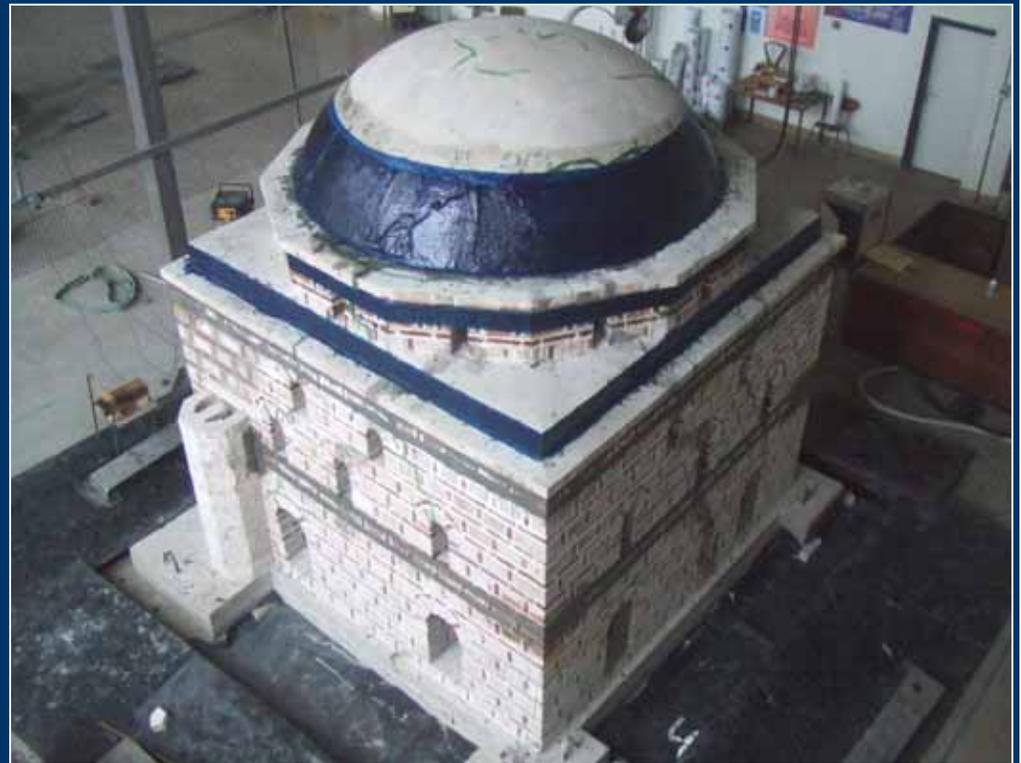
- Formation of a horizontal belt course around the tambour by applying a CFRP wrap

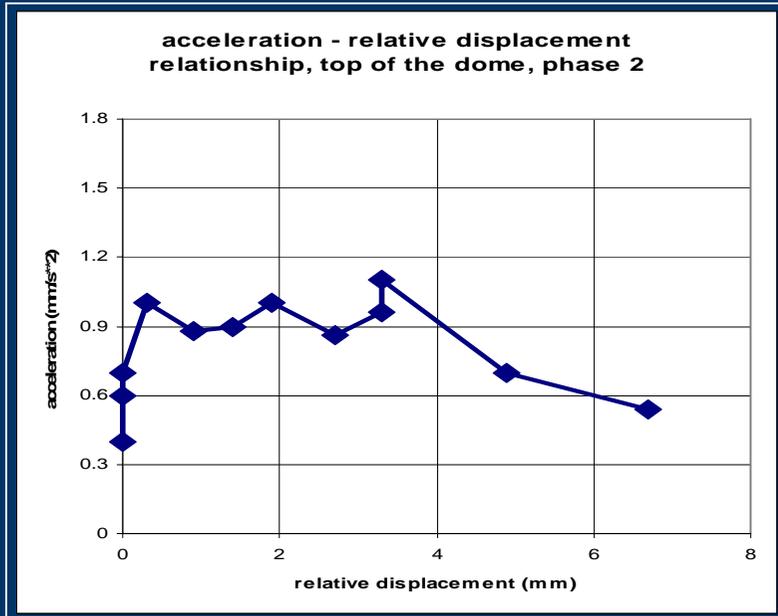
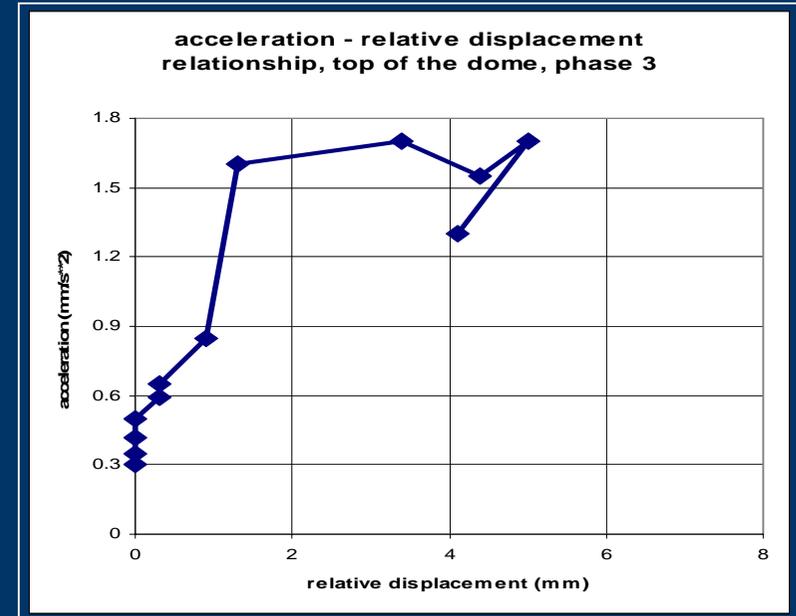
'Push-over' curves obtained for the model in phase 2 and in phase 3

- the strength of the model in phase 3 is larger for about 60%

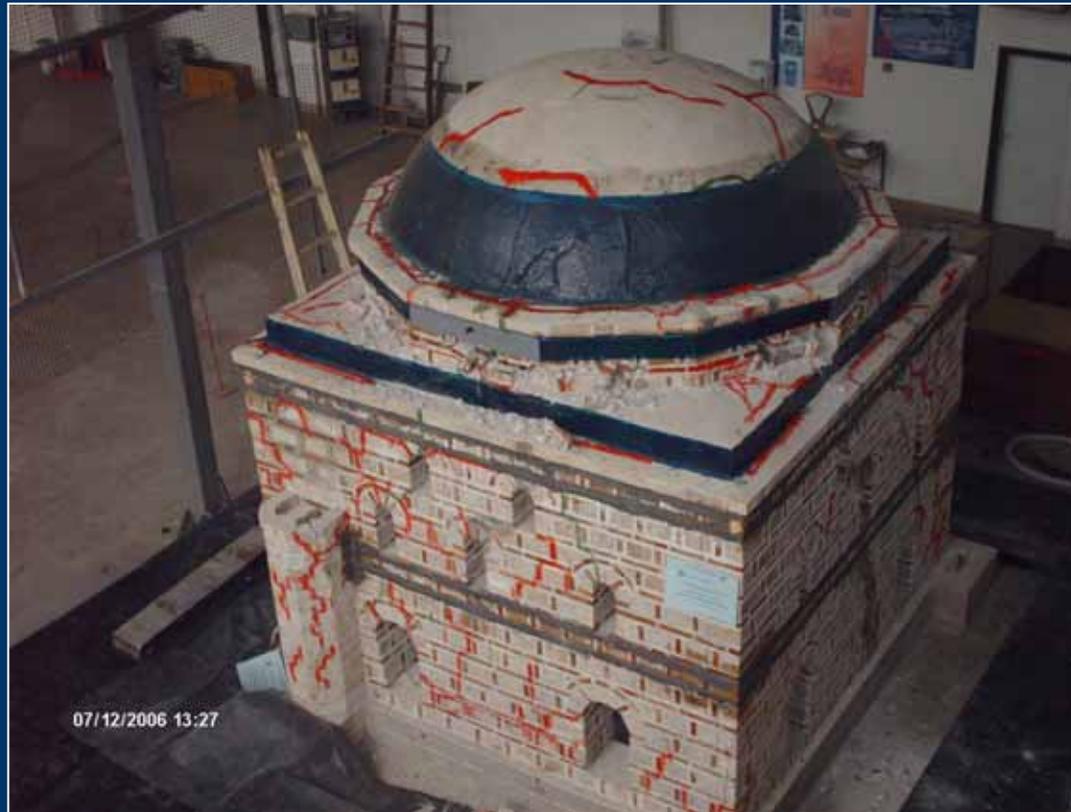
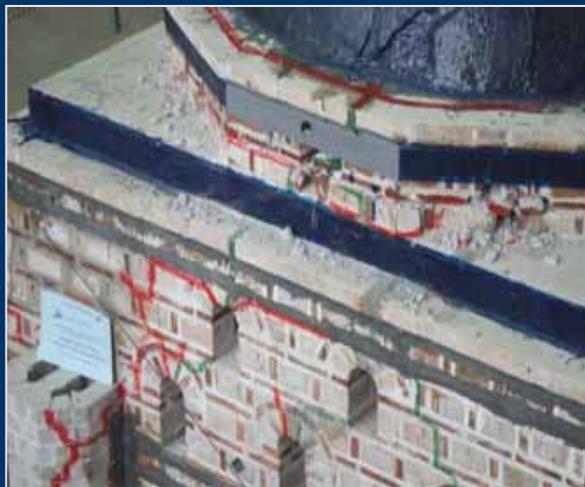
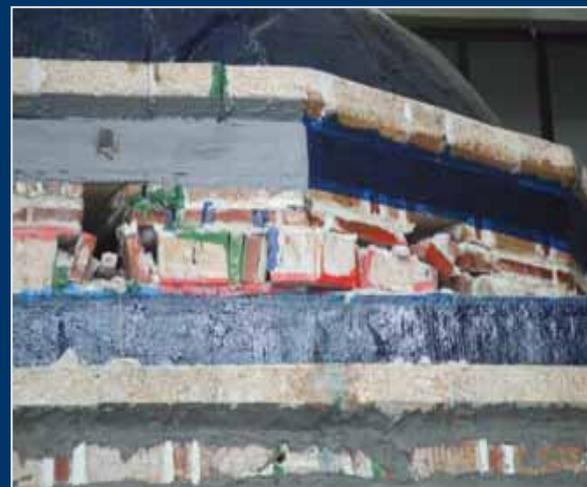
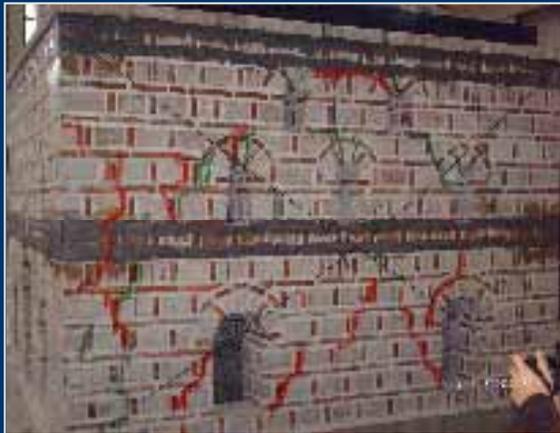
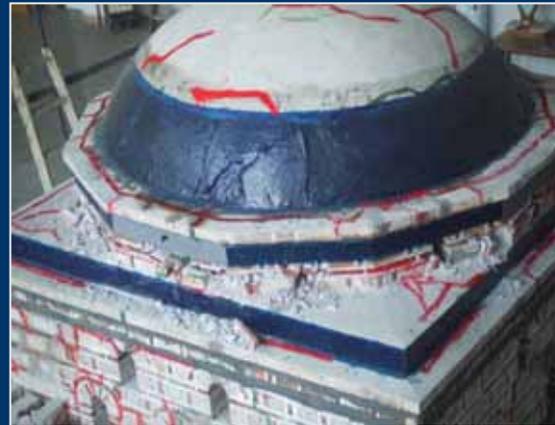
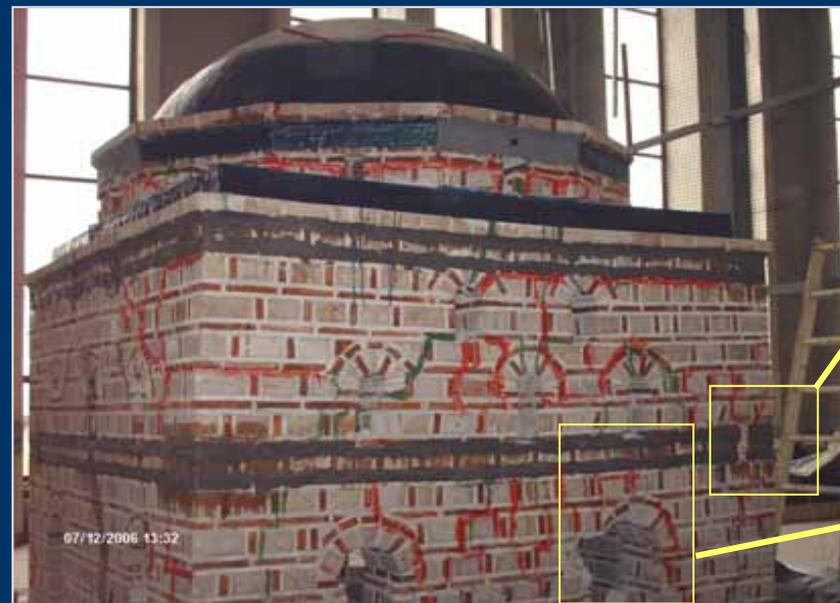
Detail of damage – phase 3

Heavy damage on many parts of the model was observed: many cracks developed on the dome and on the walls around the openings. Due to the intensive shaking inclination of one corner of the model occurred and at that part damage at the FRP belt developed.

Although the original model was not repaired after testing in phase 2, **behaviour of the strengthened model was evidently different in respect to that of the original model**. Under tests of moderate intensity, the existing cracks were activated but during the subsequent more intensive tests, the failure mechanism was transferred to the lower zone of the bearing walls, in the direction of the excitation, where typical diagonal cracks occurred due to shear stress.

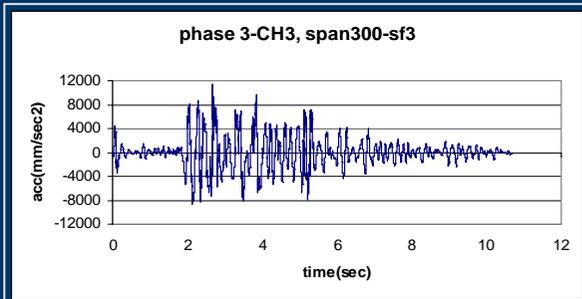
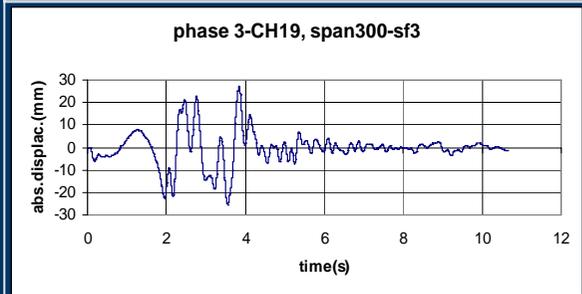
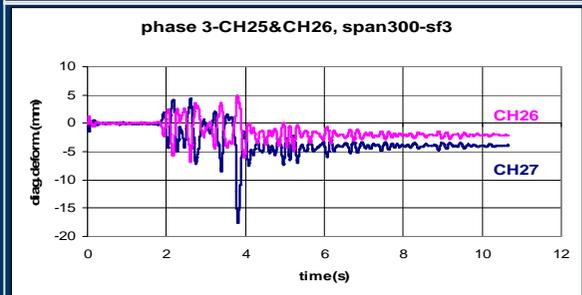
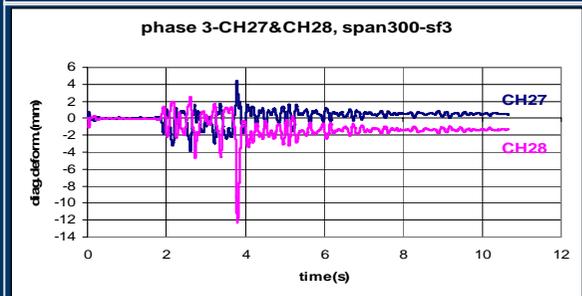
Response of the model during the test with intensity 1.2g, sf3

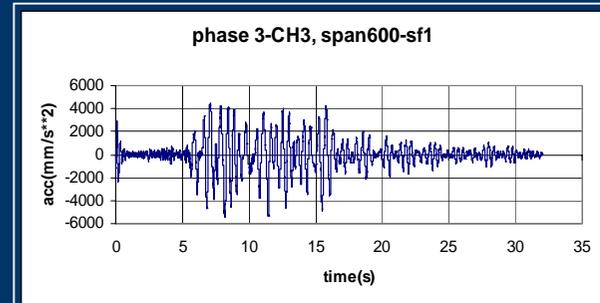
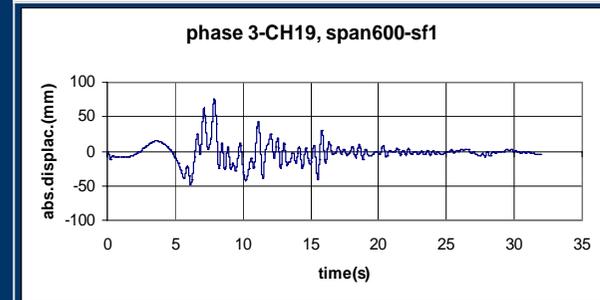
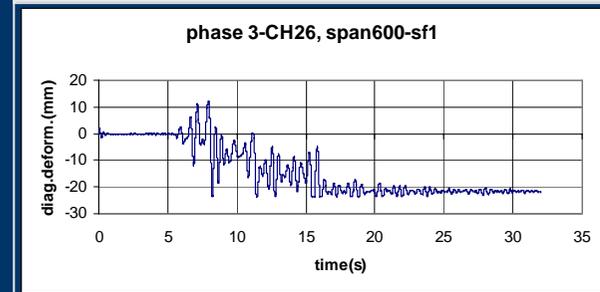
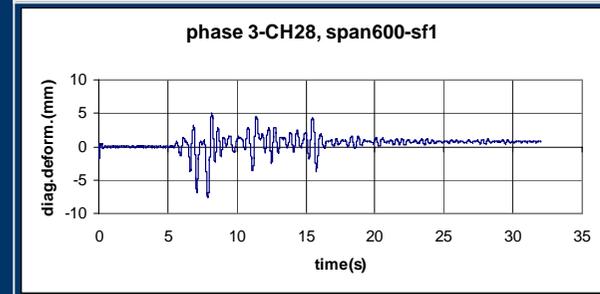
Response of the model during the final test with intensity 0.35g, sf1

The frequency value was more than twice lower comparing to the initially measured frequency of 9.2 Hz, thus indicating pre-collapsing state of the model.
