The need to design for robustness in fire

Ian Burgess

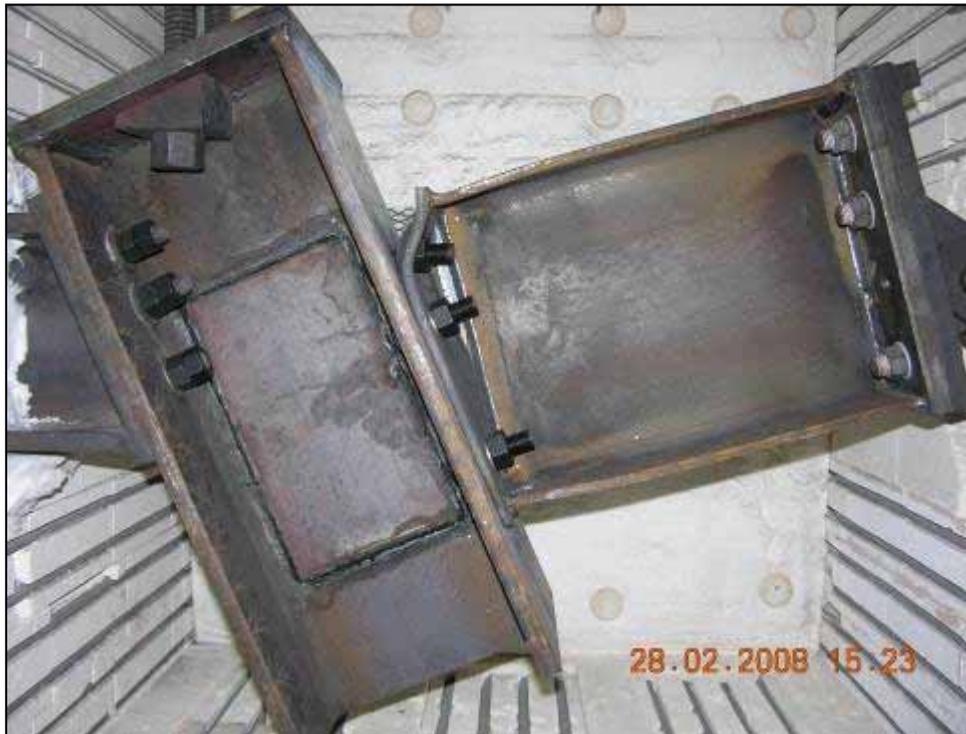
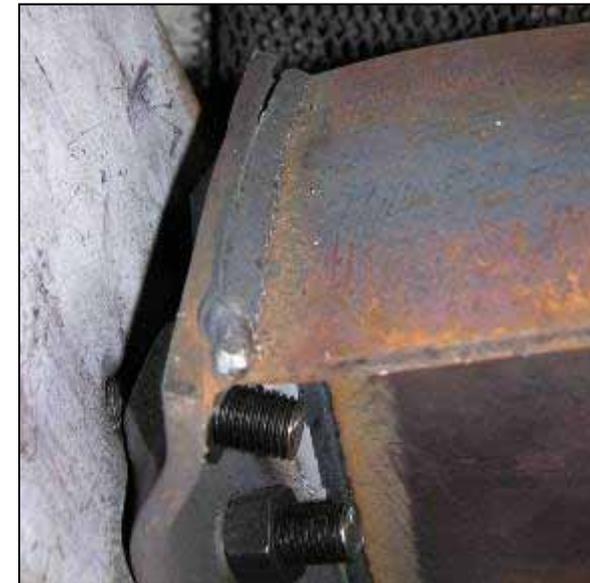
Deformed Shape and Failure Mode

At 20°C
