# Recognising Heritage Values of Bridge Structures – Path to Preserving Values

## Heritage value of structure

## Analysis of heritage value of the Čechův bridge in Prague

## E-P (Evaluation by Parts) Method

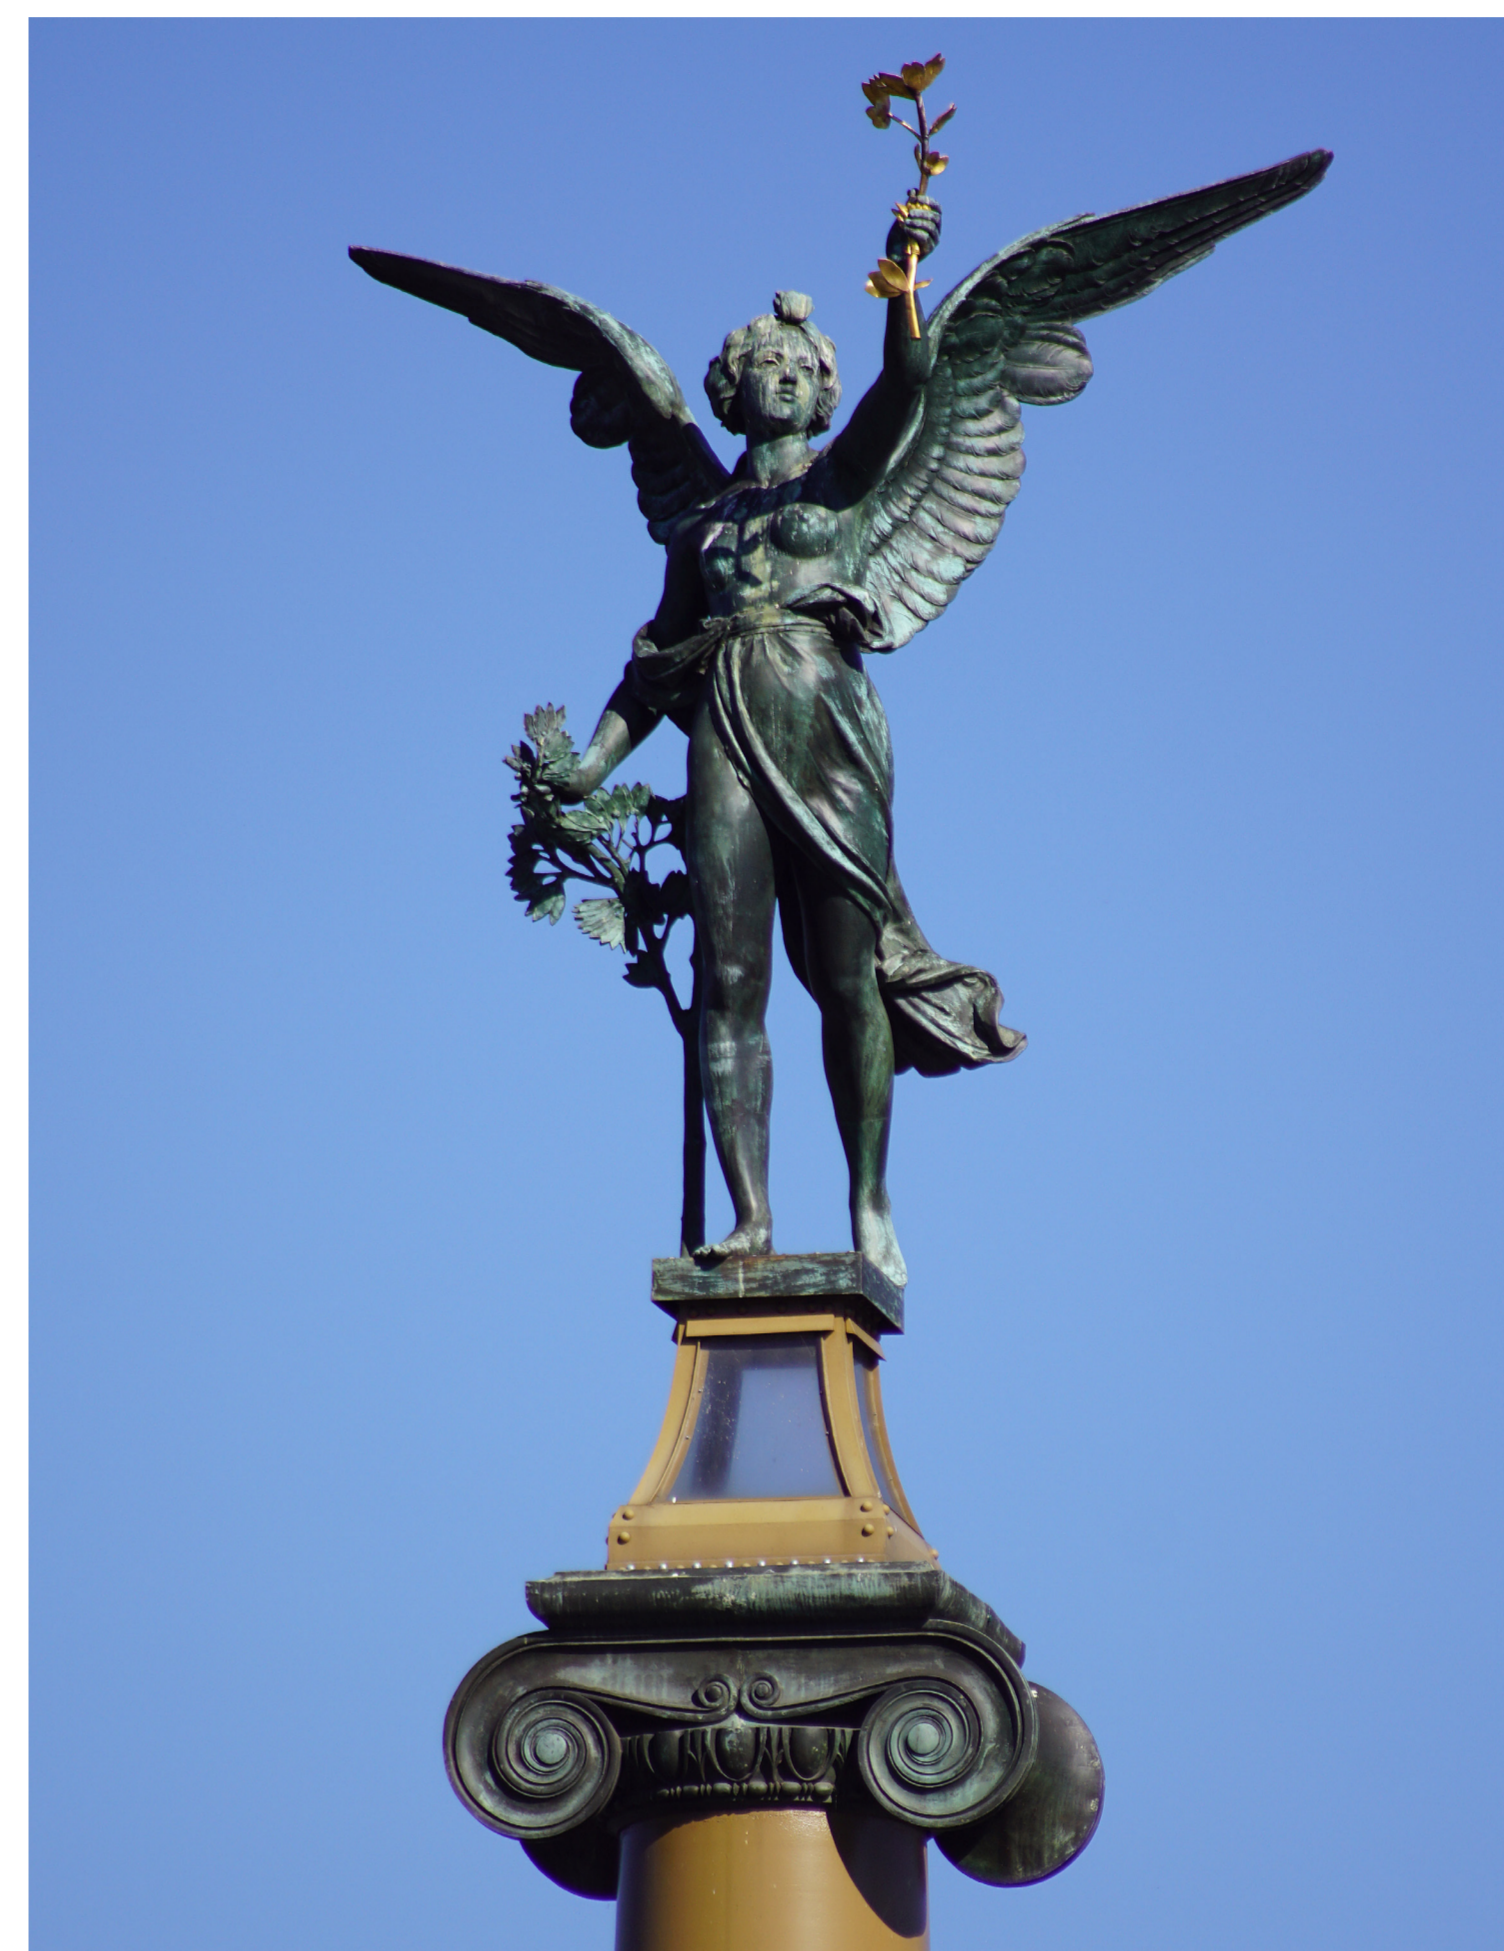
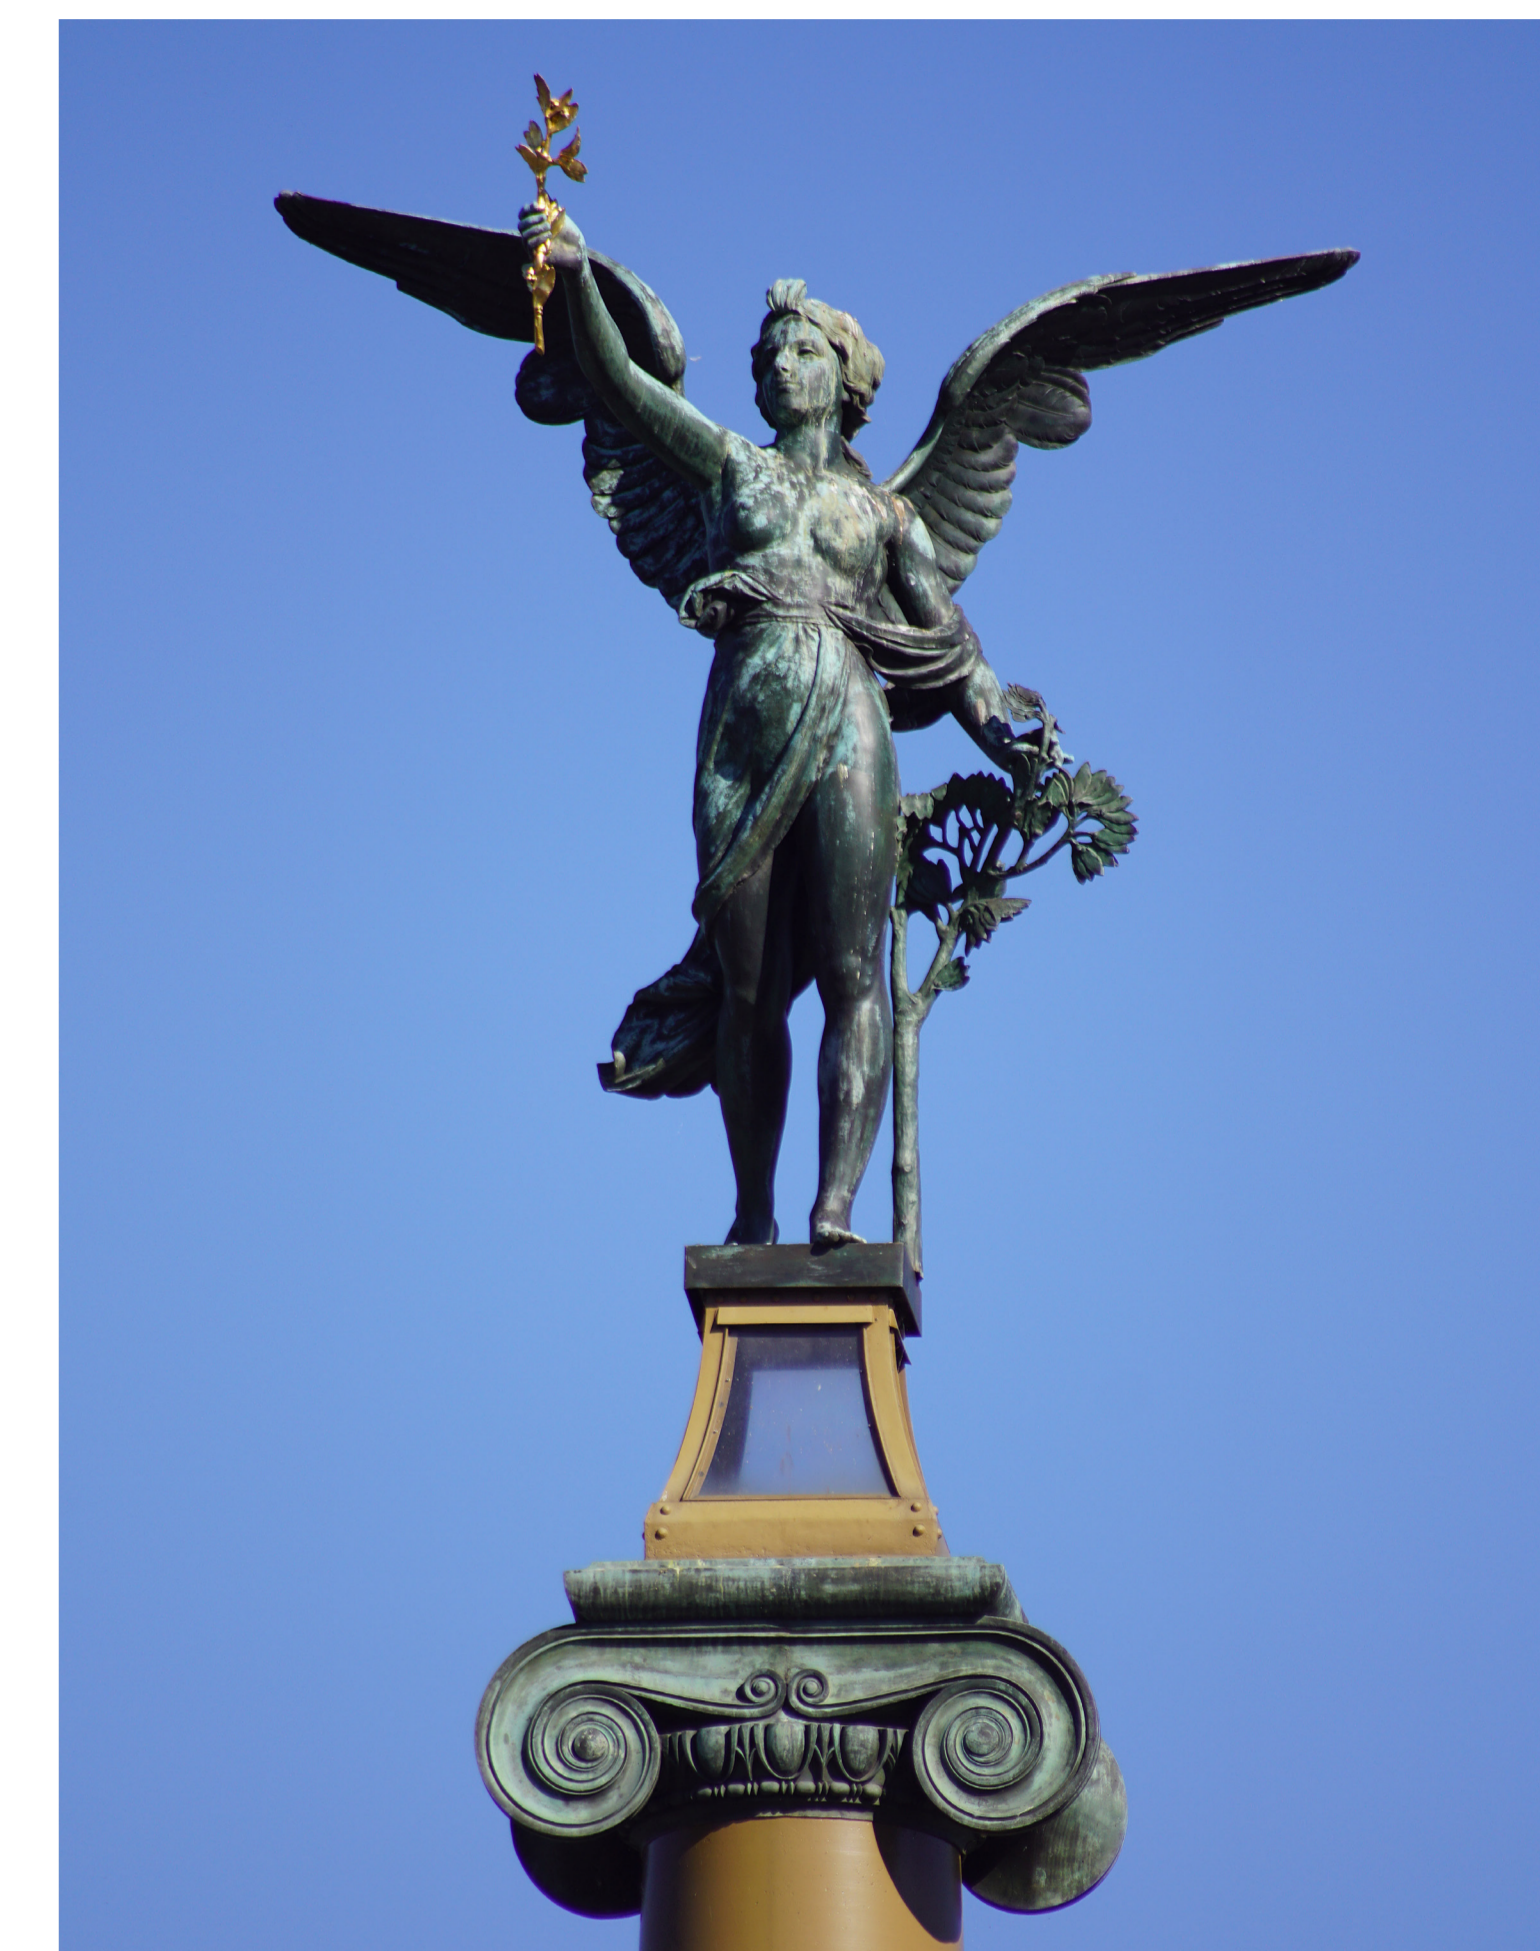
<b>Age value</b>	The bridge was renewed several times during its existence, some elements were replaced by copies and replicas (light poles, festoons, vases), some elements were completely changed (surfaces of sidewalks, road and tram lanes, windows and doors openings in toll houses). Nevertheless, some elements have been preserved from the time of their creation (e.g. main arched load-bearing beams including abutments, most secondary load-bearing elements, pillars, craftsmen worked stones) - these elements have a significant value of age. Some other elements were replaced decades ago by copies (lighting poles) and their age value is beginning to take on. The most exposed and worn surfaces of roads and sidewalks are regularly renewed for rational reasons - they cannot reach the age value. The overall current state of the age value is average (3).
<b>Historical value</b>	The era of the construction of the bridge is related to an important period of economic and political growth of the city of Prague in the early 20th century. Between 1893 and 1908, a major urban reconstruction of Josefov quarter took place (until 1850, the Prague Jewish town or Judenstadt). The current Pařížská street was designed as the main street intersecting previous medieval buildings of Josefov according to the model of Haussmann's reconstruction of Paris (1852-1870). The Svatopluk Čech Bridge was designed as a continuation of this street and was to connect the medieval Old Town (South) with the newly planned city districts in the meander of the Vltava River (to the North). The bridge was named after a Czech writer and poet Svatopluk Čech, who died shortly before the bridge was opened. The state of historical value is above average (4).

<b>Use value</b>	The structure serves as an urban bridge, important due to the high density of city traffic. The current state of the use value is excellent (5).
<b>Creative value (artistic)</b>	he structure is decorated with original sculptures and reliefs of very good artistic quality; railings and light poles are complemented by above-standard original decoration and to a much greater extent than similar other bridges. The artistic decoration had a unified architectural concept (Jan Koula) and the works of art were commissioned by several excellent contemporary artists. The state of artistic creative value is excellent (5).
<b>Creative value (technical)</b>	Very good quality of engineer design, calculations were performed by the most respected Czech engineers of the time. Unusual is the use of a very low metal arch, which was criticized at the time of construction as being too daring. The only surviving metal arch bridge in Prague and at the time of construction quite unusual in Europe (a similar construction concept as Pont Alexandre III in Paris, which span of the arch is twice longer and which is few years older). Technologically advanced solution. The state of technical creative value is above average (4).

<b>Craftsmanship value</b>	Quality production, precisely aligned and assembled elements, excellent craftsmanship of cast and wrought elements. The state of the craftsmanship value is above average (4).
<b>Symbolical value</b>	The bridge was intended and it also became a symbol of the Czech national political and economic growth (this can be evidenced by the tender conditions, which were issued specifically for Czech authors and companies, the name of the bridge was named after Svatopluk Čech, a prominent Czech poet and writer of the national revival who died only few months before the opening of the bridge). From this point of view, the construction has an above-standard symbolical value. The current state of the symbolic value is above average (4).
<b>Scientific value</b>	The structure was never intended and was never used for scientific experiments. Just standard historical, heritage and technical research is carried out here. The current state of scientific value is below average (2).

<b>Social value</b>	The end of the 19th century brought a strong social pressure from two groups of citizens (Bubeneč and Letná on the one side and Malá Strana on the other side) to build a bridge from the Old Town towards Letná, resp. to Malá Strana. The Bridge of Svatopluk Čech built in 1908 won in time, compared to the later Mánes Bridge to Malá Strana (1914). In the 1950s, a gigantic Stalin monument was built on the axis of the bridge on the Letná Hill. In 1989, during the Velvet Revolution, the hill above the bridge was a meeting place of young people and students, and in 1991 a statue of the Metronome by Vratislav Novák was placed here. The state of social value (including the Letná Hill, accessible by stairs), is above average (4).
<b>Spiritual value</b>	The structure has no spiritual value. (On the contrary, the spiritual value of the Charles bridge is very high considering the conditions of its founding and statues of saints) (0).

<b>Urbanistic value</b>	The bridge was intended as an important part of the urban development of Prague. Pařížská street (formerly Mikulášská) leads to the bridge from the Old Town, and its further extension by a street or a tunnel connecting the Old Town and Letná was planned. However, this plan was not implemented. The current state of urban value is therefore average (3).
<b>Landscape value</b>	The bridge is an important part of the picturesque city landscape along the Vltava river. The current state of the landscape value is above average (4).
<b>Uniqueness value</b>	The bridge is a part of a complex of Prague bridges, however it is structurally and artistically different; it is unique in the Central European context. The current state of the value of uniqueness is between above average and excellent (4-5).
<b>Typicality value</b>	The construction is typologically common (bridge); however, this bridge is unique in terms of both load-bearing structure and decoration. The design was never intended for series production. The state of the typicality value is weak (1).

<b>Integrity value</b>	The structure was partially damaged in traffic accidents and also due to insufficient protection against corrosion. Some elements were replaced, some fundamental material changes took place (road surfaces and sidewalks). Due to large compositional changes (relocation of toll houses) in the 1950s, it can no longer meet the original integrity from the time the structure was erected, yet it is possible to consider the newly set integrity from the late 1950s. Since 1995, the bridge has been protected as a part of the Historic Center of Prague listed on the UNESCO World Heritage List, so its integrity is closely monitored. The current state of the integrity value is average (3).
<b>Authenticity value (material)</b>	The bridge has been protected since 1958 as a part of the heritage conservation area of Prague and since 1975 it has been individually registered as a cultural monument. During its existence, its close surroundings were significantly changed during the 1950s (relocation of the chapel of St. Mary Magdalene, relocation of toll houses), later it was repaired several times, since the early 1970s already under the supervision of the heritage preservation authority. Some original elements were replaced before the cultural protection (e.g. the original Zorés steel sheets were replaced by rolled beams in combination with the sheets), some already under (the original paved road surfaces were replaced by bituminous ones). Many elements have been replaced by copies or replicas. The current state of the material authenticity value is average (3).

<b>Authenticity value (non-tangible)</b>	Due to the compositional changes in the 1950s it is no longer possible to achieve the original intangible authenticity from the time the structure was created. The reduction of intangible authenticity is also caused by the change of the original surfaces to completely different ones (e.g. road surfaces). At present, intangible authenticity is respected by the effort to use materials and craftsmanship procedures similar to historical ones, but only to an economically and operationally sustainable level. The current state of the value of intangible authenticity is below average (2).
<b>Transformation value</b>	The structure can only be used as a bridge. In the case of insufficient resistance, the road and tram traffic can be reduced, extremely down to a pedestrian traffic only. However, there is no other reasonable way to transform/convert this structure. The state of the transformability value is below average (2).

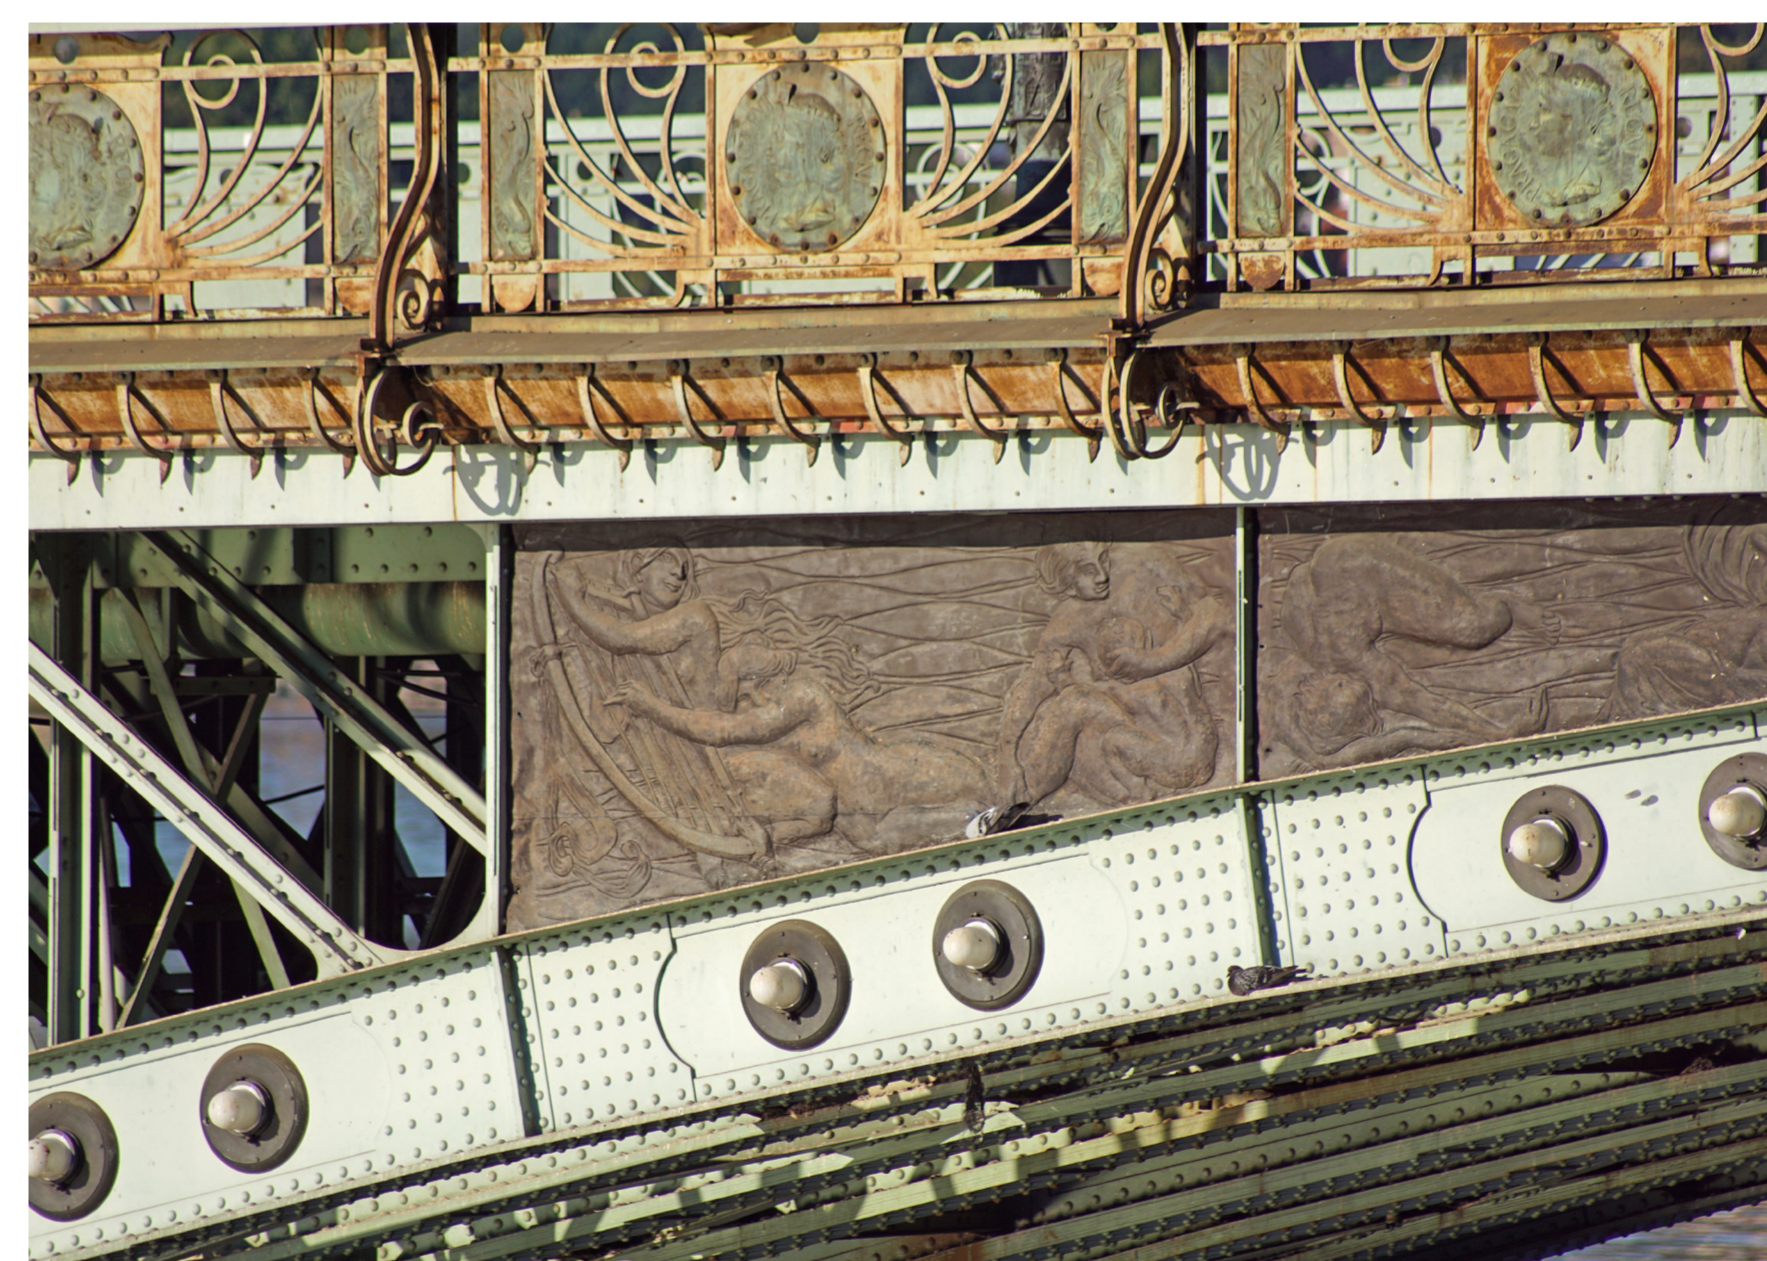
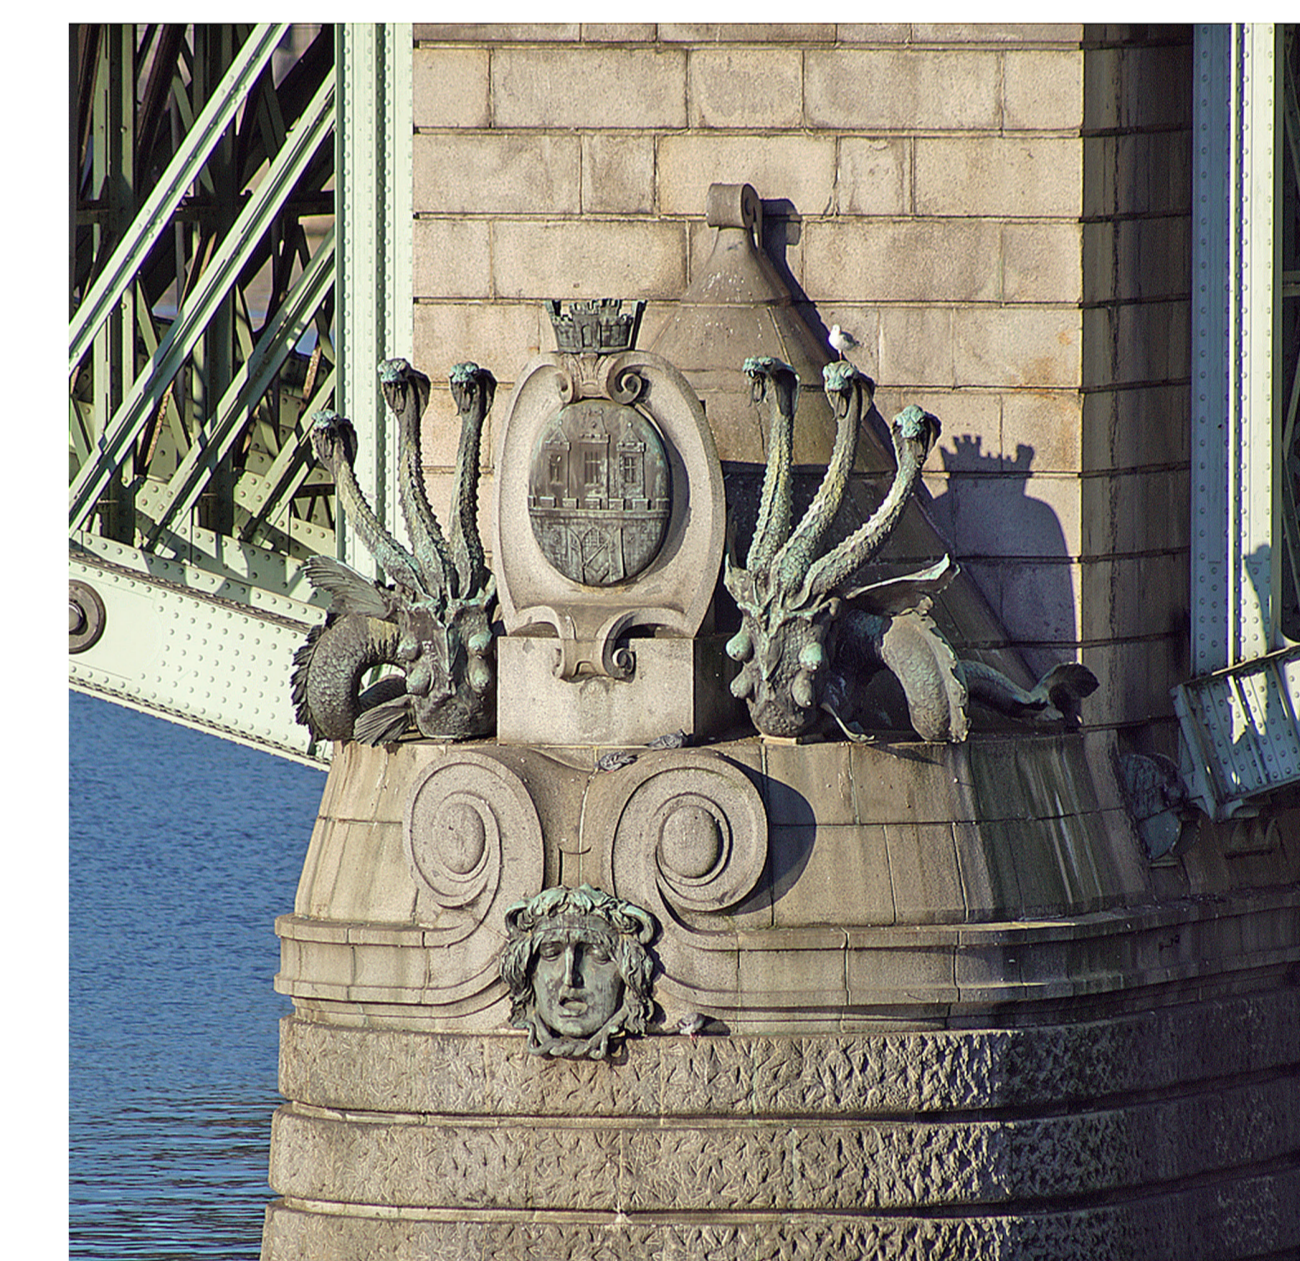
A special E-P method was proposed for the assessment of the effects of surveys and repairs on the heritage value of historic bridges, being a specific type of industrial heritage. The E-P method relies on the fact that the heritage value is a complex notion which can be easier analysed by parts. Each of these parts is specifically sensitive to surveys, repairs or to strengthening methods. The analysis by the E-P method is demonstrated by the case study of the Čechův most in Prague.
