# COMBINED WHILE-DRILLING TECHNIQUES FOR THE ASSESSMENT OF THE FIRE DAMAGED CONCRETE COVER

Roberto Felicetti

Politecnico di Milano, Milano, Italy, roberto.felicetti@polimi.it

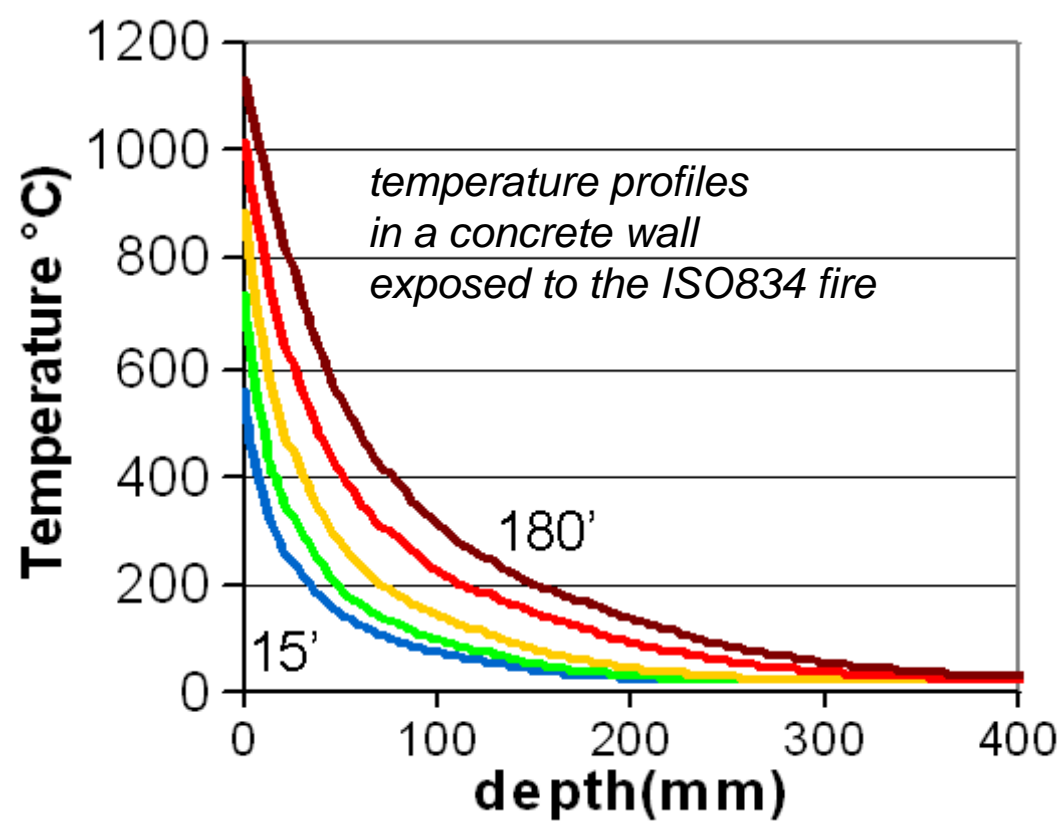
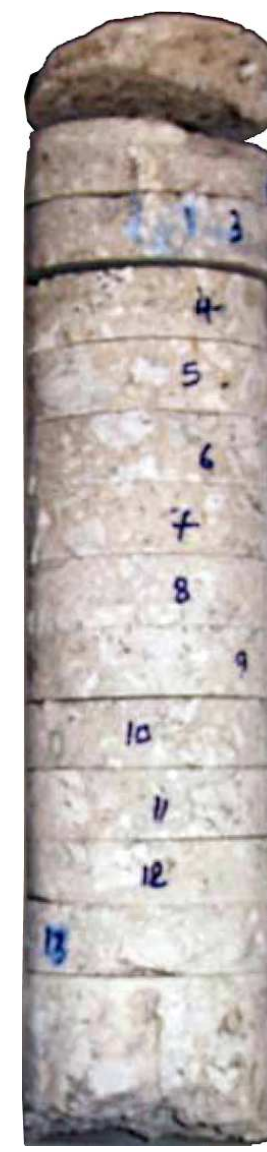
**1) The assessment of fire damaged concrete** is quite a difficult task because of the steep temperature gradients undergone by the material (it is strongly layered)

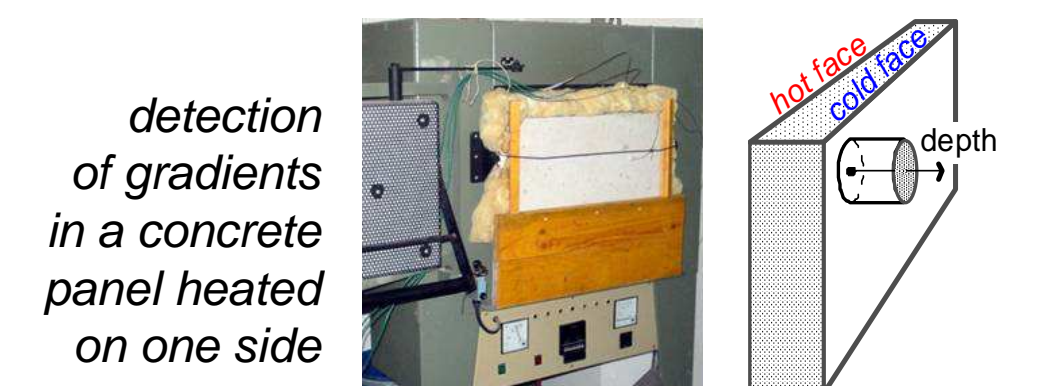
**3) Core drilling as a way to scan the cover response**

the drilling time (s/mm) under a constant thrust is the most significant parameter to monitor

**pros** it is a sensitive technique (~ Ultrasonic Pulse Velocity) the influence of the hard aggregate pebbles is smoothed it can be combined with the analysis of the ensuing core

**cons** drilling a core is a demanding operation possible detriment to the structure the point-by point analysis of the core is time consuming

The traditional approach based on the analysis of the drilled cores can take advantage at no extra cost of a proper monitoring of the drilling operations (elapsed time per unit depth under a constant exerted thrust).

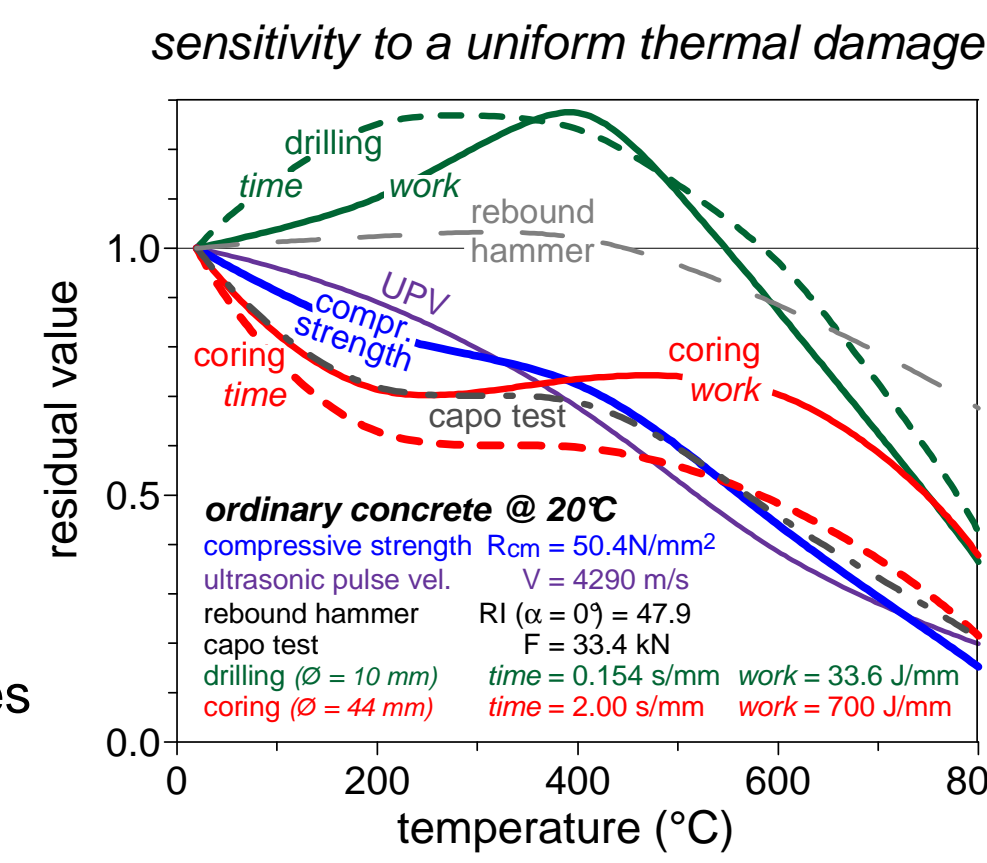
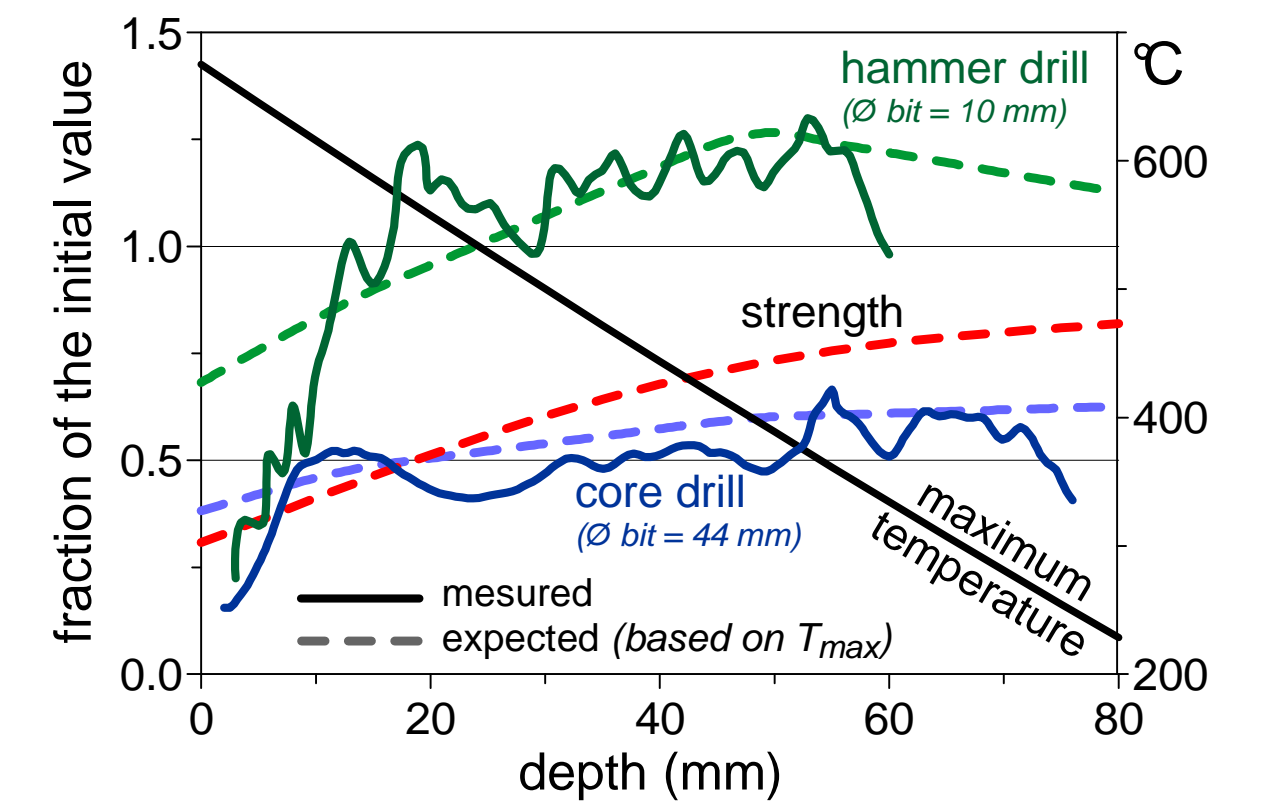
**4) Damage detection via the hammer-drill resistance**

the drilling work (J/mm) is the most significant parameter to monitor

**pros** it is a very fast and easy technique (one test in 10 seconds) no water or AC supply needed little damage to the structure

**cons** only a marked damage can be detected (strength decay = 30-50%) sensitive to the hard aggregate pebbles (more tests to be averaged) no undisturbed concrete samples are provided for laboratory analyses

The hammer drilling resistance is a fast and viable technique, with the limitation of a poor sensitivity to low levels of damage ( $T_{max} \leq 500^\circ\text{C}$ ).

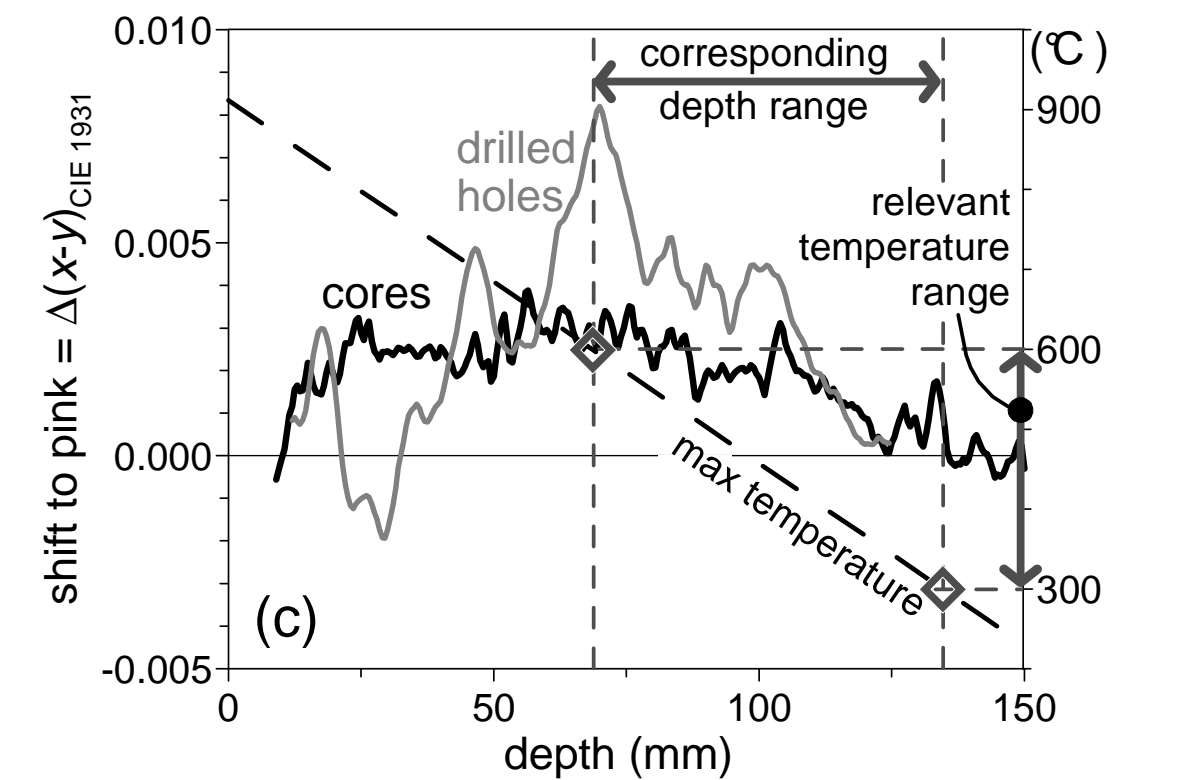
c) discoloration profiles

The colorimetric analysis of the drilled hole and the concrete powder leads to discoloration profiles that are comparable with cores.

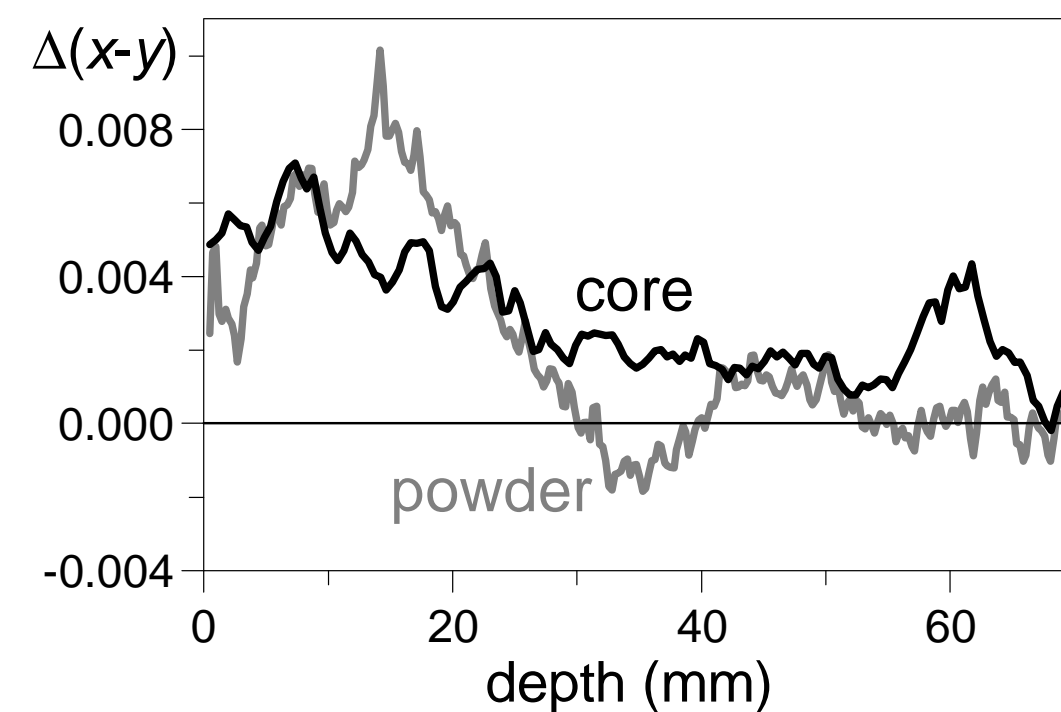
comparison between the two samples

The impracticality of neglecting the coarse aggregate in the analysis and the smaller size of the material sample are the reasons for the larger dispersion of the results.

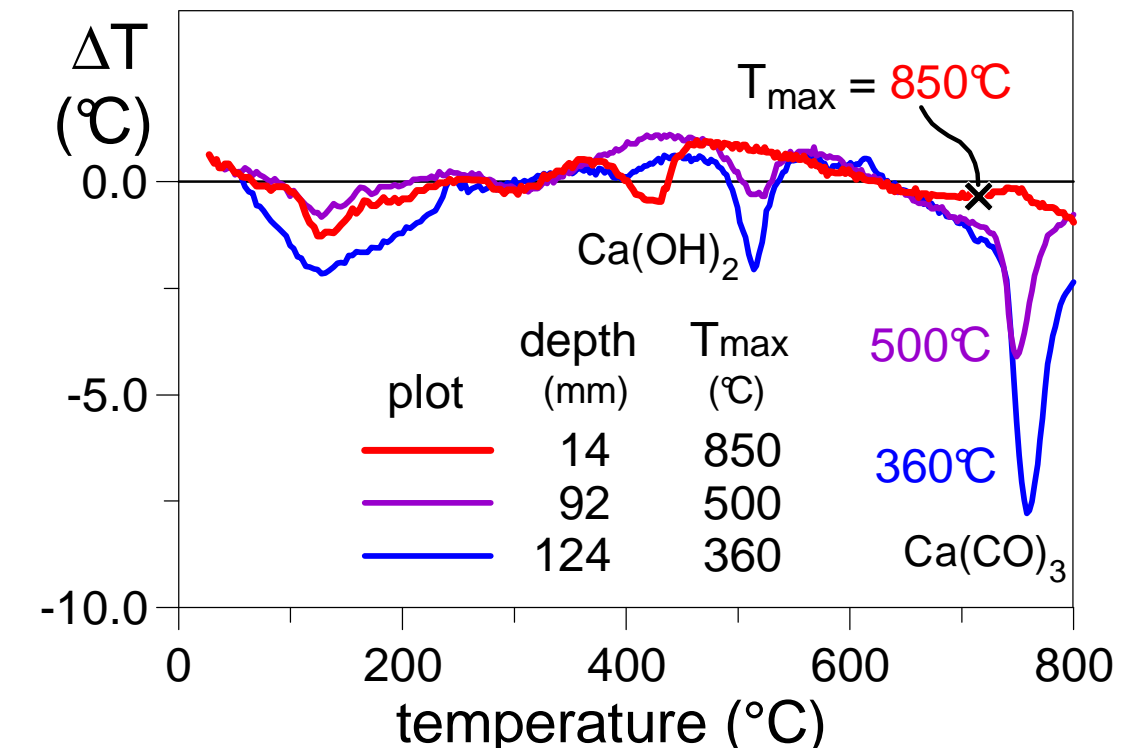
**5.3) Differential Thermal Analysis on the powder**

DTA at different depth in a heated panel

Though less rigorous compared to the normal laboratory practice, the Differential Thermal Analysis on the drilling powder is definitely far less demanding and maintains the ability to detect the main changes in the response of a concrete sample surviving a fire.

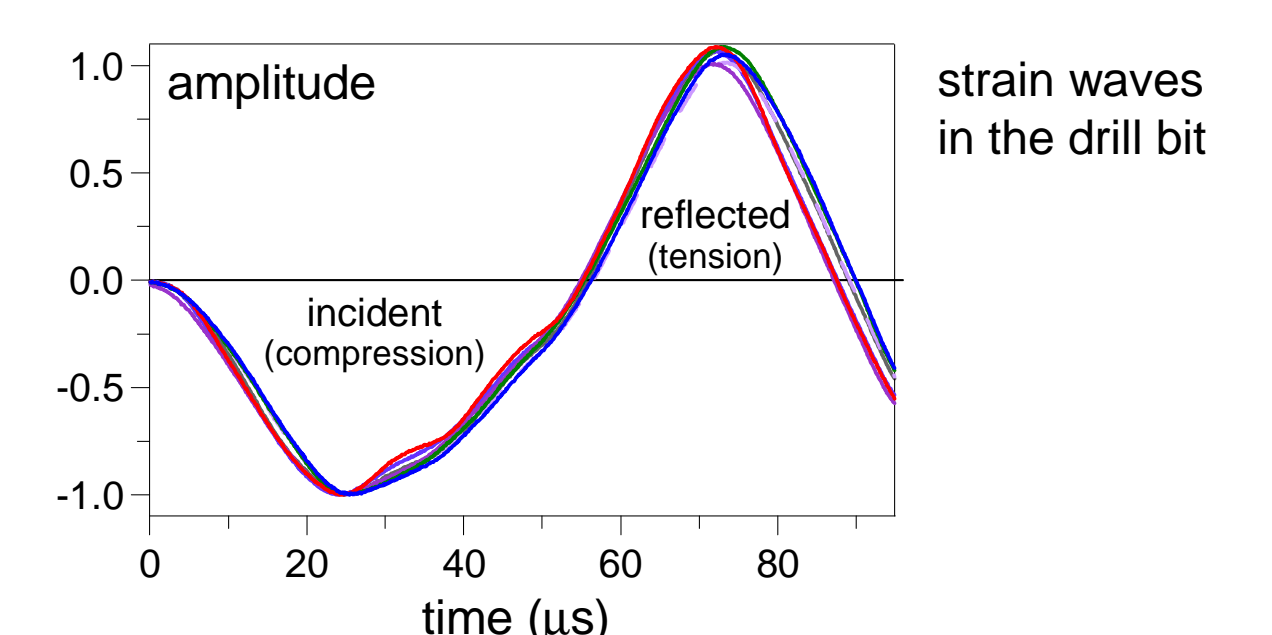
Colour measurement directly in the drilled hole (optic fibres, special probes, etc)

Improvement of the sensitivity to low damage levels of the hammer-drilling technique by monitoring other parameters (e.g. propagation of elastic waves during the drilling process)
