COST C26 Urban Habitat Construction under Catastrophic Events

WG2: Earthquake Resistance

## Consolidation, rebuilding and strengthening of the St. Panteleymon church - Ohrid

Roberta Apostolska, Golubka Necevska-Cvetanovska, Gavrilovic P., Talaganov K., Mijic N., Stojanovski B. et al.

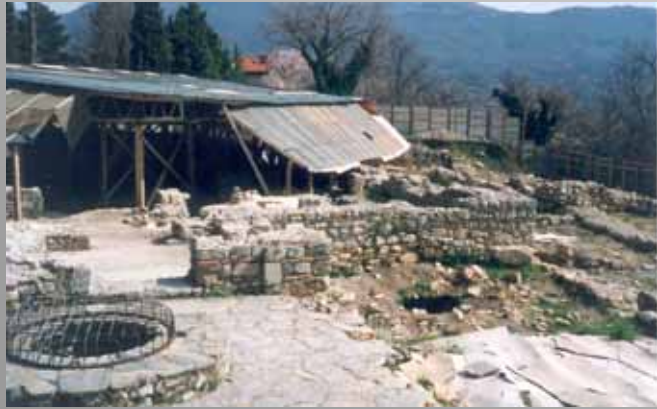
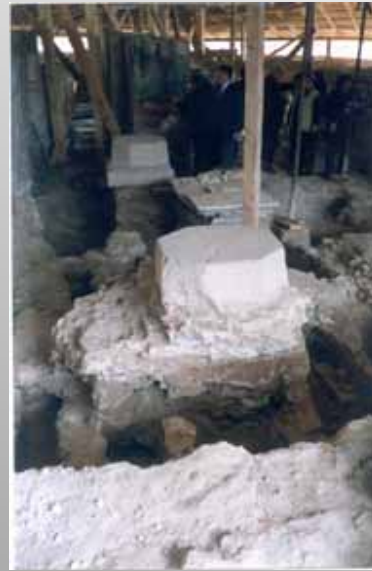
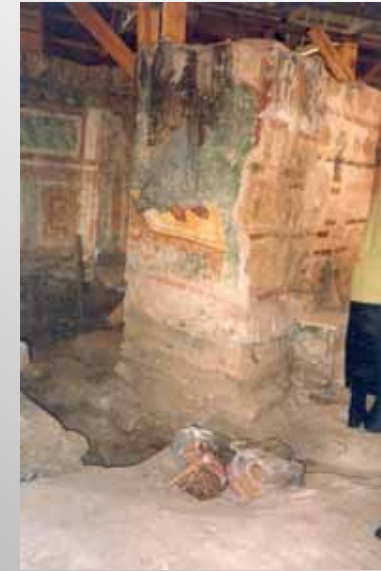
The St. Clement's church was restored upon the existing foundations from the construction phases dating back to IX to XIV century. The renovation was carried out upon the original remains of the church walls, without damaging the excavated fresco fragments, by previously eliminating the parts of the walls that were added during the conservation of the structure in 1965. During the restoration of the church, the traditional material (stone, brick and lime mortar) was used as construction material, preserving the original walling pattern of each of the different chronological periods of construction of the structure.

Existing state of the church- excavated materials (2001)
