COST C26: Urban Habitat Construction under Catastrophic Events

Prague, 31 March, 2007

Veronika SENDOVA, Blagojce STOJANOVSKI,
Ljubomir TASHKOV

Reconstruction, Seismic Strengthening and Repair of St. Athanasius Church damaged by explosion

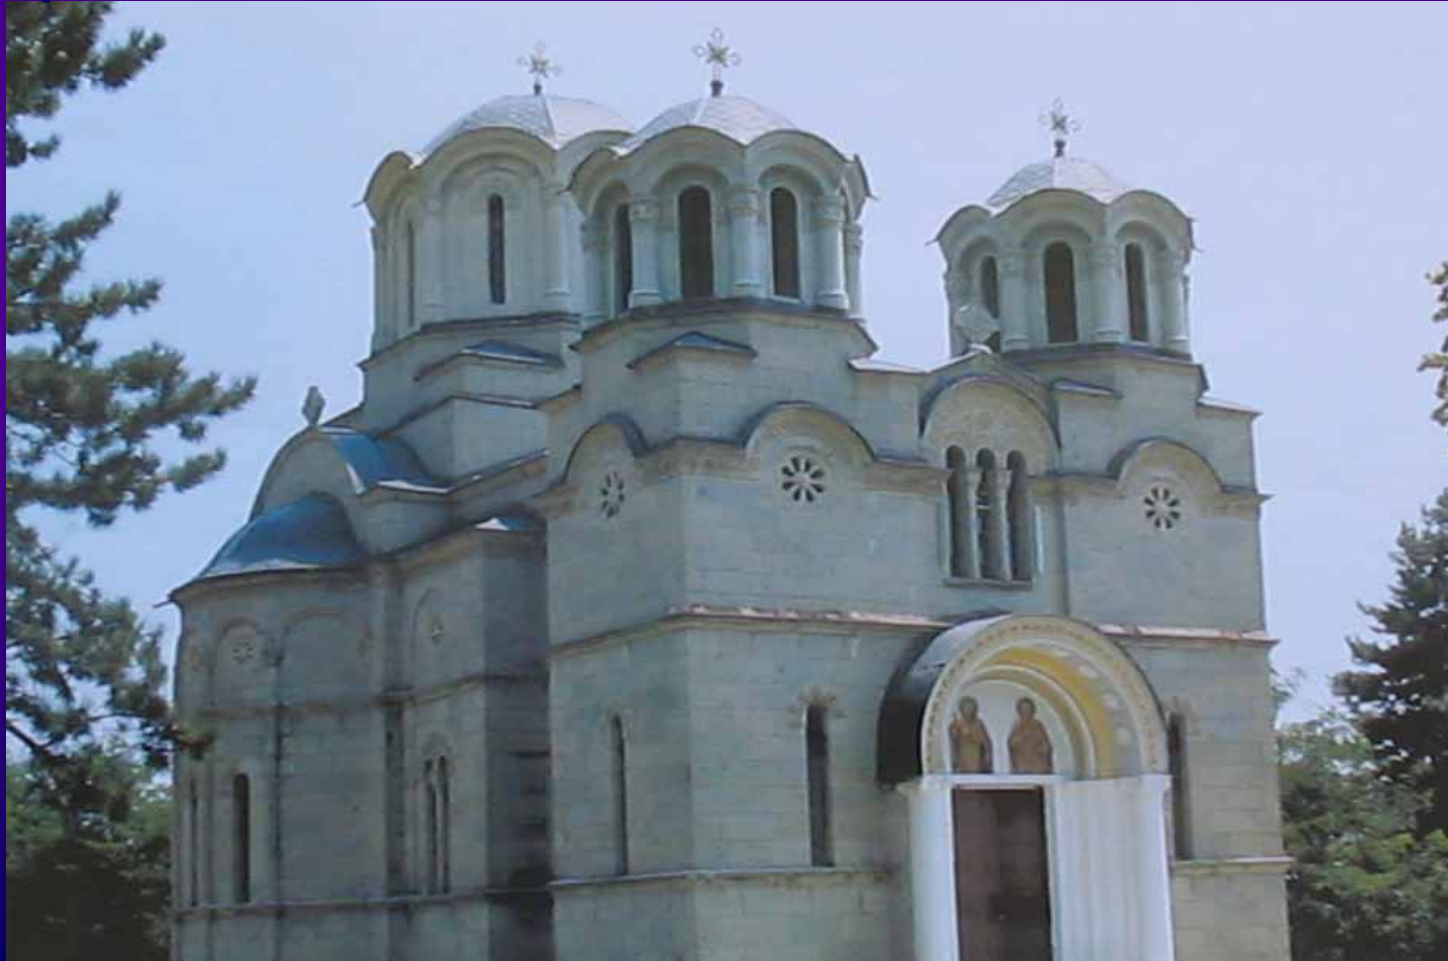
Monastic Church St. Athanasius, Leshok

- three conched structure with narthex and belfries
- massive circular (inside) and polygonal (outside) apses
- pendentives, tambour, central dome

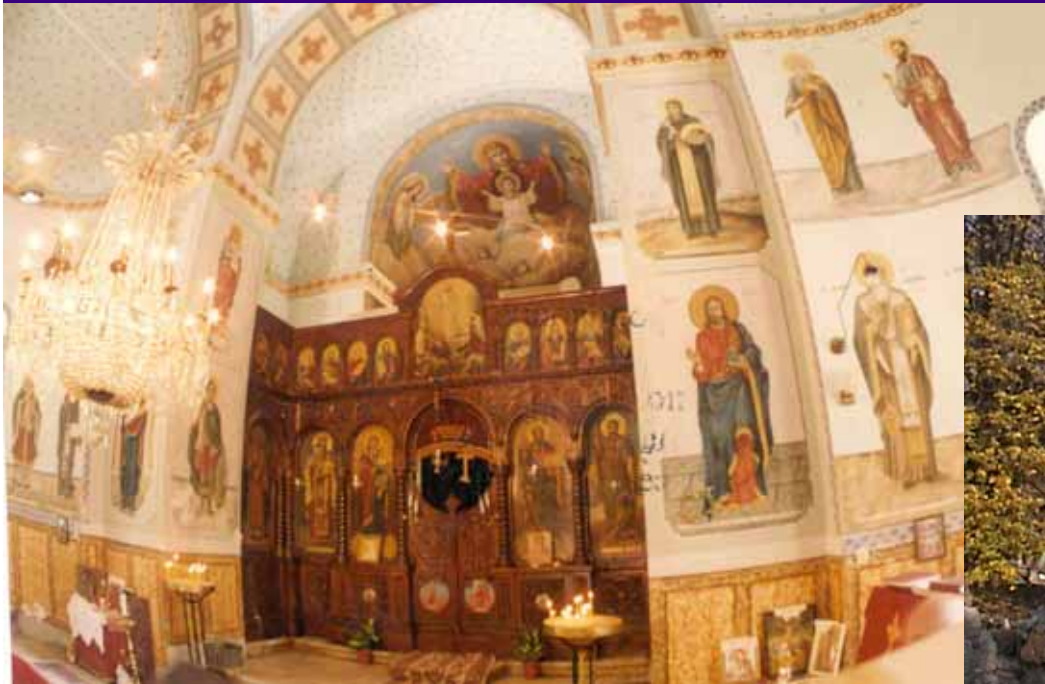
before

21 August 2001

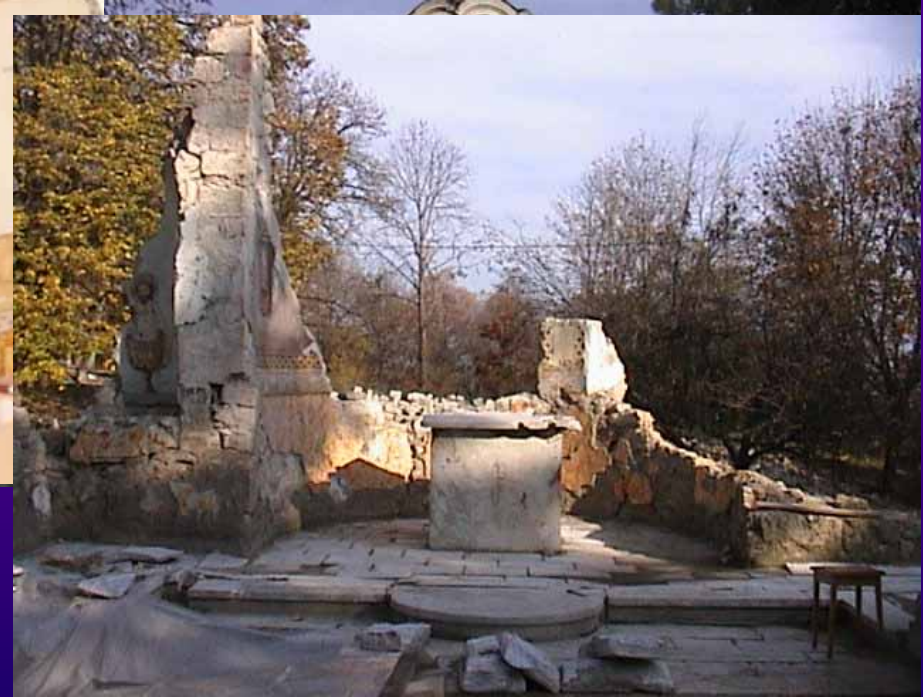
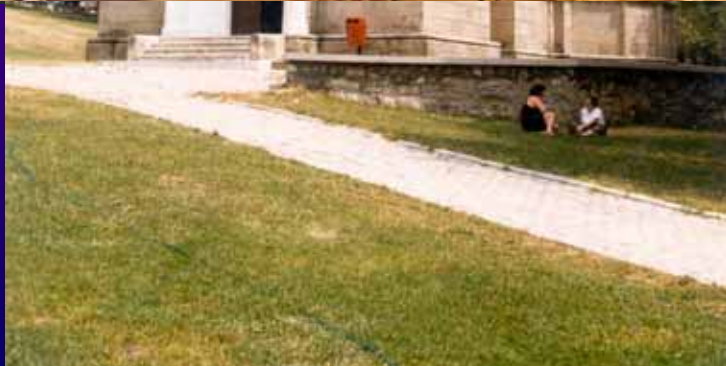
Damage

after

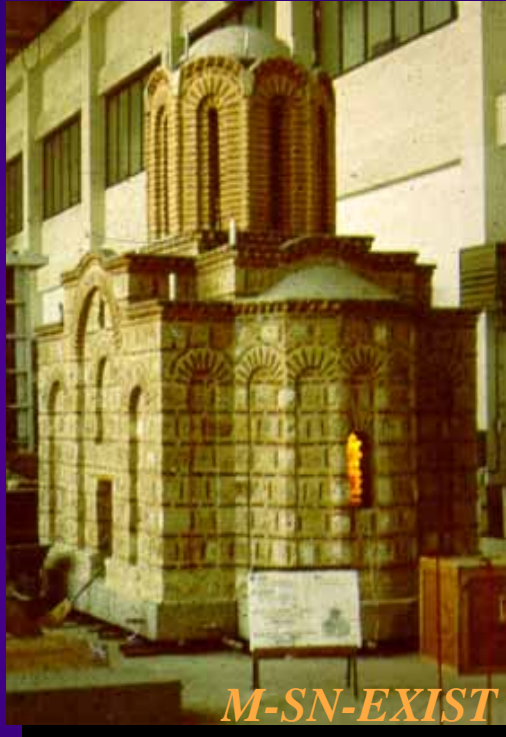
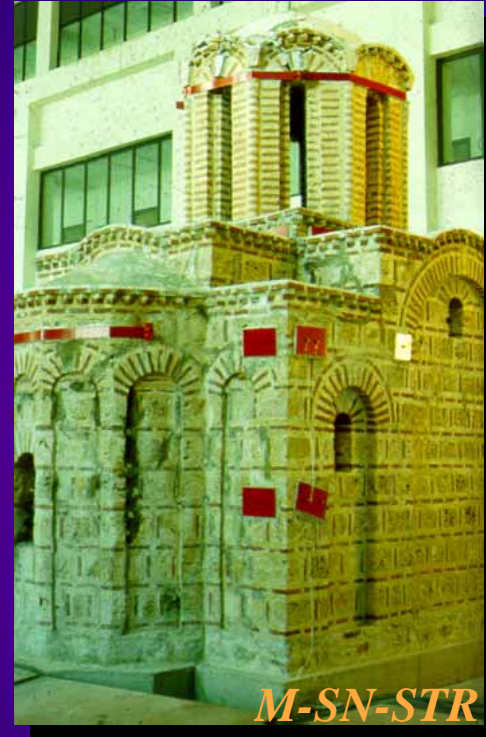
Church Models on Shaking Table

- *Determination of natural frequencies and mode shapes (models M-SN-EXIST and M-SN-STR)*
- *Shaking table testing testing of the models by gradual increase of the input intensity*

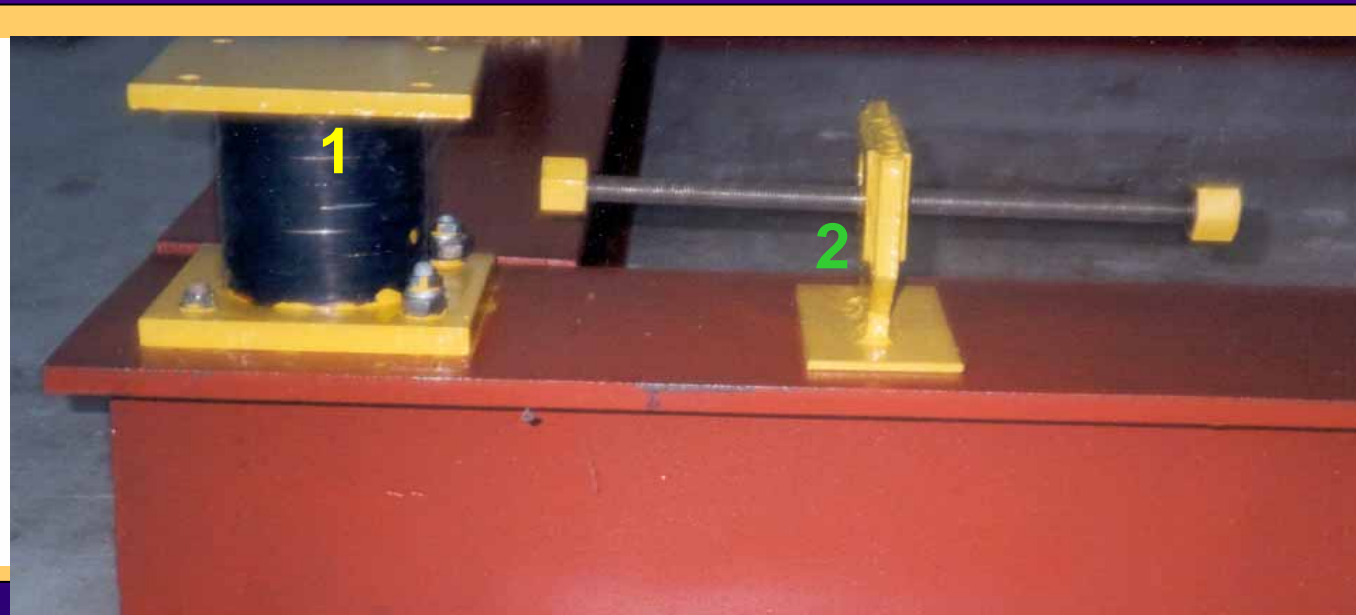
Laminated Rubber Bearing (1) with Stopper Elements (2)

$D = 13.1 \text{ cm}$

$H = 15.1 \text{ cm}$

$K = 2.5 \text{ kN/cm}$

$T = 0.8-1.0 \text{ s}$

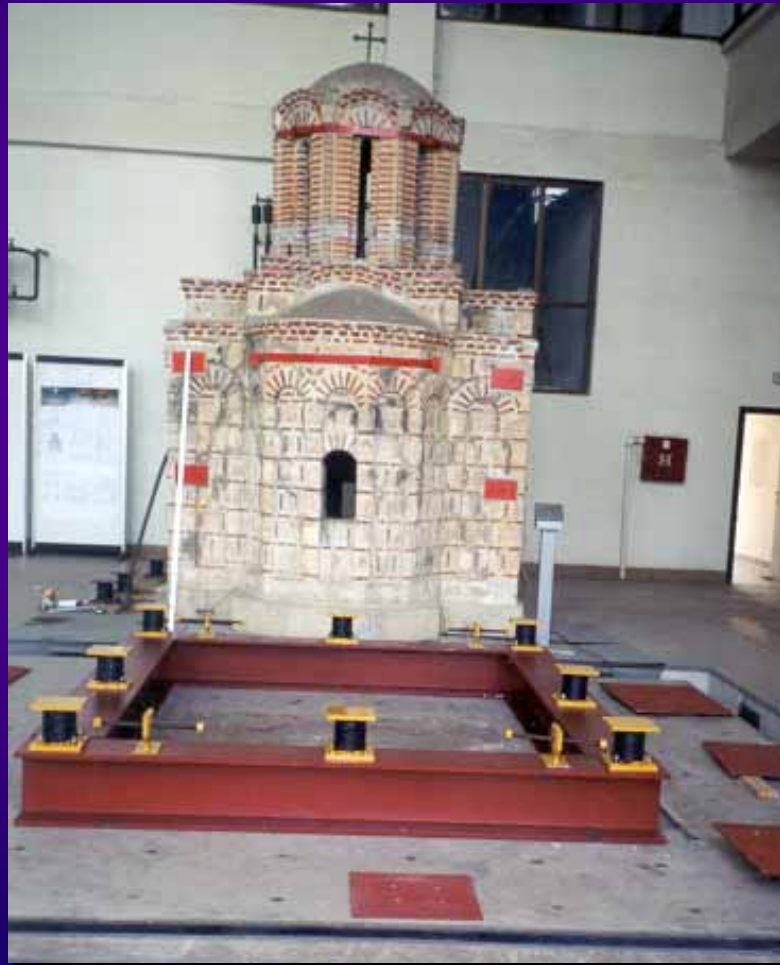
Steel structure and Isolators

Shaking Table Testing of Model M-SN-BIC

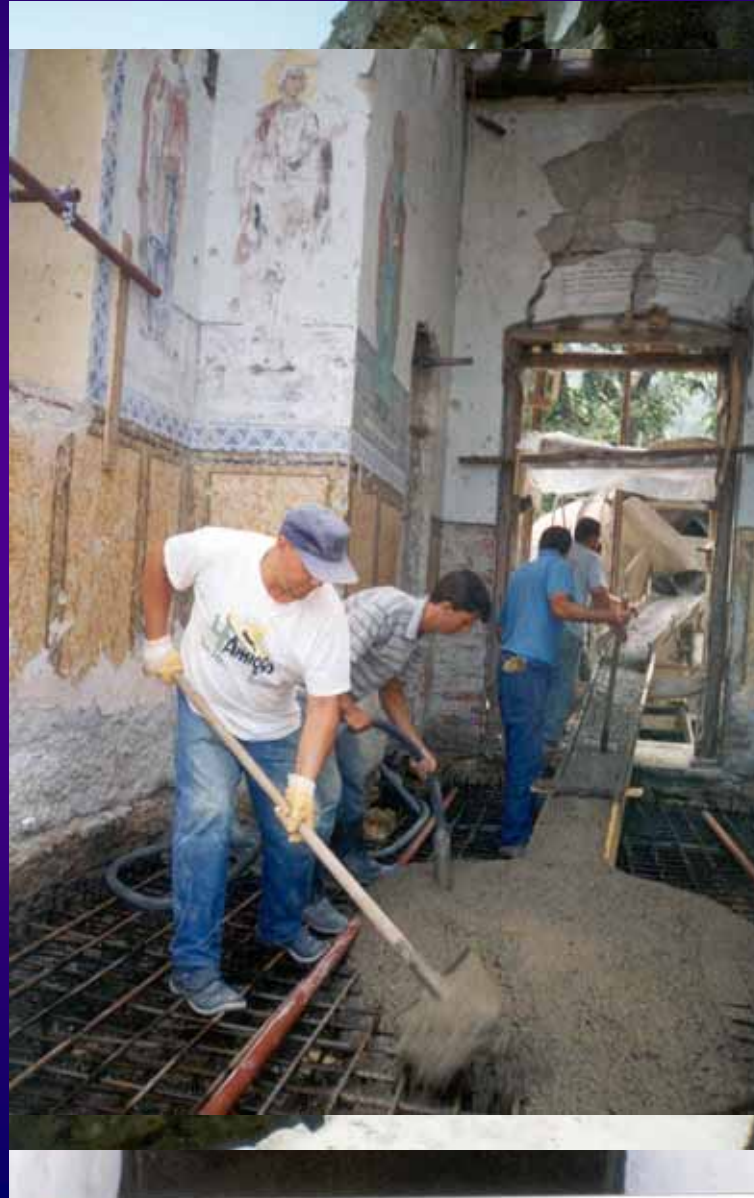
July – December 2003

realization

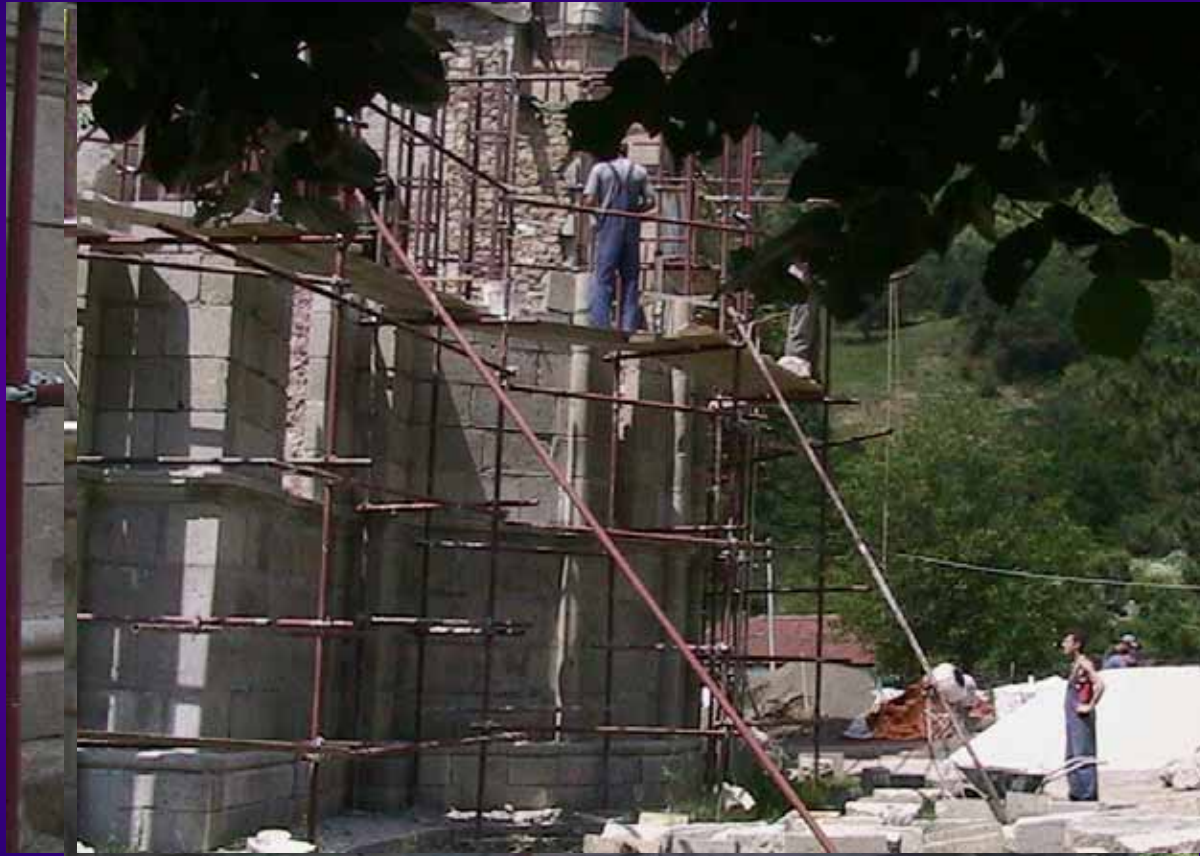
April - September 2004

realization
