30 EXAMINATION, ASSESSMENT AND REPAIR OF FIRE DAMAGED RC STRUCTURE OF „REFINERY-OKTA“ IN SKOPJE

In November 2008 a part of the structure of “Refinery–Okta” in Skopje, Macedonia, was in fire and the last three spans were completely burned. According to the damages recorded in situ, it was found out that fire caused severe damage to the reinforced concrete bearing structure. For realization of the repair project of the RC structure, nonlinear and transient thermal analysis, nonlinear stress-strain analysis of the frame structure and experimental determination of the residual concrete strength after action of fire were recommended. Results obtained by this analysis are presented in this paper. The global repair recommendations are given, also.

31 EXAMINATION, ASSESSMENT AND REPAIR OF RC STRUCTURE OF BUILDING DAMAGED IN FIRE

A twenty storey building structure was in fire and two apartments at the seventh and eighth floor were completely burned. According to the damages recorded in situ, it was found out that fire caused severe damage to the reinforced concrete bearing structure. Based on the data gathered through detailed visual survey of the bearing structural elements, nonlinear a

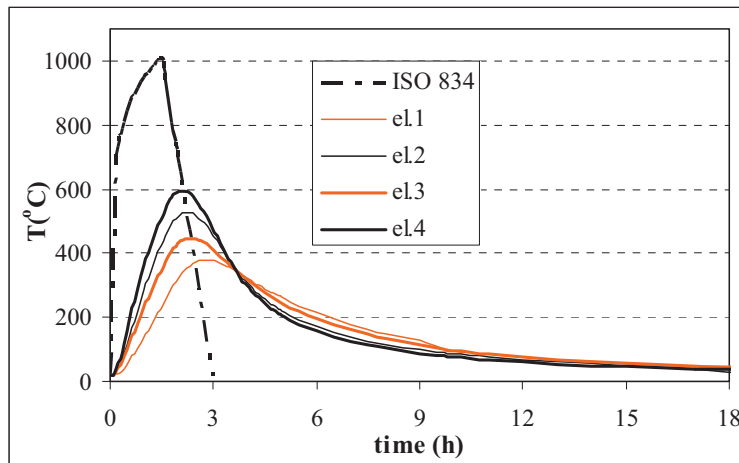
Fig. 30.8 Time dependent temperatures of the reinforcing bars of the beam B2 which is exposed to fire from three sides

The thick concrete layers (6-7 cm) on the bottom side of the beams protected reinforcement from high temperatures, but after a time the bars which were close to the fire became hotter, and opposite (Fig. 30. 6, 8). The increase of negative moments at the ends of the beams was accommodated, but the redistribution that occurred was sufficient to cause yielding of the top bars which were in the corners. In the same cross section, the reinforcing bars which were on the side of the fire were all the time in compression by the action of the fire and the negative bending moment (el.2 on Fig. 30.10, 12). The yield strength was reduced due to the high temperatures, hence the reinforcement started to yield very soon. Large plastic deformations occurred at the end of the heating period, so during the cooling phase the reinforcement changed the sign and residual stresses in tension occurred. The residual tension stresses were significant for bottom bars placed at corners of beams B2 and B3 and their values were up to 90% of the yielding strength at room temperature (Fig. 30.10). Beams G1 were in a better situation. The residual tension stresses were not higher than 50% of the yielding strength at room temperature (Fig. 30.12), therefore the repair of the beams G1 was not recommended.

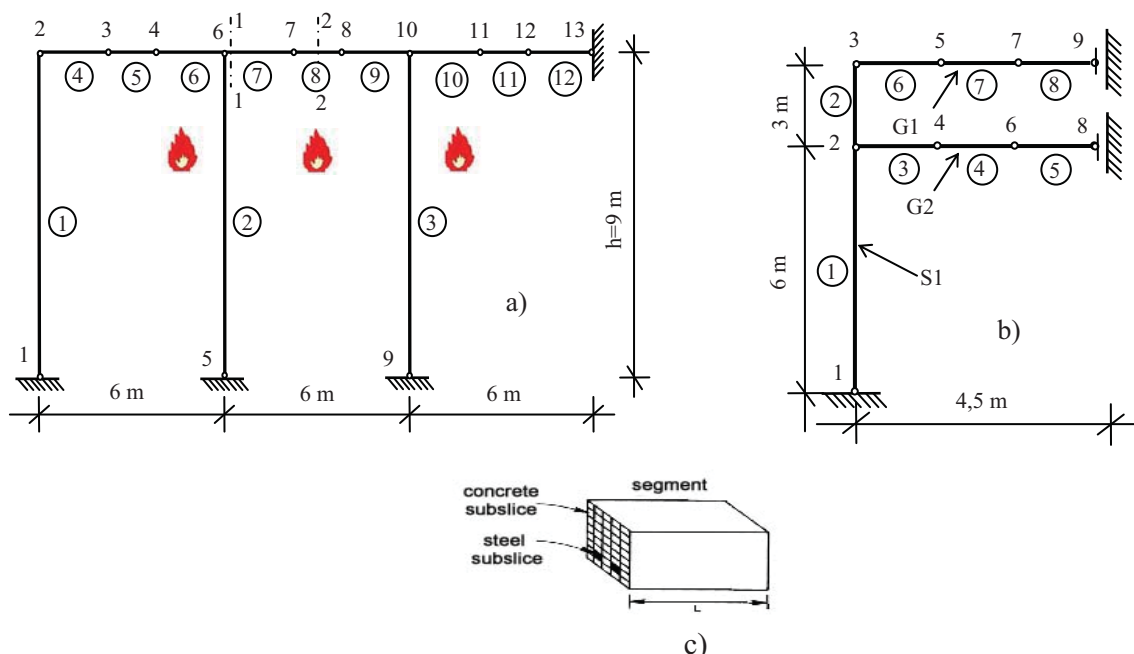
Fig. 30.9a presents discretization of beams B2 and B3 (supported by frames R1), Fig. 30.9b presents discretization of frame R1 (axial symmetry is used).

Fig. 30.9c presents discretization of the cross section of the elements (isoparametric finite elements with four node are used). Period of 30 hours was analyzed. The cooling phase was important for defining the residual bearing capacity of the structure.

Fig. 30.9 Schematic presentation of the fired structure and discretization of the elements:

a) longitudinal beams B2 and B3, b) main frame R1, c) discretization of the cross section

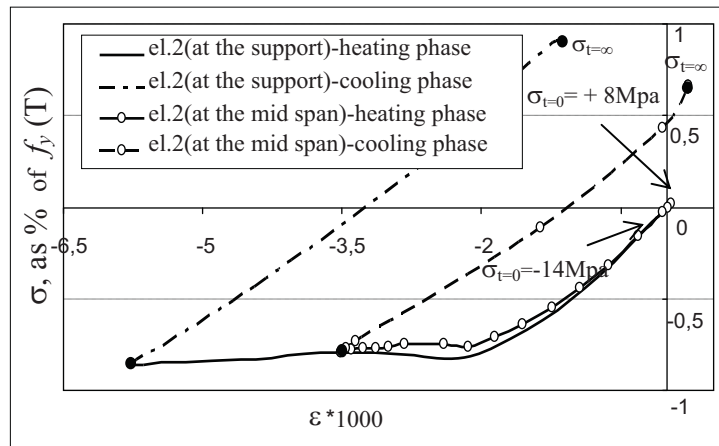
Fig. 30.10 Time dependent stresses of reinforcement no.2 of beam B2, for cross section at support and mid span, as a percent of yielding strength at corresponding temperature

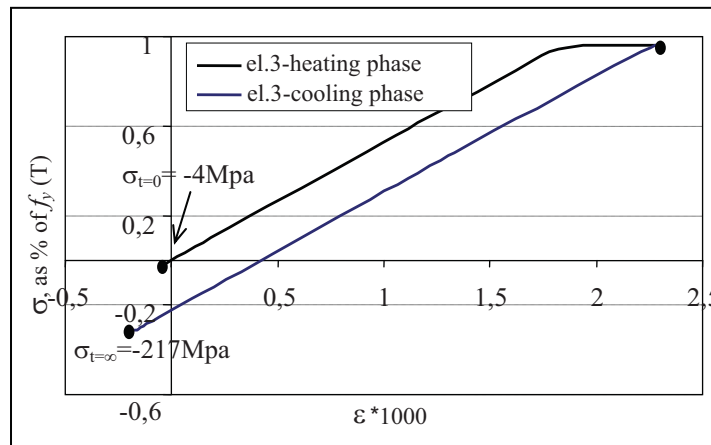
Fig. 30.11 Time dependent stresses of reinforcement no.3 of beam B2, for cross section at mid span, as a percentage of yielding strength at corresponding temperature

The stress-strain diagram for the mid span top reinforcement (temperatures less than 200°C) is as for room temperatures (Fig. 30.11).

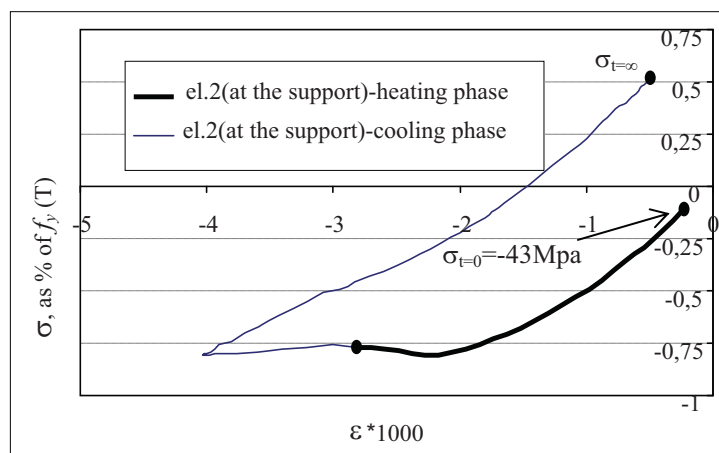
Fig. 30.12 Time dependent stresses of reinforcing bar no.2 of beam G1, for cross section at support, as a percent of yielding strength at corresponding temperature.

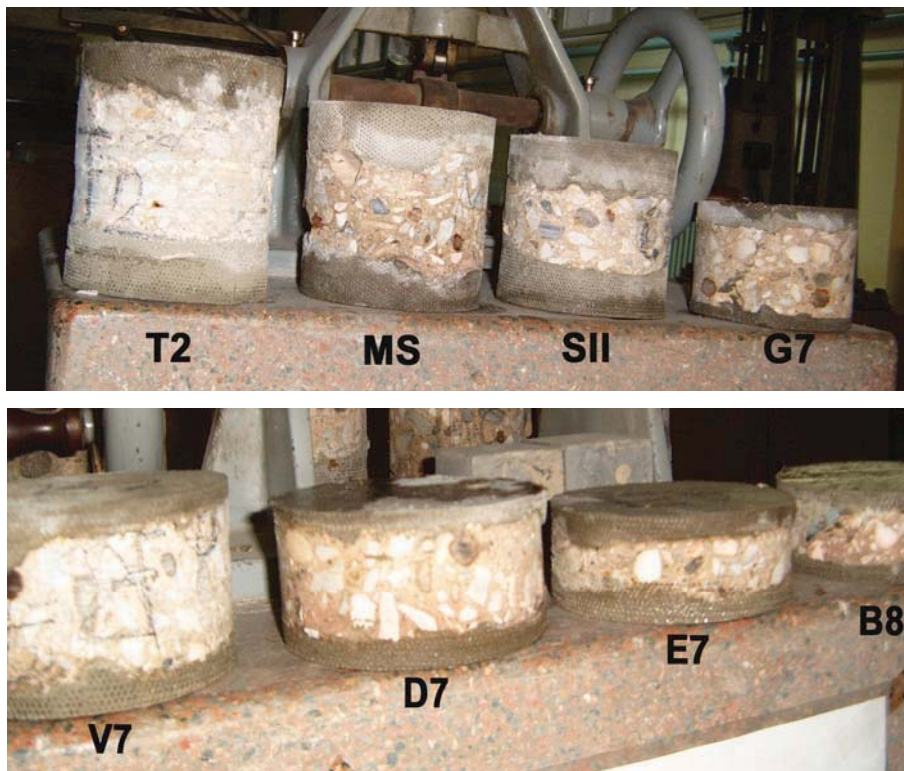
Fig. 31.4 Deteriorated concrete specimens, prepared for testing

Before testing all the specimens were divided in two slices. The deteriorated (burned) slices had small height (3-6cm) and rough surface therefore they were specially prepared by adding plaster layers (fig.4). In that case the measured values for the compressive concrete strength were reduced with coefficients depending on the shape and height (h) of the deteriorated concrete specimens. Test results are presented in Tab. 31.1.

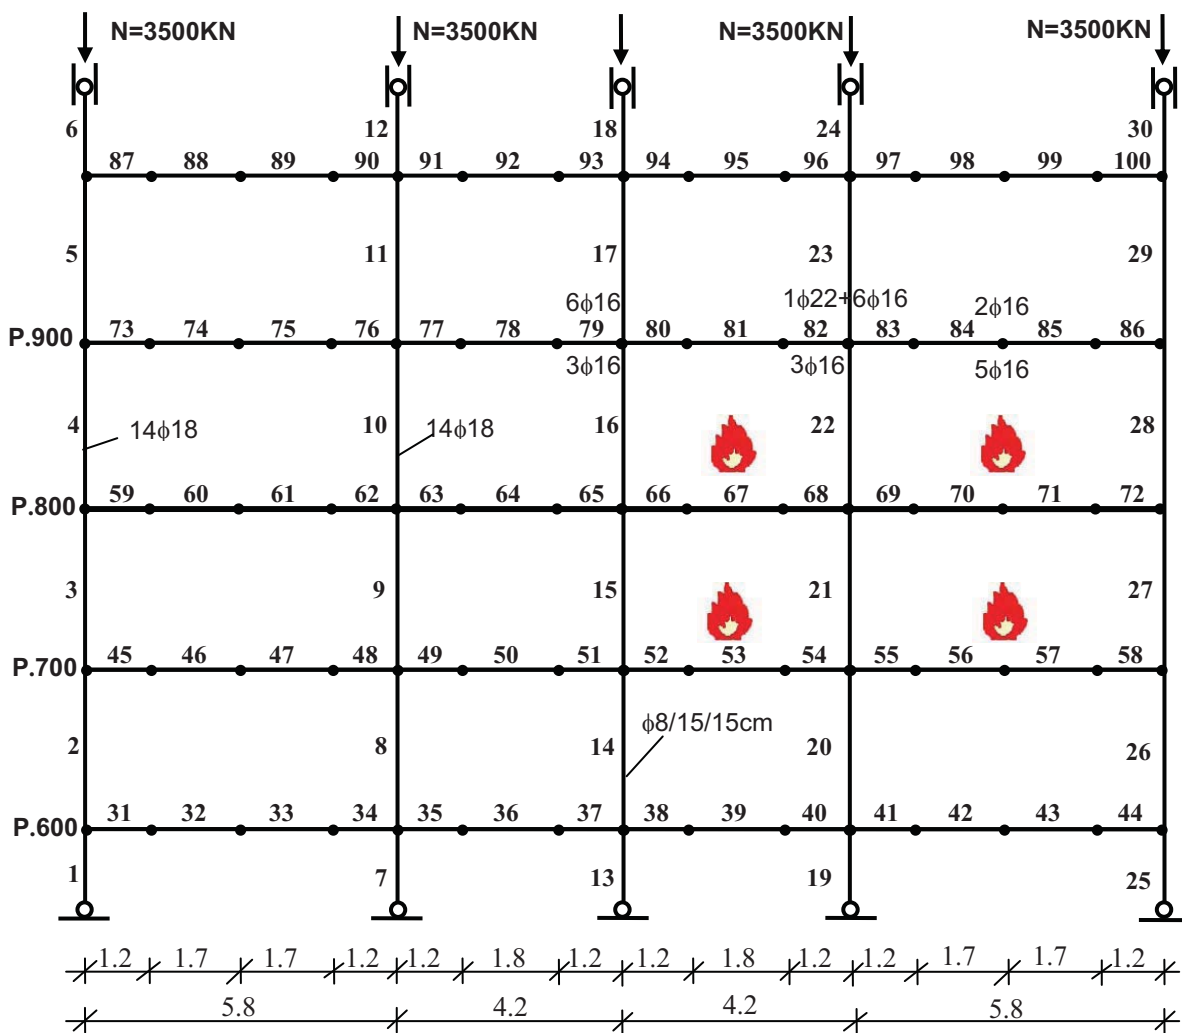
Thermal and structural response of four-bay, five-story reinforced concrete frame (only one part of the whole frame with defined support conditions) exposed to fire scenario at the two floors only, has been investigated analytically (Fig. 31.5). Elements geometry; support conditions; concrete cover thickness; type of aggregate; compression strength of concrete; steel ratio and defined fire scenario were taken into account while the nonlinear and transient temperature field and the concrete strength reduction in the cross section of the elements exposed to fire were determined.

Fig. 31.5 Schematic presentation of the fired frame (elements discretization)

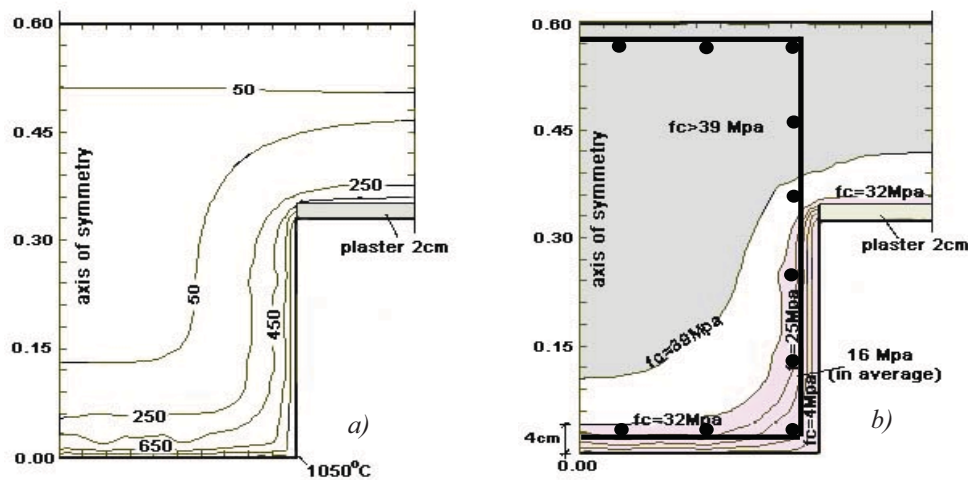
The concrete strength was reduced as a result of high temperatures in the surface layers of the cross section (fig.6a). Calculation results indicate that on the side of fire, in 4-5cm thick layer, which is 17% of the cross section of the column, the strength reduction is significant and the residual strength of concrete is 16Mpa in average (Fig. 31.6b). These results correspond well with experimental results obtained by laboratory testing of kerns taken from the nearest RC wall (B8, Tab. 31.1). In the core of the cross section the strength of concrete is not reduced.

Fig. 31.6 a) Temperature distribution; b) Residual concrete strength in the cross section of the most damaged column

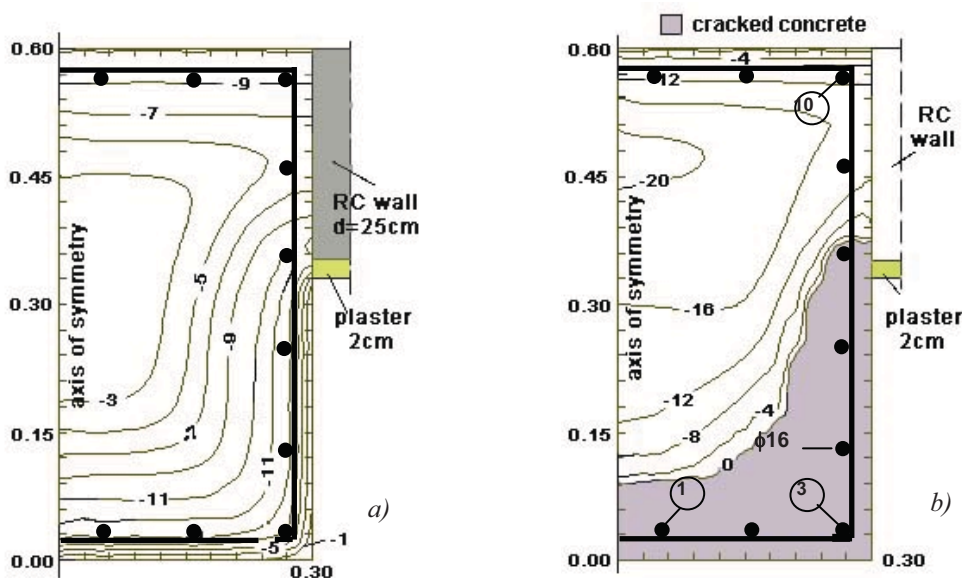
Stress redistribution was caused due to the high temperature difference between the surface layers and inner layers (Fig. 31.7a and Fig. 31.7b). During the cooling phase, when the temperature in the cross

Fig. 31.7 Stress distribution in the cross section of the most damaged column
 a) at max. temperatures; b) after the cooling period

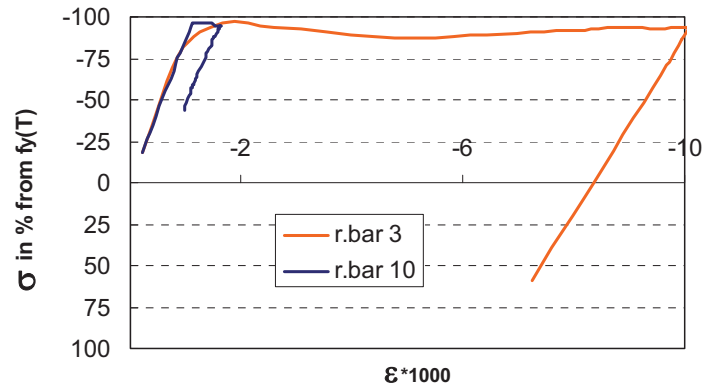
The reinforcing bars were close to fire and they were all the time in compression by the axial force and the action of fire. The yield strength was reduced due to the high temperatures, so the reinforcing bars started to yield very soon and high plastic deformations were noticed. During the cooling phase the stresses in reinforcement changed the sign and residual stresses in tension occurred, although they were loaded in compression (Fig. 31.8).

Fig. 31.8 Stresses in the reinforcing bars no.3 and no.10 of the most damaged column, as a percent of yielding strength at corresponding temperature

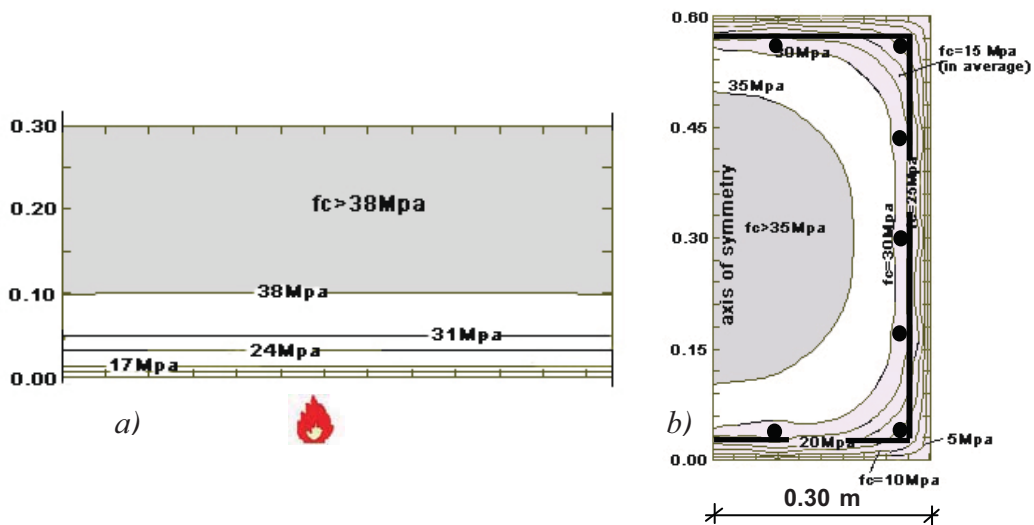
Columns S2 and S3 were exposed to fire almost from all sides, so it caused almost symmetrical cross section temperature field. In the cross section surface layers, as a result of high temperatures, the concrete strength was reduced. Calculation results indicate that in 4-5cm thick layer, which is 30% of the cross section of the column, the strength reduction is significant and the residual compressive strength of concrete is 15Mpa in average (Fig. 31.9b).

Fig. 31.9 Residual concrete strength in cross section of
 a) RC wall exposed to fire from inside; b) RC column exposed to fire from all sides

The RC walls were fire exposed only from the inside of the compartment, the temperature didn't penetrate deep in the cross sections (fig.9a) and the strength reduction was significant only in the concrete cover layers (3.0-3.5cm), therefore the repair of the RC walls is not recommended. These results correspond well with experimental results obtained by laboratory testing of specimens B8, G7, D7, E7 (Tab. 31.1) taken from the RC walls from the 7th and 8th floor. It is not the case only for the specimen V7 (Fig. 31.3a) taken from the RC wall in the room where the fire started and the temperature was highest.

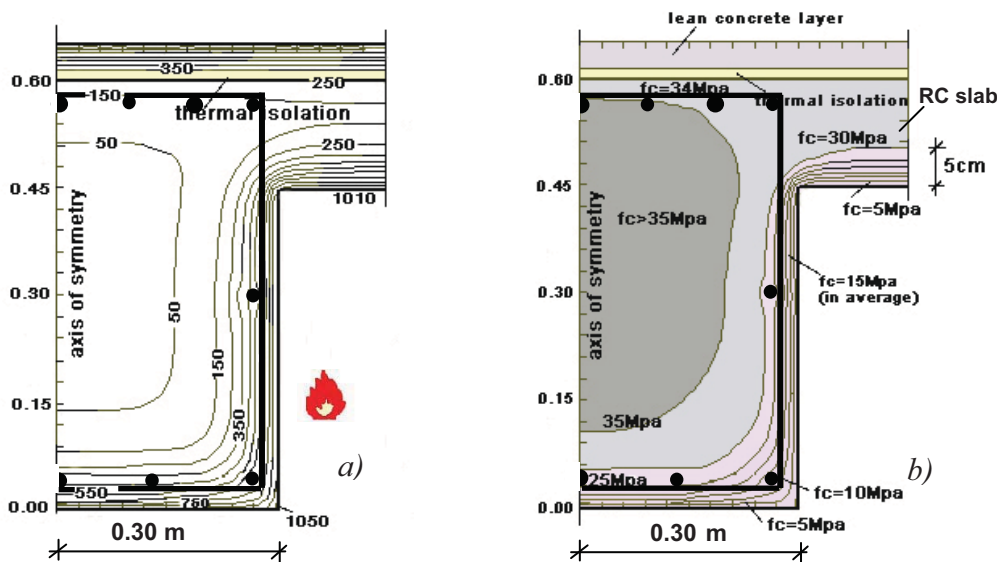
Beams from level 800 (over the 7th floor) were fire exposed from both sides, but from the upper side, as a part of the RC slabs, they were covered with 1cm thermal isolation and 4cm lean concrete (Fig. 31.1c), that directly influenced upon the cross section temperature field (Fig. 31.10a) and the concrete strength reduction (Fig. 31.10b). Beams from level 900 (over the 8th floor) were fire exposed only from the bottom side.

Fig. 31.10 a) Temperature distribution; b) Residual concrete strength
 in cross section of beam and corresponding RC slab

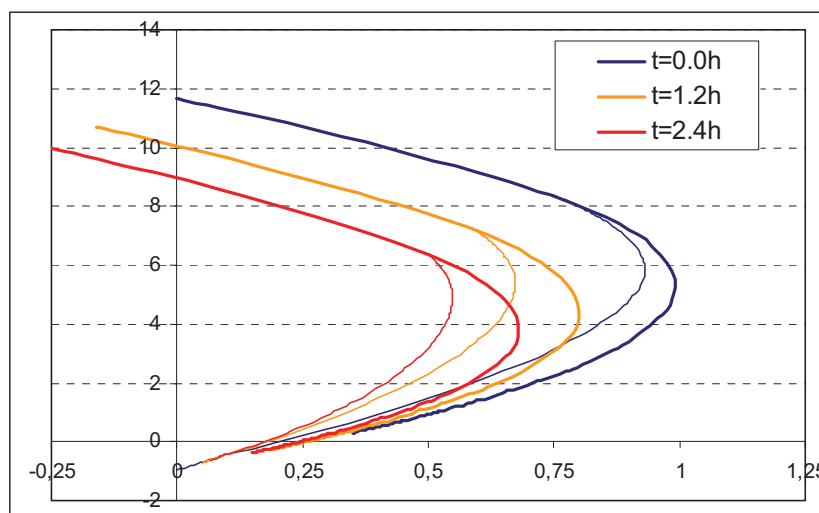
Fig. 31.11 Interaction diagram “bending moment-axial force” for column S4
(before action of fire and at the moment of max. temperature)

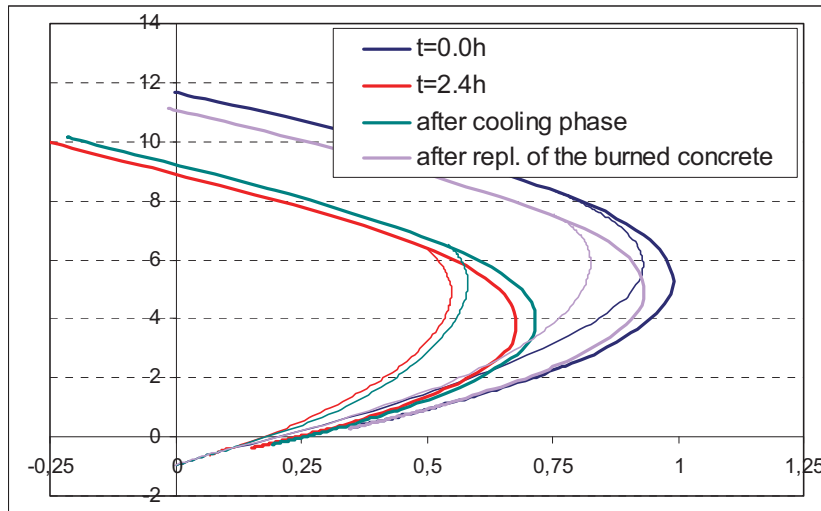
Fig. 31.12 Interaction diagram “bending moment-axial force” for column S4 (before action of fire, at the moment of max. temperature, after cooling phase and after replacement of 5cm thick layer of burned concrete)

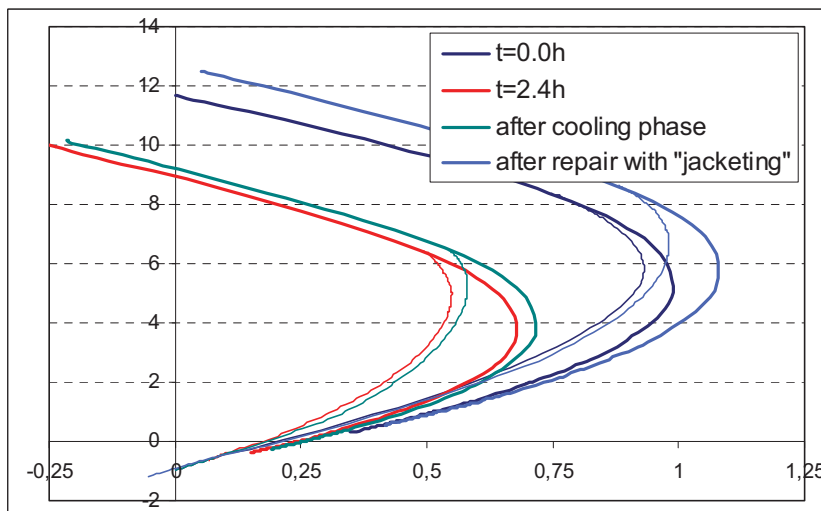
Fig. 31.13 Interaction diagram “bending moment-axial force” for column S4 (before action of fire, at the moment of max. temperature, after cooling phase and after suggested repair with “jacketing”)

The interaction diagrams indicate negligible increase in bearing capacity and ductility of the cross sections after the cooling phase. Replacement of the deteriorated 4-5cm thick concrete layers with new concrete layers has a negligible effect too, therefore the suggested repair is: replacement of the deteriorated 4-5cm thick concrete layers with new concrete layers; addition of main reinforcement and stirrups, addition of new lateral 3cm thick concrete layers. This method is well known as “**jacketing**” and it is most effective if the new layers are made from all sides (the jacket is closed). In this case, due to the elements position, jacketing is not possible from all sides and the suggested solution is jacketing of columns

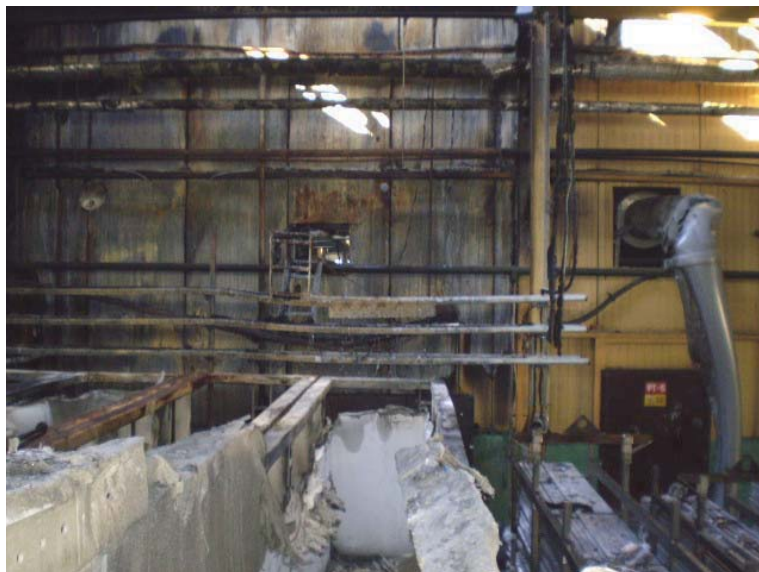
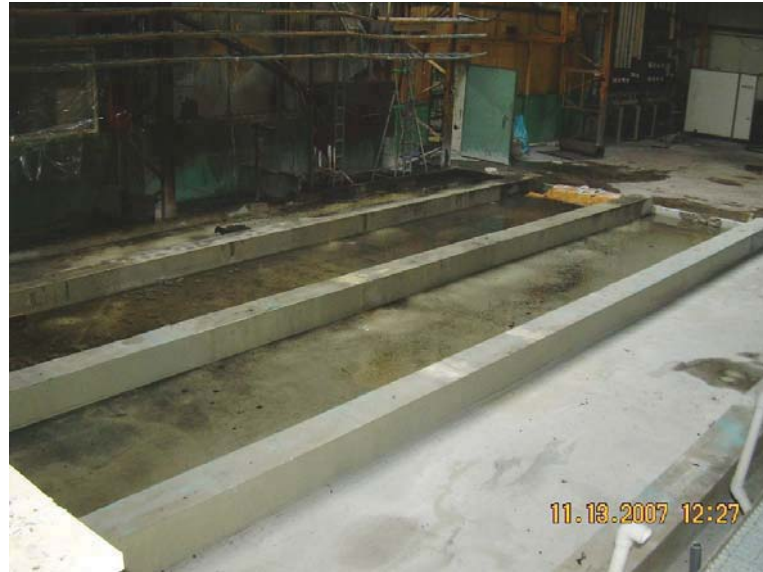
Fig. 32.1.1

The fire took place on 1st of August 2007. In a result, few lacquer tanks made of polypropylene which were located near the outer longitudinal wall, were completely burnt, (Fig. 32.1.1, 32.1.2).

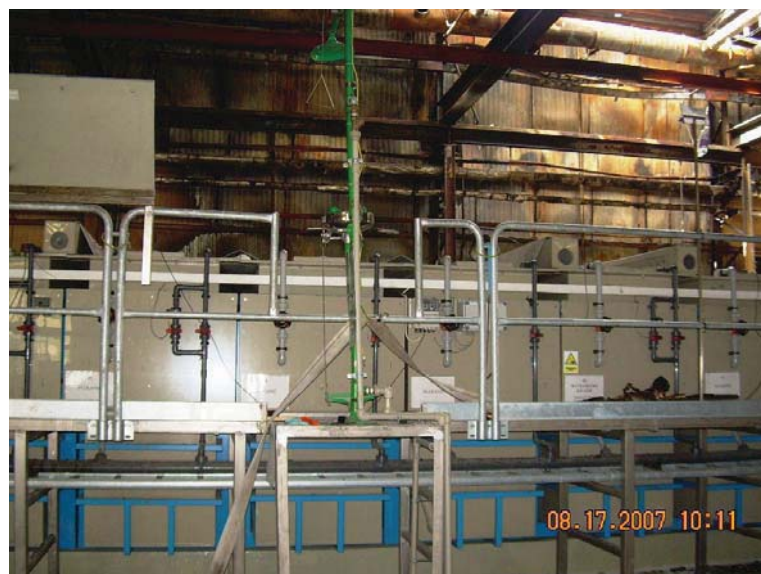
Fig. 32.1.3

Unfortunately, no data are available, how long the fire lasted, and what temperature prevailed in the hall during a fire. As it was mentioned before, the steel structure of the object was not protected against high temperatures at all. The upper parts of two neighbouring columns, located near the fire source were strongly damaged. Some structural components of columns such as diagonals and posts have been locally deformed and destroyed, (Fig. 32.1.3).
