## High-rise Buildings in Post 9-11 Period

Venkatesh Kodur  
Michigan State University

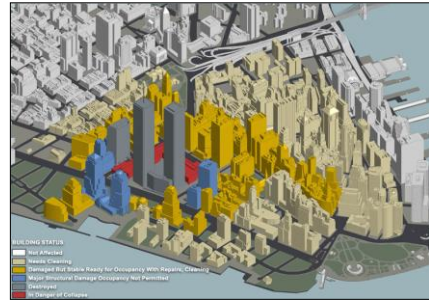
## New York Financial District

Excerpt from FEMA report

- Collapsed – 4
- Partially collapsed – 4
- Major structural damage – 9
- Minor structural damage – 18
- Needed cleaning – Number of buildings
- Buildings inspected – 406
- Loss of office space – 30 million sq. ft.
- Affected area – 1 to 2 miles radius

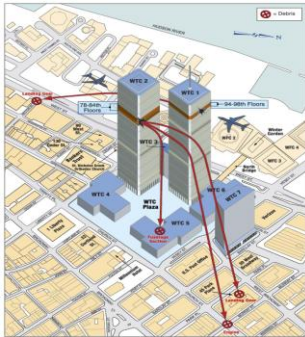
## Significance of Impact

Excerpt from FEMA report

- Debris penetrated building core
- Damage to core columns

- Impact shattered and fractured 2/3 of columns on one face
- Partial collapse of floors occurred at
- Impacted columns
- Debris penetrated building core
  - Damaged core columns
  - Damaged stair shafts & elevators
- Impact caused failure of fireproofing in affected area
- Initiated fire
