## 15 Text of PowerPoint Lesson

#### Connection Design for Fire Safety - Cardington Structural Integrity Fire Test

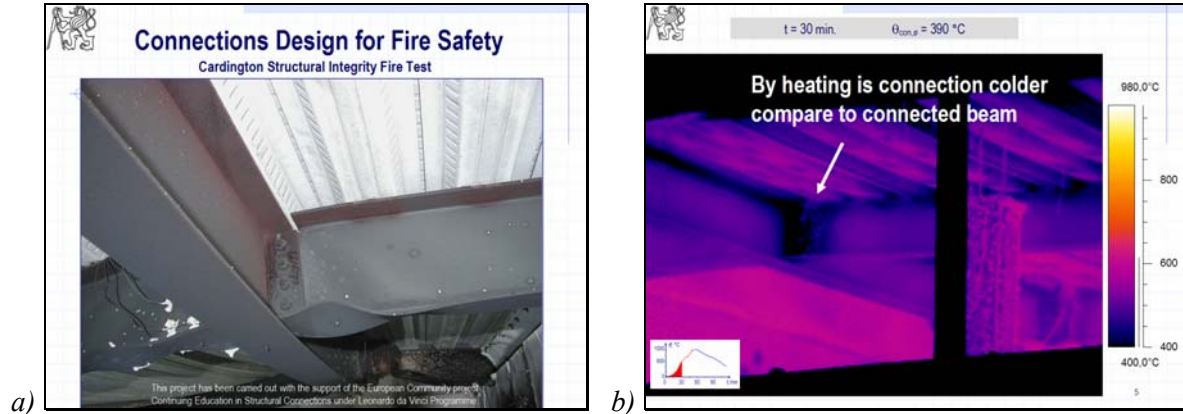
Figure 15.1 a) Front page of PowerPoint lesson "Connection Design for Fire Safety",  
b) a slide from the lesson "Heating and Cooling of Structure"

The Chapter 9 - Fire design is equipped with the PowerPoint lessons including video/audio sequences, see Figure 15.1.
