**TENSILE MEMBRANE ACTION AND ROBUSTNESS
OF STRUCTURAL STEEL JOINTS UNDER NATURAL FIRE
EC FP5 HPRI – CV 5535**

**Cardington Fire Test
January 16. 2003**

David Moore, František Wald, Aldina Santiago
BRE Watford, CTU in Prague, Coimbra University

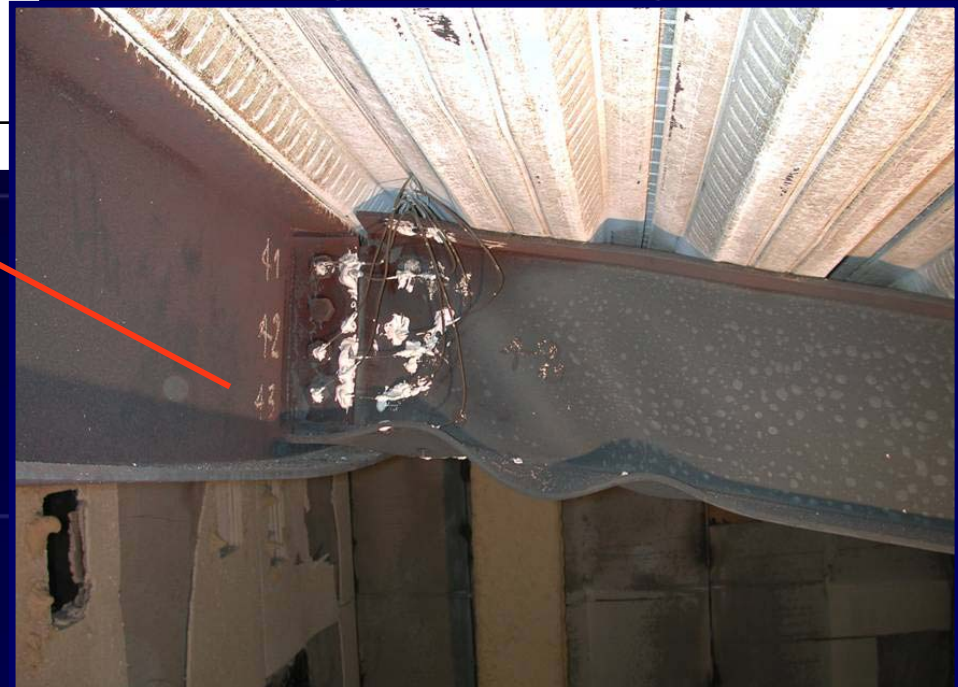
Ovalization of holes in the web beam in the fin plate joints

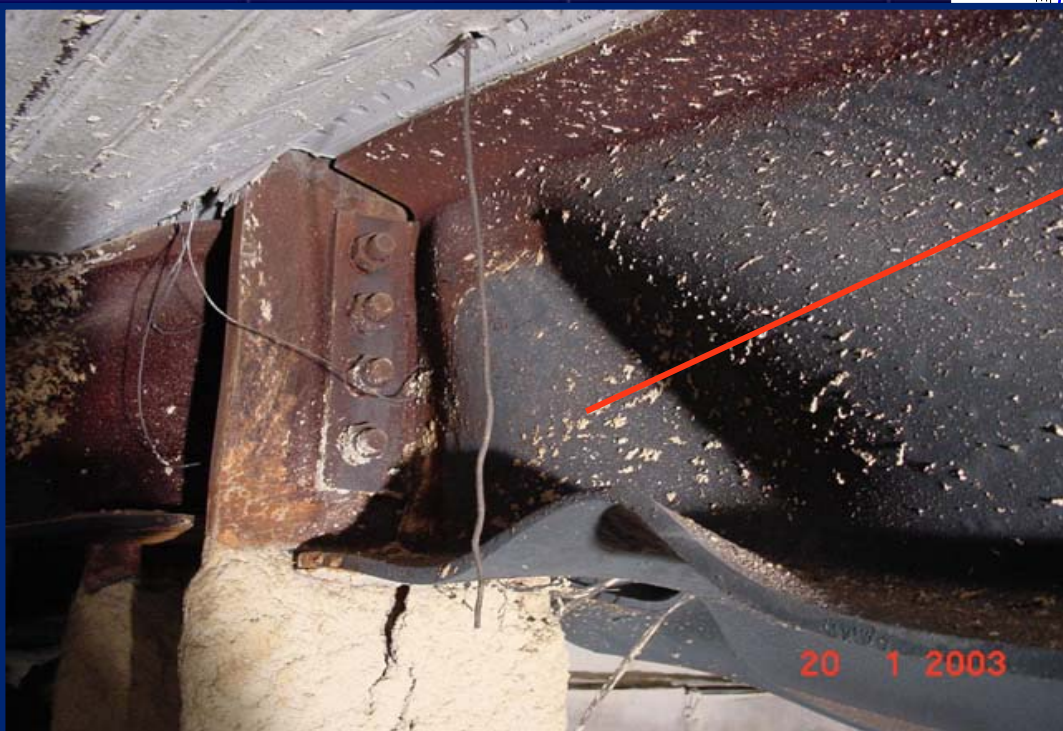
Beam Web Shear Zones

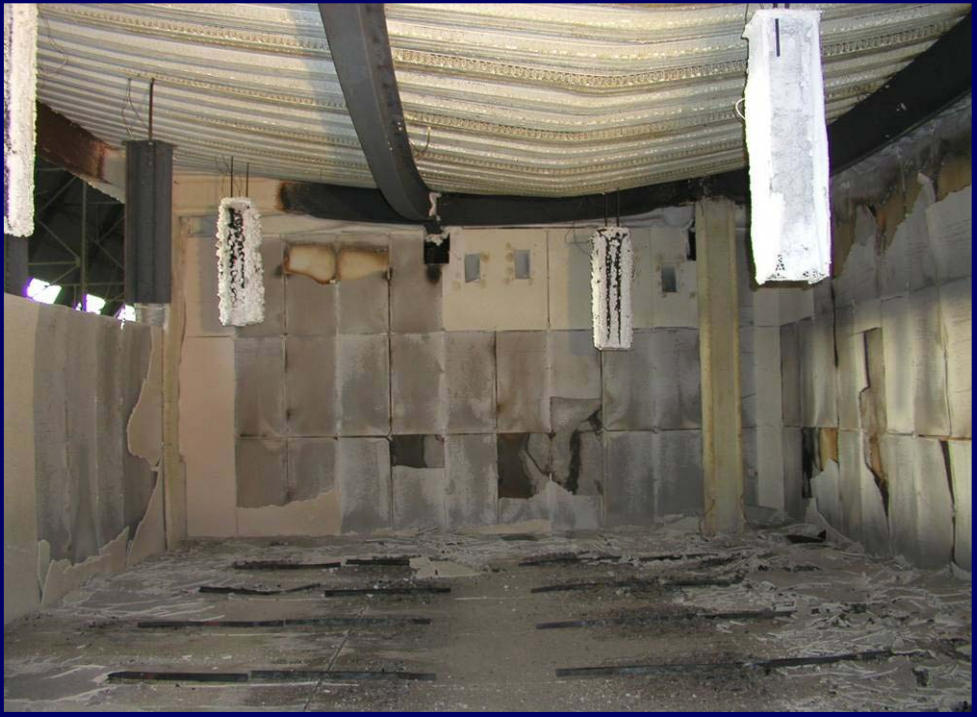
Slab deflection after test
Date: 23th January 2003

Residual deformation max 925 mm
